# FOUNDATION SOIL CHARACTERISATION FOR A BUILDING WITH MULTIPLE CRACKS AT TARKWA, GHANA

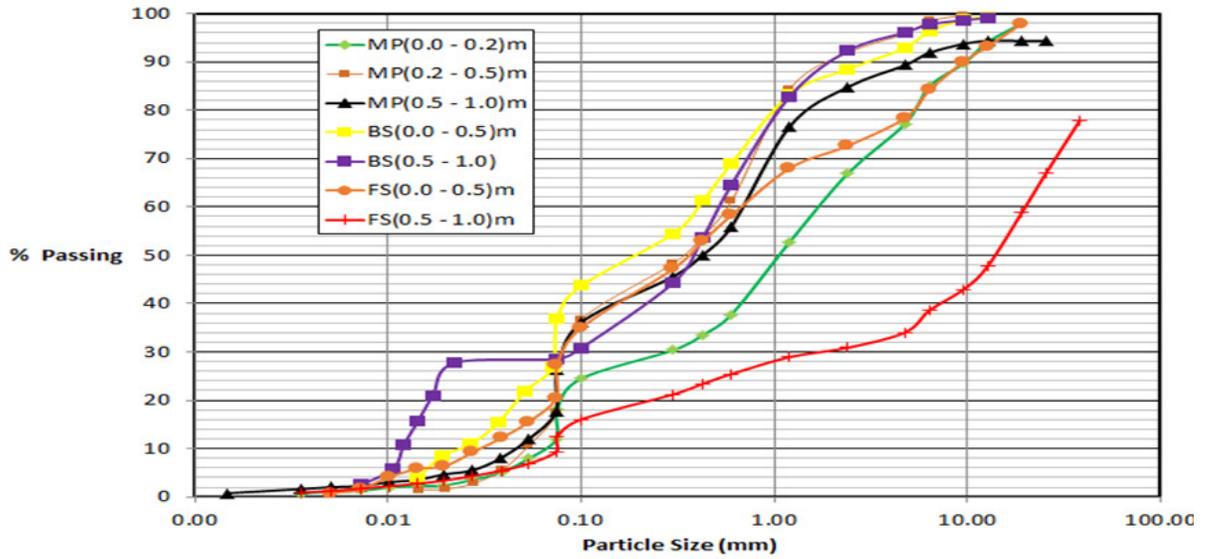
Figure 1: Particle Size Distribution of Soils at the Tarkwa Site

The area is underlain by dense silty sand with admixtures of gravel and minor clay. The average moisture content is 8.9% with average specific gravity of 2.7; typical of quartz sands.

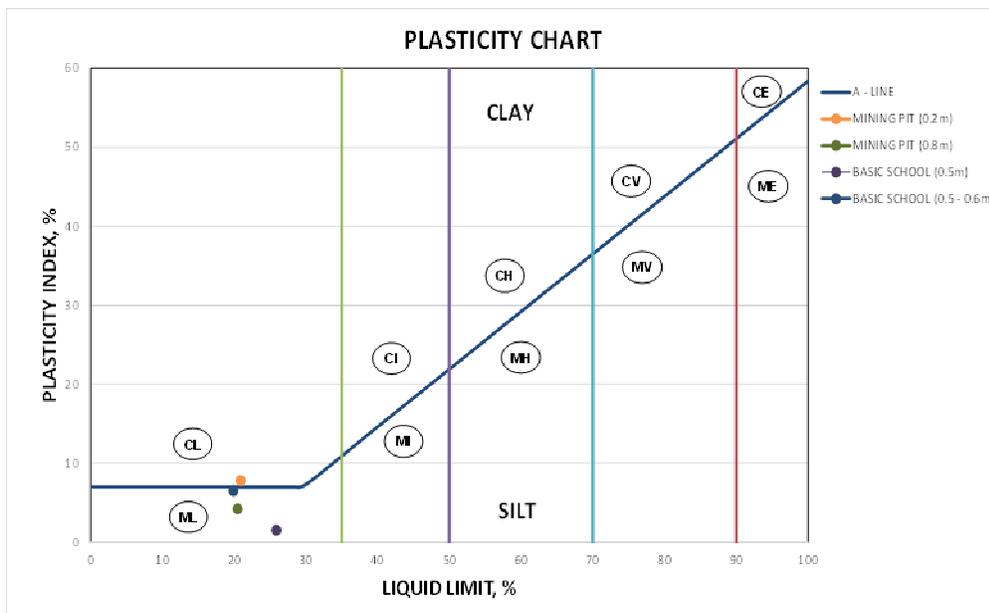
Figure 2: Plasticity Index vs. Liquid Limit of the Soils from Tarkwa Site

The plasticity index ranges from 1.5% to 7.8% with an average of 4.9%. Figure 2 shows that the soil is silty with low plasticity.
