**Usefulness of River Training Structures and Present Status in Patuakhali District Bangladesh**

**ABSTRACT**

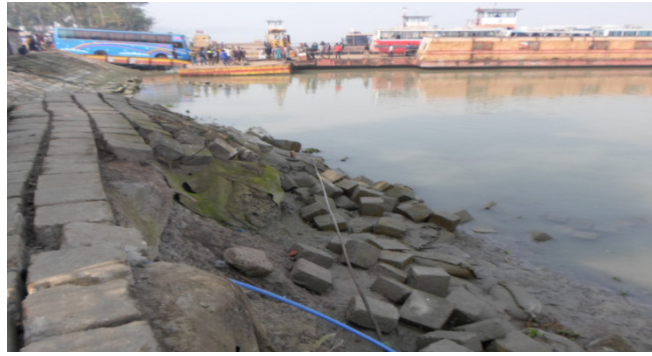
| Name of River | Bank failure | Location Name | Level of risk |
|---|---|---|---|
| Payra, | Sever | Lebukhali Feri Ghat point | High |

**Fig.2.** Photographic view showed the severe erosion prone area at Lebukhali Point of Payra River.

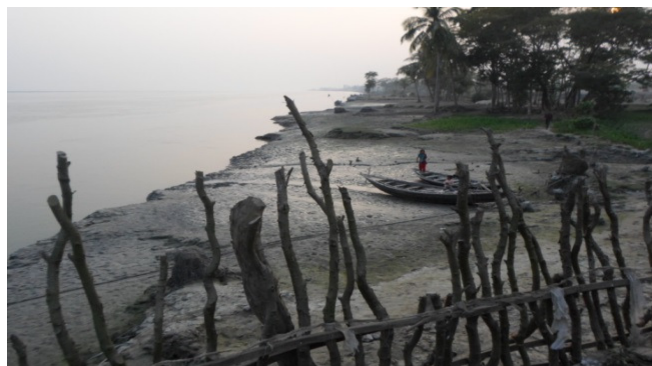
| Bandals | Short time stable | Velocity of water reduced and flow diverted. Sand bar formed near bank finally reduce erosion. |

**Fig.5.** Photographic view of bandaling structure used for controlling bank erosion at Kajal river side in Galacipa.
