Degradation of Crystalline Silicon Photovoltaic Cells/Modules under Heat and Temperature Effect

Original Research Article

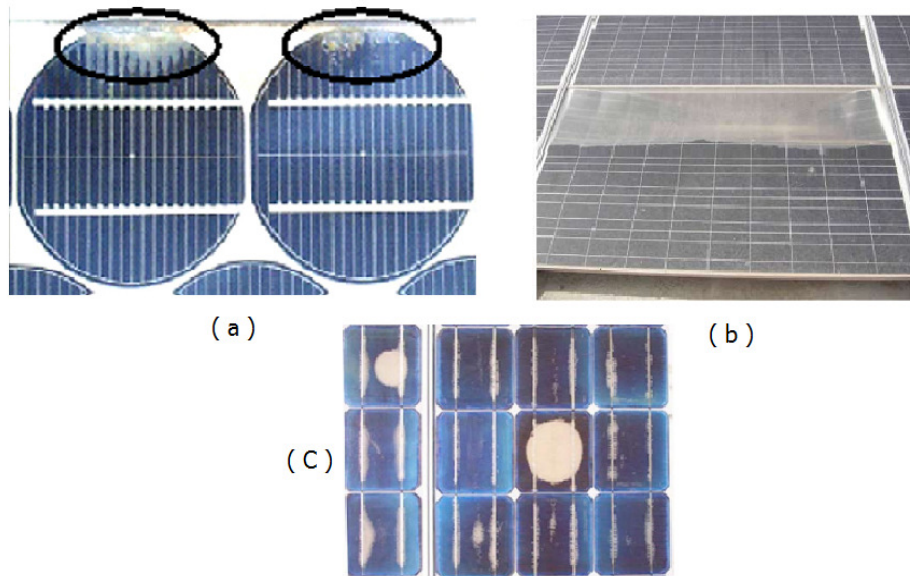
Delamination is very frequent in hot and humid climates. It causes moisture penetration in the PV module and therefore induces various chemical and physical degradations such as metal corrosion of the module structure most frequently. Delamination is more severe if it occurs in the borders of the module because, a part from the power losses causes electrical risks to the module and the installation. Delamination is also related to a transmittance loss, as materials are not well optically coupled and a part of the light escapes [16-19] (Fig.1).

Fig. 1. (a) PV module délamination; (b)-(C) severe delamination (this figure presents an example of how an extreme delamination could destroy a PV module when the defect appeared after barely a year of functioning) [1,16,17]

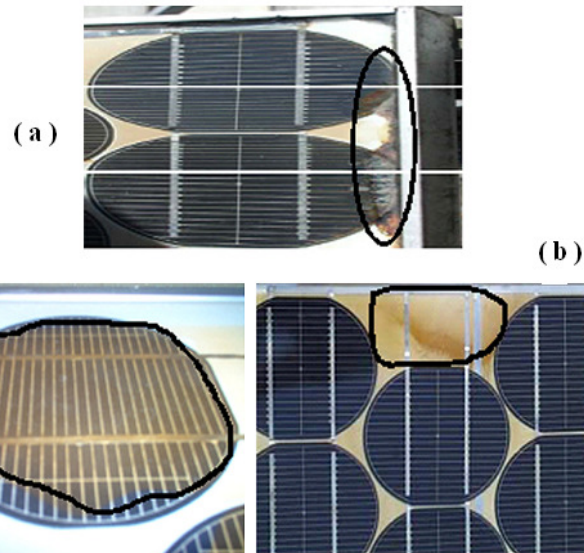
The corrosion attacks the metallic connections of PV cells causing a loss of performance by increasing leakage currents. Corrosion also degrades the adhesion between cells and metallic frame [3]. [20] Have been found out that corrosion appeared after 1000h of exposure of PV module under 85°C and 85% of relative humidity. Corrosion and discoloration are the predominant modes of photovoltaic modules degradation [3, 5] (Fig.2).

Module discoloration is a change in color of material which turns yellow and sometimes brown. It modifies transmittance of light reaching PV cells and therefore the power generated by the module is reduced. In addition, discoloration degrades the short-circuit current (I_{sc}) of PV module. This degradation may vary from 6% to 8% below the nominal value for a partial discoloration of the PV module surface and from 10% to 13% for complete discoloration [1,4,21,22,23]. The Maximum power (P_{max}) of the PV module is also degraded by module discoloration.

Fig. 2. (a) PV module affected by corrosion at the edge and the junction box [3]; (b) Solar cells discolored [1,19]

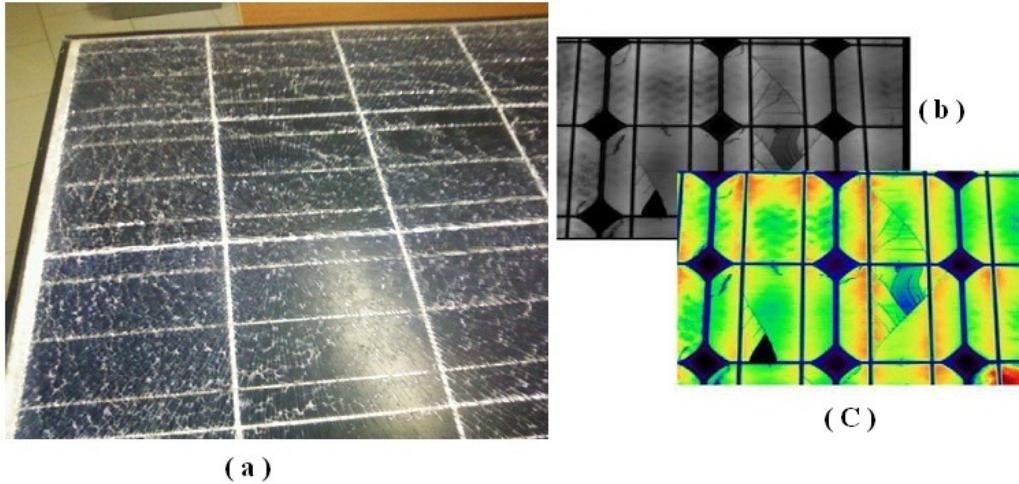
Glass breakage is one of an important degradation factor of PV cells/modules. Breakages and cracks are usually followed by other degradation types such as corrosion, delamination and discoloration [1, 13, 20] (Fig.3). Our investigations shown that, it is generally impossible to detect cracks on the already operational PV module to the naked eye. This detection can be done by using optical methods [24]. This method essentially consists of applying an intense wideband light (1000 suns) and detecting the path where the light passes through the cell or, on the contrary, is blocked due to the reflections that can cause a crack.

Fig. 3. (a) PV module with broken glass; (b) and (C) Cracks in cells. B &W image a simulated color image [1,24]

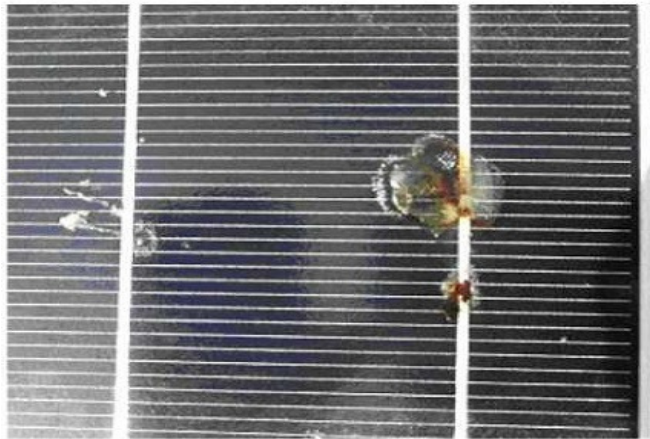
parts of the cell avoiding the photocurrent generation. The effect of long-term exposure of the PV modules to a very high temperature, damages the cell or any other elements of the module [1]. This induces hot spots in some areas of the cell. Hot spots cause a variety of cell failures: shadowing, cells mismatch or failures in the interconnection between cells. This defective cell becomes a load for other cells, and a place of a relatively high thermal dissipation constituting thus a hot spot [1, 25]. Hot pots can cause damage to the cell or the

encapsulant within a short time of operating (Fig. 4).

Fig. 4. Hot spot damages the PV cells/modules and reduces their performance [26]

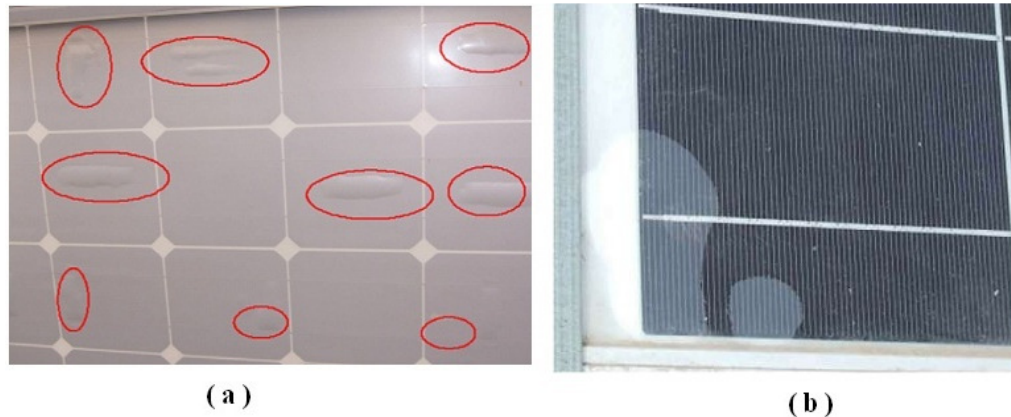
Fig.5. (a) Bubbles on the back side of a PV module [1, 3]; (b) Bubbles on the front side of a PV module [24]

Bubbles are generally due to chemical reactions that emit gases trapped in the PV cell/module (Fig. 5).

Bubbles located on the module front side produce a reduction of the radiation reaching the module. Which cause a decoupling of the light and increase reflection [3]. This kind of defect is similar to delamination, but in this case, the lack of adherence of the EVA affects only a small area and is combined with the blowing of areas where this adherence has been lost. These defects appear in the center of the cell and may be due to poor adhesion of the cell caused by the high temperature. [1, 3]. When bubbles occur in the back side of the PV module, a bulk appears in the polymeric encapsulant or the back cover, forming a bubble. Bubbles make the heat dissipation of the cells more difficult, overheating them and subsequently reducing the lifetime of these cells. Bubbles have been detected using IR techniques [27], as they are not visible through visual inspection alone but rather cause a temperature change (Fig.5). In addition, the bubble forms an air chamber, and although the air temperature in the chamber appears lower than in the adjacent cells, the cell temperature is actually higher because the heat of the cell is less dissipated [26]. Moreover, the yellowing and browning cause a change in the transmittance of the light reaching the solar cells and thus a decrease in the power generated. The main cause of these defects in EVA and in ethylene copolymer films is UV radiation and water exposure combined with temperatures above 50 °C that induce a change in the chemical structure of the polymer [21]. In some PV cells/modules, yellowing appears in some areas but not in adjacent areas with a different polymeric encapsulant of a different origin or
