Original Research Article**REPAIR AND STRENGTHENING OF R.C FLAT
SLAB CONNECTION WITH EDGE COLUMNS
AGAINST PUNCHING SHEAR****ABSTRACT**

Aims: Study the strengthening and repair of the flat slab-edge column connections against punching shear.

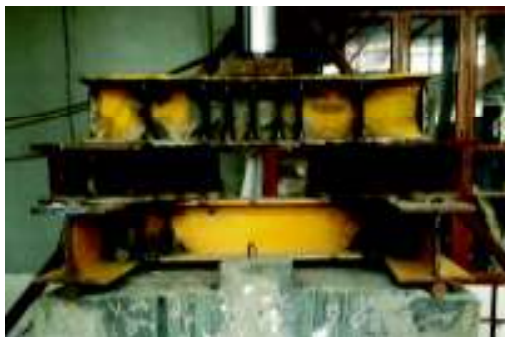
Fig. 5. The rigid steel system used to distribute the concentrated load.

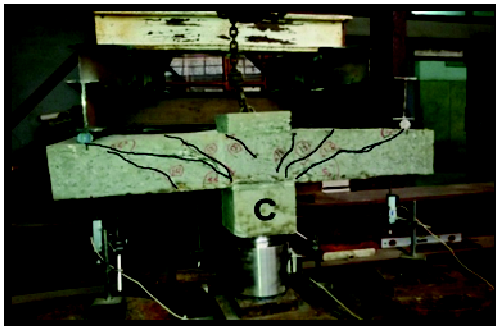
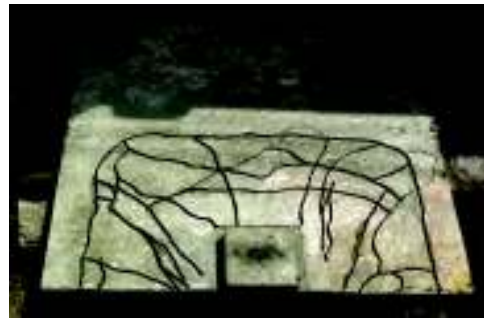
Fig. 20. Cracking pattern of specimen (C).

All the tested specimens were loaded until failed due to punching shear. For all specimens, the first crack was recorded, cracks propagation were monitored, and the mode of failure was determined. Table. 4. shows the load value corresponding to cracking initiation (V_{cr}). Strengthening and repair systems led to an increase of the first crack load. Cracks began firstly at the slab compression side near to the column edges. As the applied load increases the number and width of the cracks increase and new cracks develop and began to propagate in radial directions towards the slab edges. Also, fine cracks were observed running from column edges at tension side towards the slab edges in the three directions. For all the tested specimens, it was observed that the column penetrated the slab at failure and the upper perimeter crack had a semi - rectangular shape at the slab tension face.

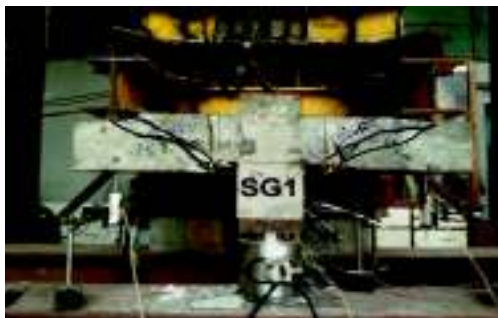
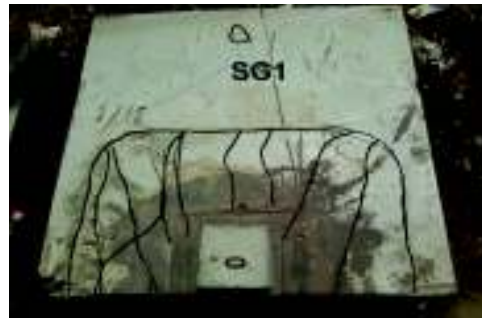
Fig. 21. Cracking pattern of specimen (SG1).

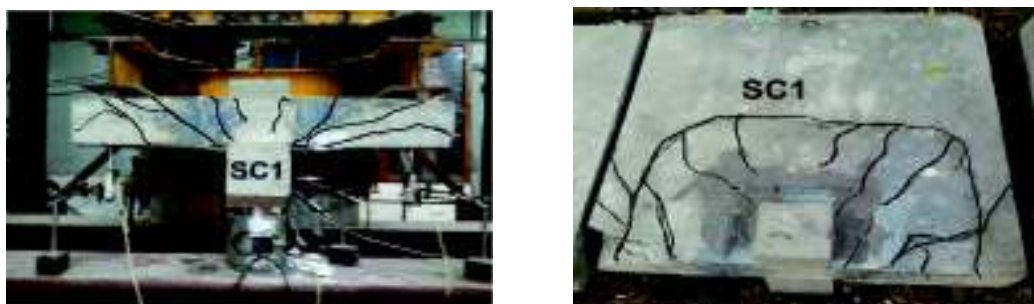
Fig. 22. Cracking pattern of specimen (SC1).

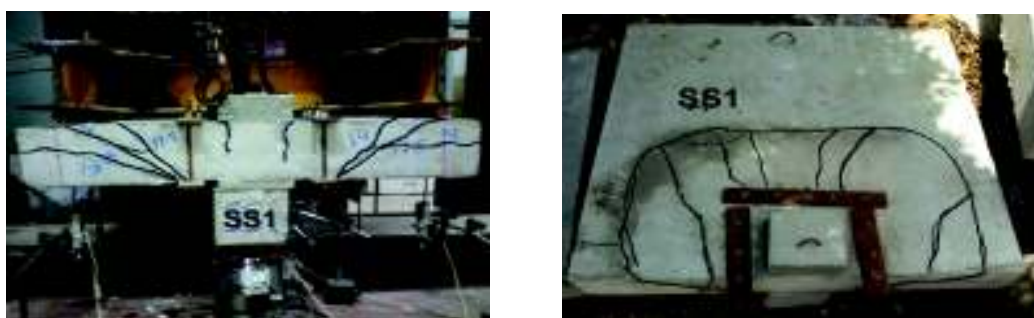
Fig. 23. Cracking pattern of specimen (SS1).

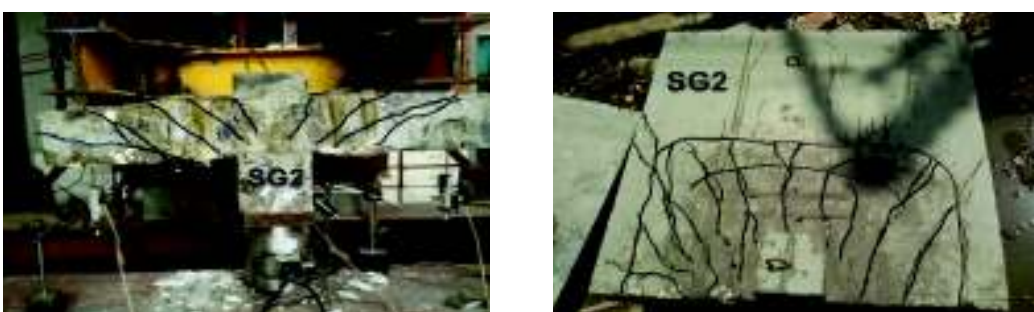
Fig. 24. Cracking pattern of specimen (SG2).

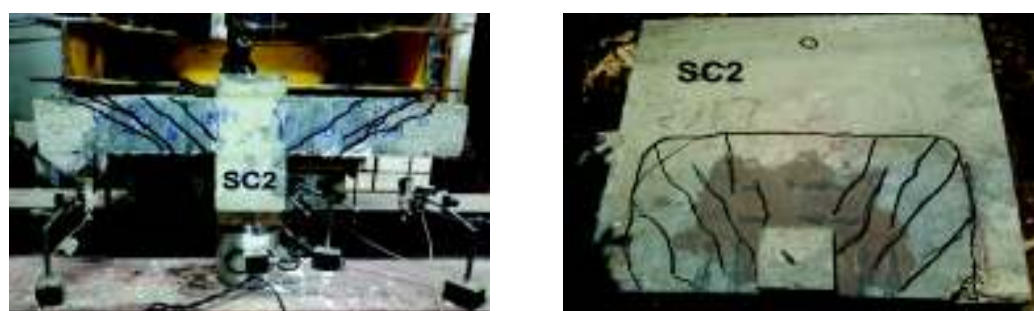
Fig. 25. Cracking pattern of specimen (SC2).

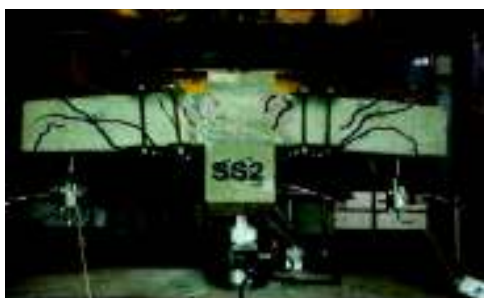
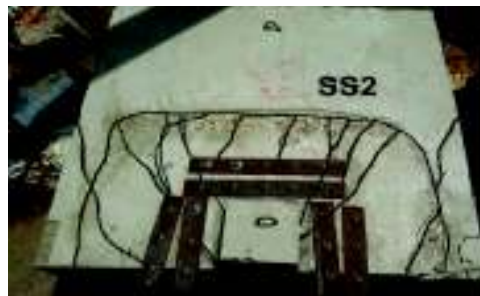
Fig. 26. Cracking pattern of specimen (SS2).

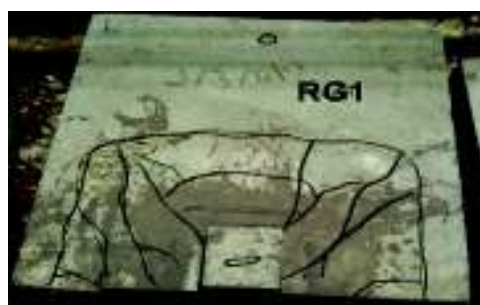
Fig. 27. Cracking pattern of specimen (RG1).

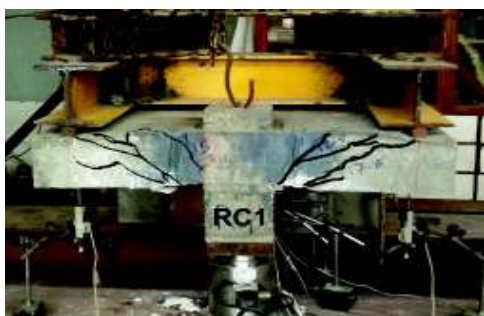
Fig. 28. Cracking pattern of specimen (RC1).

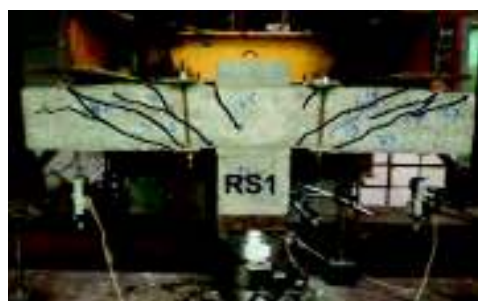
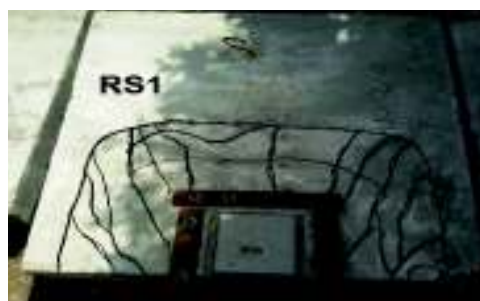
Fig. 29. Cracking pattern of specimen (RS1).

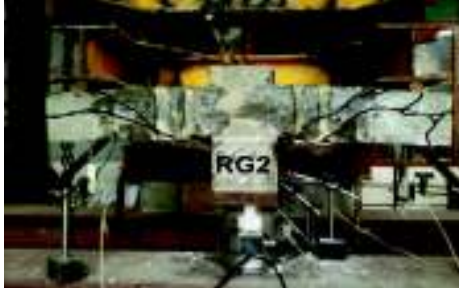
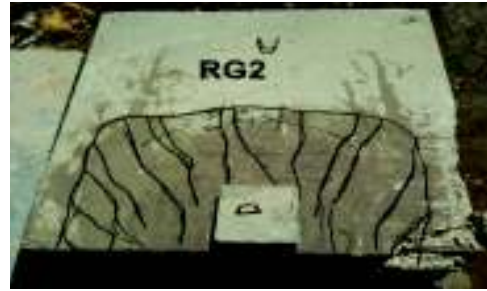
Fig. 30. Cracking pattern of specimen (RG2).

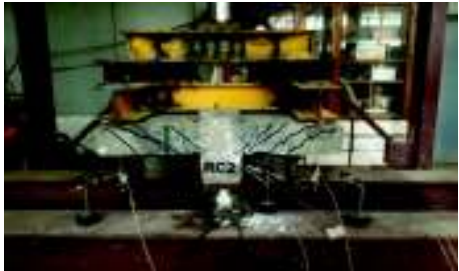
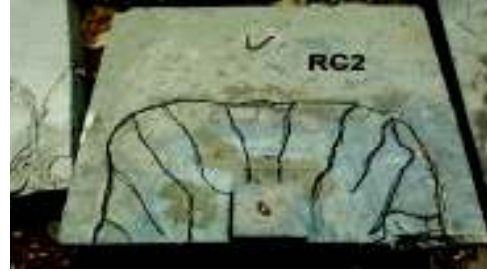
Fig. 31. Cracking pattern of specimen (RC2).

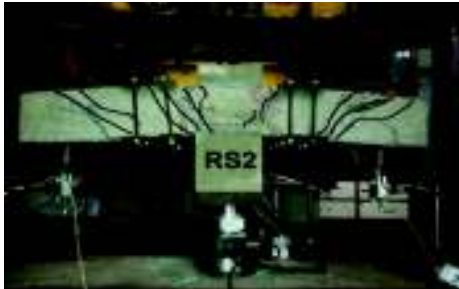
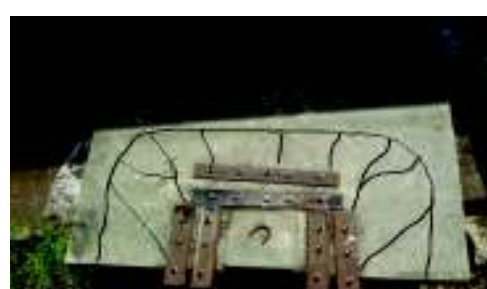
Fig. 32. Cracking pattern of specimen (RS2).
