Flexural Behavior of Steel–Concrete–Steel Sandwich Slabs

ABSTRACT

Aims: study the flexural behavior of steel–concrete–steel sandwich slabs.

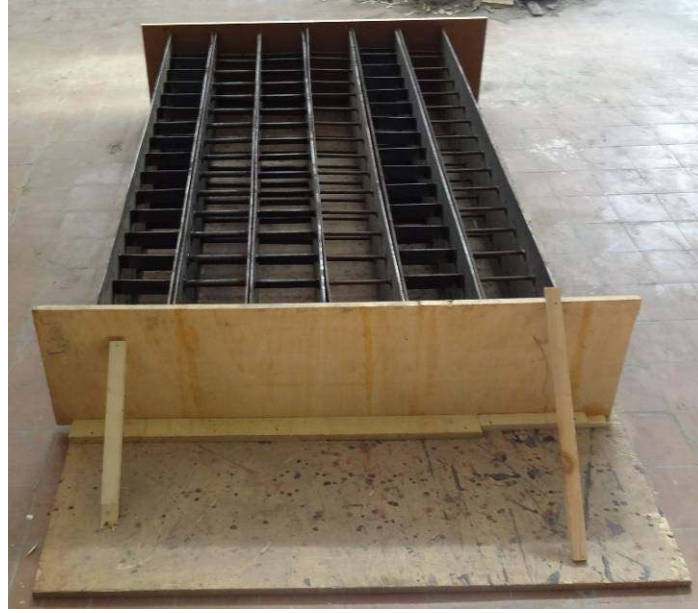
Fig. 4. Formwork in vertical position for concrete pouring.

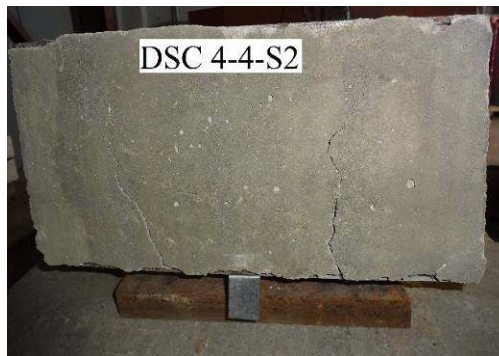
Fig.6. Mode of concrete cracking for specimen DCS 4-4-S2.

Two types of cracks were observed. The first type occurred due to tensile stresses at the bottom side of the specimen, especially at mid span, as shown in Fig 6-a. The second type occurred due to the mutual pressure between steel studs and concrete which causes a longitudinal splitting cracks of concrete at the studs line, as shown in Fig 6-b. For all tested specimens, both cracking types were observed. However, the first type was noted firstly then the second type was observed suddenly at failure.

(a) Wide flexural crack in concrete core.

(b) Splitting cracks in concrete core.

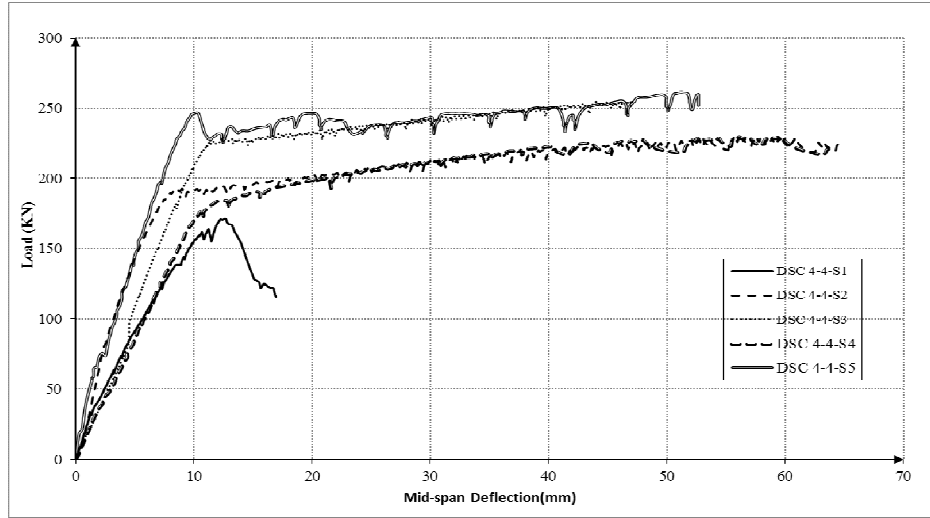
The measured test results for the ten specimens are summarized in Table 3. Load-deflection Plots are given in Fig.7.a and Fig 7.b for plates of 4 mm and 6 mm thickness, respectively.

(a) Load -deflection curves for (DSC 4-4) series experimental test results

(b) Load -deflection curves for (DSC 6-6) series experimental test results
Fig. 7. Load-deflection plot for all the tested specimens.

It can be seen from Fig.7 that load-deflection curve deviates from linear behavior after the beginning of steel plates yielding in most cases. For specimen DSC 4-4-S1, the first sign of crack appeared in the concrete when the load reached to 50 KN. A loud sound was heard indicating the breaking of shear studs when the load reached to 172 kN. After maximum load was reached, a load reduction was observed in load-deflection curve. Strain results at the mid span showed that yielding of bottom plate started when the load reached to 138 kN.

Specimen DSC 4-4-S2 compared to DSC 6-6-S2 had showed a softer behavior which is expected, at a load of 50 kN, the first sign of cracking appeared in the concrete at the mid span, then the crack were propagated and the load-deflection curve became even more flat and continued till the load failure is reached at 228 kN and deflection recorder 57 mm. The tension cracks at mid span and splitting cracks at the ends are shown in Figs. 8a and 8b, respectively. Wide cracks in the concrete at the supports indicated the presence a high pressure on concrete. 28 mm slip was observed between bottom plate and concrete at the ends.

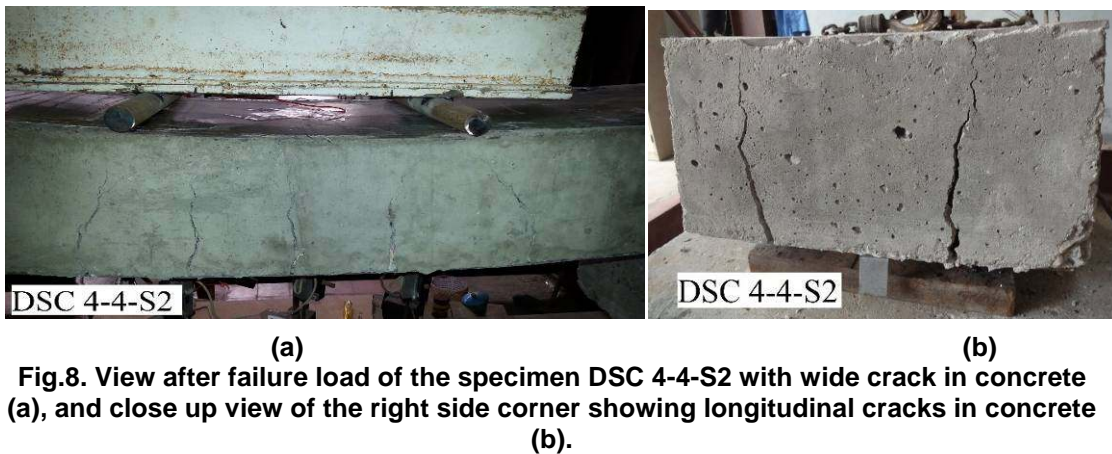
Fig.8. View after failure load of the specimen DSC 4-4-S2 with wide crack in concrete (a), and close up view of the right side corner showing longitudinal cracks in concrete (b).

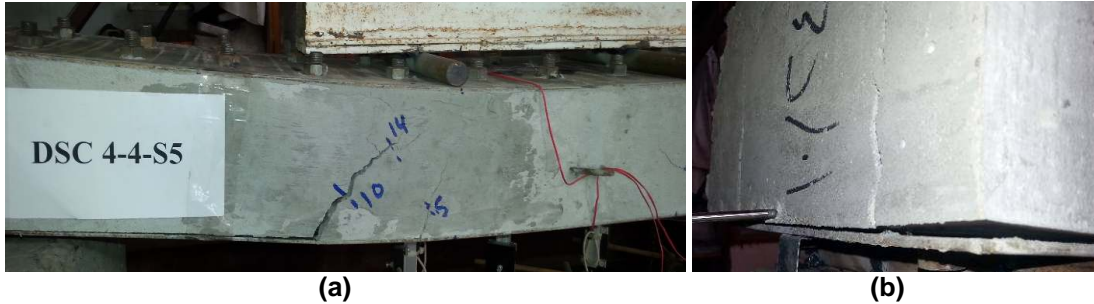
For DSC 4-4-S5, the first crack appeared in concrete when the load reached to 50 kN. Cracks appeared in the concrete at many locations of mid span then the load-deflection curve became even more flat and continued till the load failure is reached at 198 kN and the deflection was 51 mm, as show in Fig.11a and 11b.

Fig. 11. View after failure load of the specimen DSC 4-4-S5 with wide crack in concrete (a), and close up view of the right side corner showing longitudinal cracks in concrete (b).

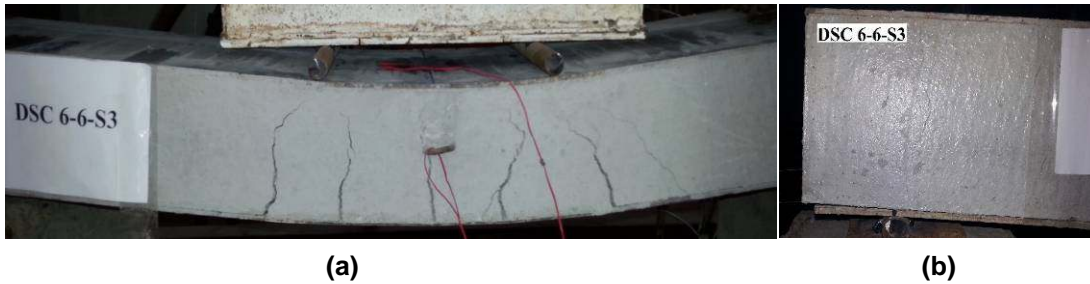
For DSC 6-6-S3, the first crack appeared in concrete when the load reached to 80 kN. Small cracks appeared in the concrete at many location of mid span, then the load-deflection curve became even more flat and continued till the load failure is reached at 276 kN and the deflection was 45 mm. The tension cracks at mid span and splitting cracks at the ends are shown in Fig 14a and 14b, however these cracks were relatively narrow due to the low mutual pressure between concrete and steel studs as mentioned before.

Fig. 14. View after failure load of the specimen DSC 6-6-S3 with wide crack in concrete (a), and close up view of the right corner showing slide between concrete and steel plate (b).

The specimens DSC 4-4-S3 and DSC 6-6-S3 revealed a narrow cracks -on both side- relative to the rest of specimens as shown in Fig 9 and Fig 14 respectively. The large projected area of steel studs (5*40 mm) of specimens DSC 4-4-S3 and DSC 6-6-S3 produced lesser pressure on concrete compared to the other steel studs, consequently narrow cracks were generated as mentioned.

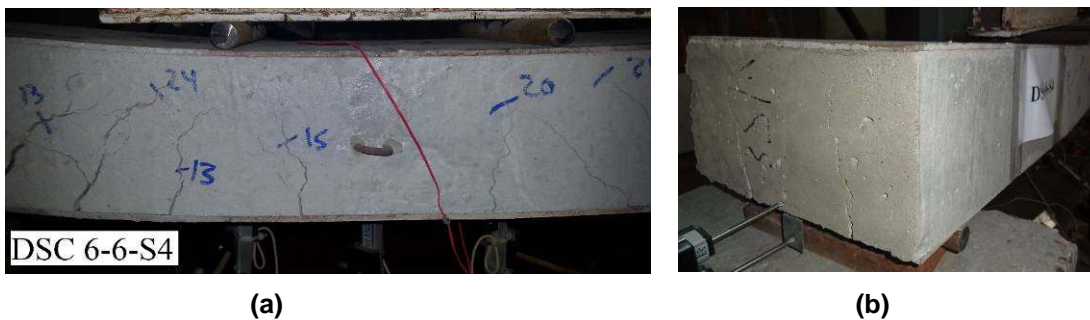
For DSC 6-6-S4, the first crack appeared in concrete when the load reached to 80 kN. Cracks appeared in the concrete at many locations of mid span then the load-deflection curve became even more flat and continued till the load failure is reached at 246 kN and the deflection was 35 mm. Splitting in concrete was also observed indicating that concentrated pressure on concrete from shear studs, as show in Fig 15a and 15b.

Fig. 15. View after failure load of the specimen DSC 6-6-S4 with wide crack in concrete (a), and close up view of the right side corner showing longitudinal cracks in concrete (b).

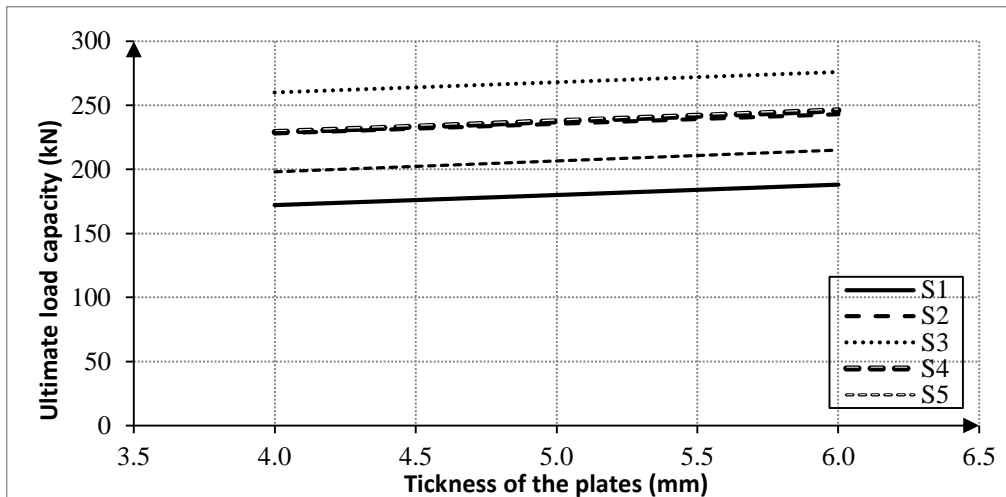
For all shear studs types, using steel plates of 6 mm thickness led to increase the ultimate load capacity by a range from 6.15% to 9.3% compared to specimens with 4 mm thickness, as show in Fig 17.

Fig.17.Effect of steel plate thickness and shear connector type on ultimate load capacity.
