***Case Study*****A Progressive Prolapse of a Left Ventricular Pacing Lead into the  
Right Ventricle in a Patient with Cardiac Resynchronized  
Therapy****Short Title:** A progressive prolapse of an LV lead into the RV**ABSTRACT**

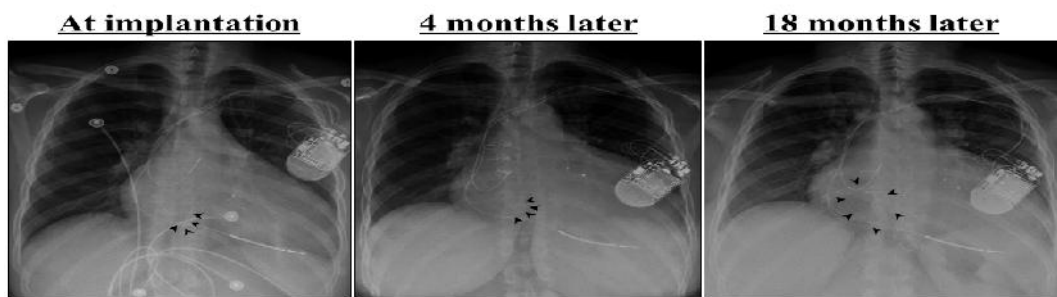
74 **Figure 1.** Chest radiographs exhibiting a progressive prolapse of the left ventricular lead  
75 into the right ventricle.

76 The arrowheads indicate the part of the left ventricular lead that prolapsed into the right  
77 ventricle.

A 33-year-old woman with a history of congestive heart failure secondary to nonischemic cardiomyopathy and left bundle branch block underwent an implantation of an implantable cardioverter defibrillator (ICD) with cardiac resynchronized therapy (CRT-D) (CD3231-40Q, St Jude Medical, Saint Paul, MN) (Figure 1). Right atrial pacing and ICD leads were placed through the cephalic vein, and a left ventricular (LV) pacing lead (1258T-86, St Jude Medical) was placed through the axillary vein in the lateral branch of the coronary sinus. She had been followed up regularly, and the CRT-D had been functioning normally without any significant changes in the pacing measures. She underwent an implantation of an LV assist device 3 years after the CRT-D implantation, when the LV lead was found to have prolapsed looping into the pulmonary artery (Figure 2). The chest radiographs were then reviewed, and it was found that the prolapse of the LV lead had started 4 months after the implantation, and progressed for more than 2 years (Figures 1 and 2). An LV lead revision was performed, but the LV lead could not be pulled back, and was left in place.

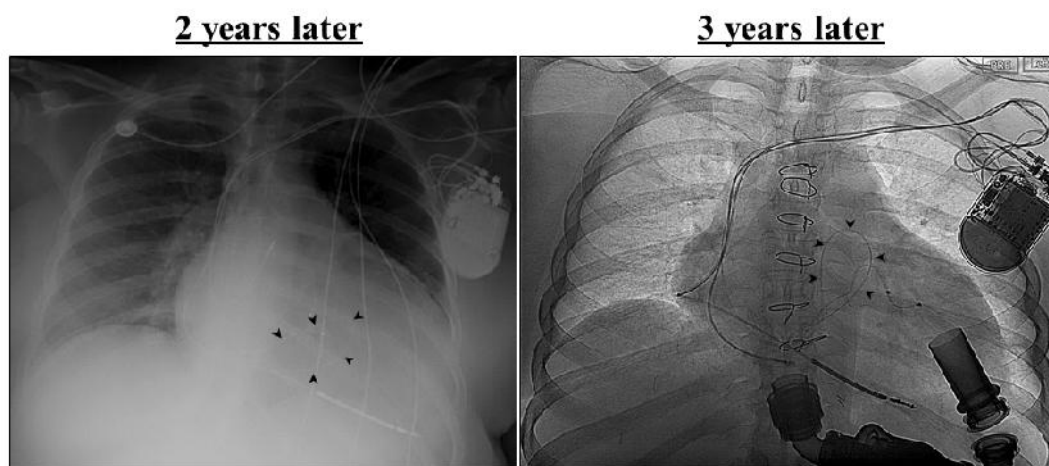
78 **Figure 2.** A chest radiograph (left panel) and fluoroscopic image (right panel) exhibiting a  
79 progressive prolapse of the left ventricular lead into the right ventricle and pulmonary artery,

80 respectively.

81 The arrowheads indicate the part of the left ventricular lead that prolapsed into the right

82 ventricle and pulmonary artery.
