# ESTABLISHING RISK ASSESSMENT FROM RECLAIMED NEKEDE MECHANIC VILLAGE OWERRI, NIGERIA.

The current resettlement of Nekede Auto-Mechanic village by Imo State government of Nigeria created a sparse piece of land awaiting government utilization. Risk assessment was carried out on the land using existing boreholes and soil to determine land utilization potential. Analysis of the physicochemical water parameters showed that there was no contamination of boreholes. The high value of COD correlated with the high levels of Fe in soil and water samples. Heavy metals concentrations showed that Fe was very much present in the soil while Pb, Cd and Cu had reduced concentrations. Risk assessment for the soil samples showed that Fe had the highest mean and median value. The highest mean value for water was Cu metal. Highest variance value was Cu in soil while Pb had the lowest value in water. Hazard quotient of water samples showed that hazards existed for Cd, Cu and Pb but at a moderate level for Fe. Estimated daily/weekly water intake values were all below WHO/FAO standards. The soil enrichment factor showed no enrichment for Pb, minimal enrichment for Cd, moderate enrichment for Cu and signi

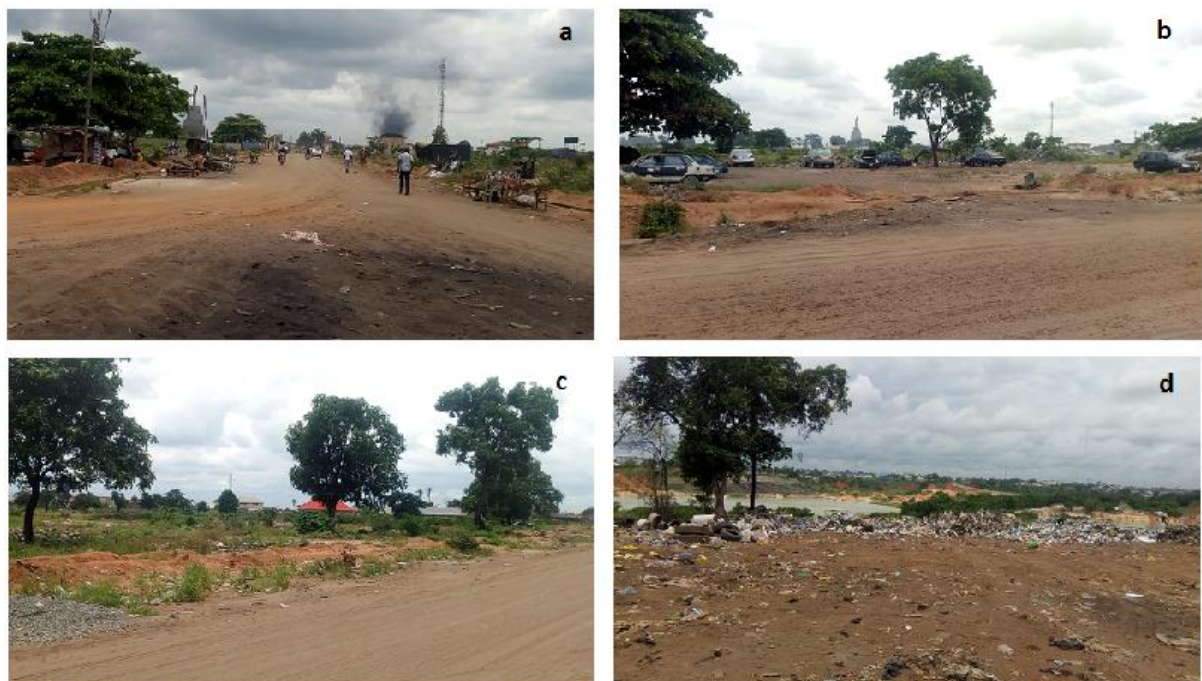
Figure 2: Area view of Nekede Auto mechanic village. (a) abandoned entrance leading to the mechanic village, (b) abandoned vehicles at the site, (c) abandoned sparse of land overgrown with weeds, (d) ongoing excavation and removal of waste dumps near a dredging site

The study area is Nekede Auto-Mechanic Village, located within the Owerri Municipal council in Imo State of Nigeria as shown in figure 1. Owerri is in the South eastern region with longitudinal locations  $6^{\circ} 32^1$  to  $7^{\circ} 15^1$  East and Latitudinal locations  $6^{\circ} 20^1$  to  $6^{\circ} 35^1$  North respectively. It has fairly low topography and undulating land surface. Nekede Mechanic village is in the sandy Benin Formation and well drained by Otamiri River and Nworie River. The workshop had existed for over 35 years with up to a 1000 automobile auto technicians working at the site on a land area of over 20 hectares with 12 major roads. The majority of the auto technicians serviced between 5 and 10 vehicles per week, ranging from minor faults to major breakdown. An estimated 1.5 million litres of used oil or 7400 drums of spent engine oil are discharged at the site yearly and other waste products like scrap metals, paints and tires. [17, 18, 23, 24]. Also in figure 2 below is the current picture of Nekede auto-mechanic workshop showing an empty land that is bare and unutilized after relocation of the technicians.
