### **Environmental laws in Nigeria and occurrence of some geohazards: a review**

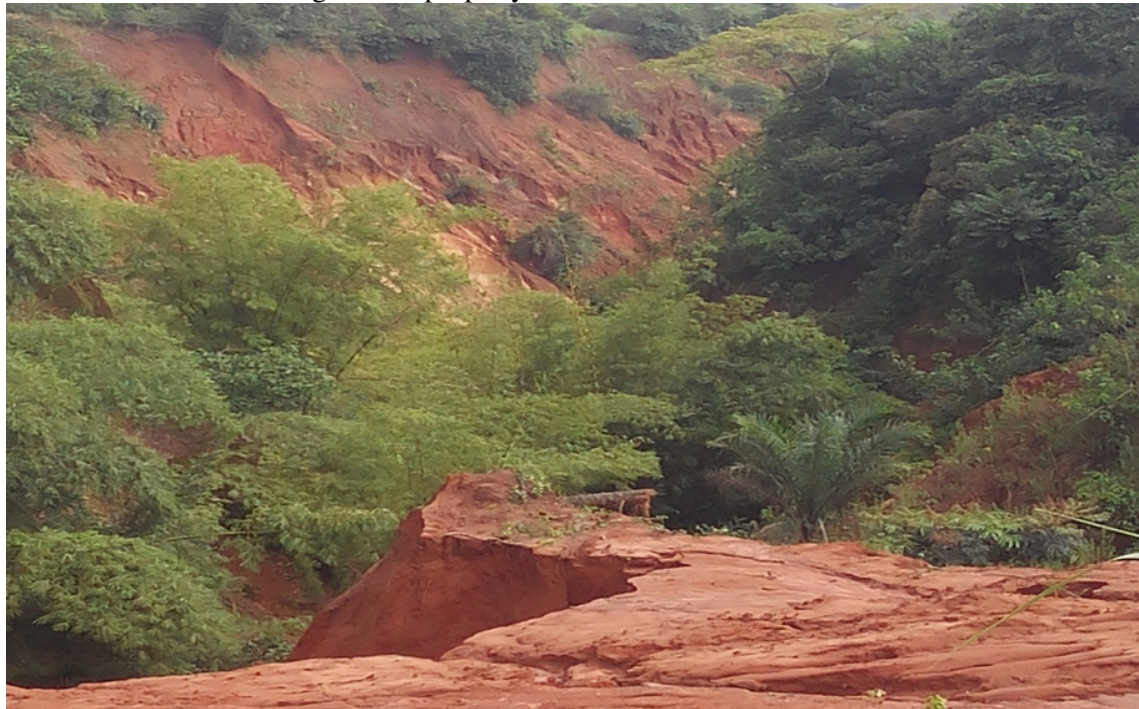
Plate 1: Severe gully site, Umueshi, Imo State, Nigeria

other factors have been implicated as causative factors of gully erosion. Nwachukwu and Eburukevwe (2013) identified human activities such as roadside excavation of borrow pits and absence of functional drainage systems, which causes runoff to wash off roads, as contributors to accelerated erosion in south-eastern Nigeria. Many communities in southern Nigeria have suffered untold hardships as a result of severe gully erosion, loss of farmlands as shown in Plate 1, river silting, displacement of communities, threat to vegetation, property loss and effect on lives.

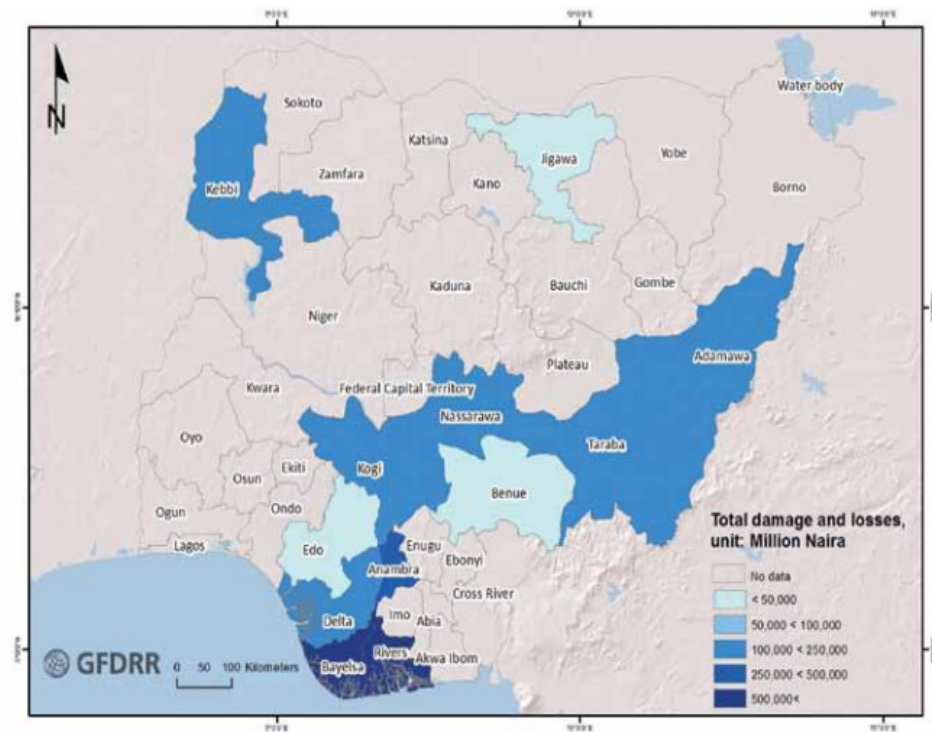
Figure 1. Most affected states by the 2012 flooding in Nigeria. Source; NIGERIA Post-Disaster Needs Assessment 2012 Floods, 2013

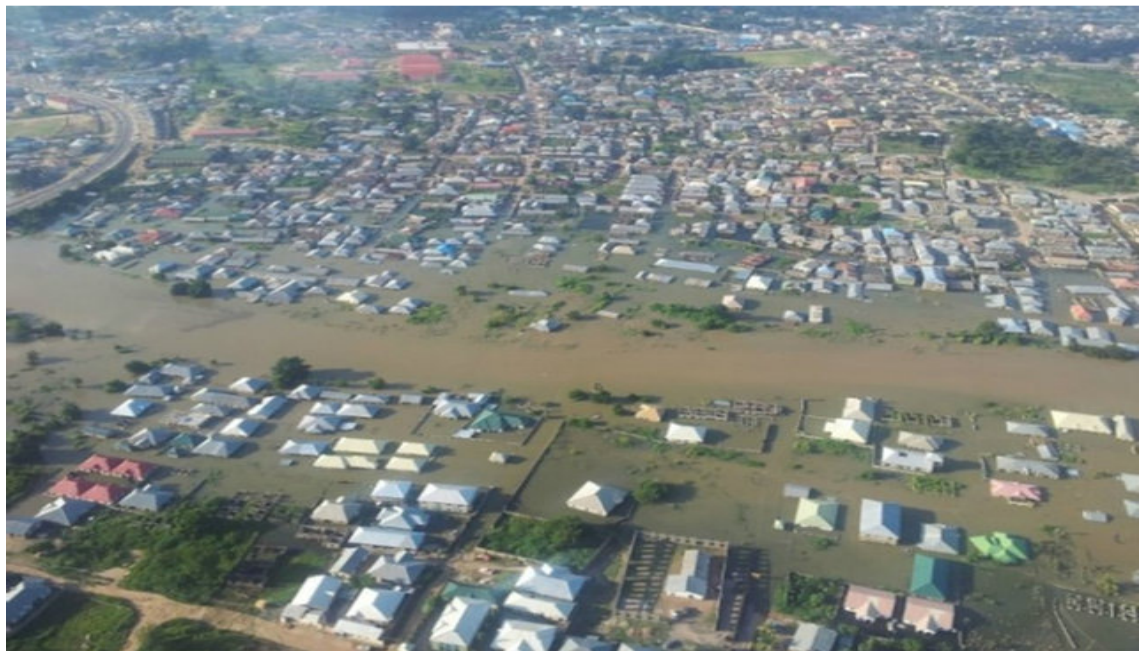
Plate 2. Submerged houses along Niger River in Lokoja, source; Nkeki et al, 2013

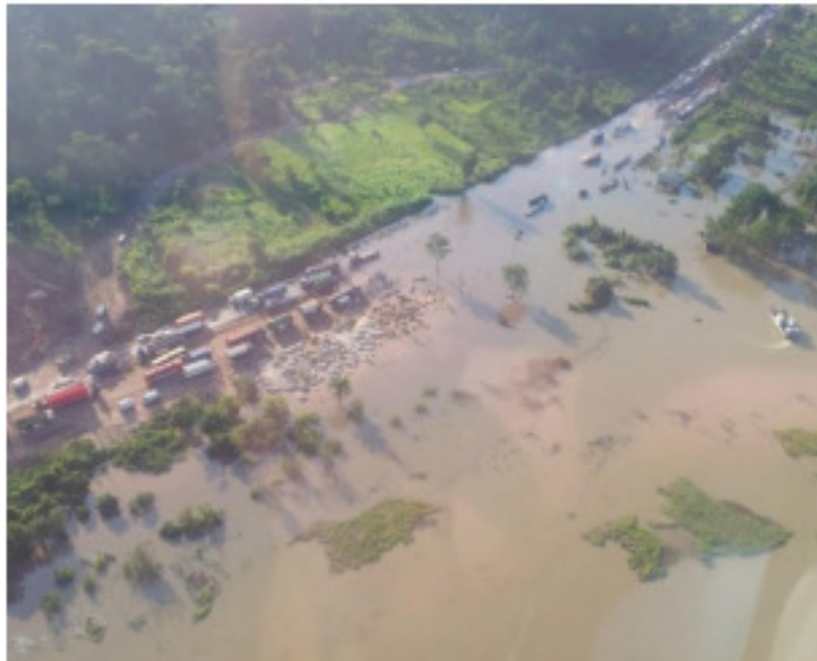
Plate 3. Severed major transportation route (Lokoja-Abuja) in Lokoja left travelers stranded, source; Nkeki et al, 2013
