## **APPLICATION OF GEOSPATIAL TECHNOLOGIES IN ASSESSING GULLY EROSION IN THE HUMID TROPICS OF ENIONG OFFOT, UYO, AKWA IBOM STATE**

**Keywords:** Geospatial technology, geo-mapping, gully erosion, land use, Humid Tropics.

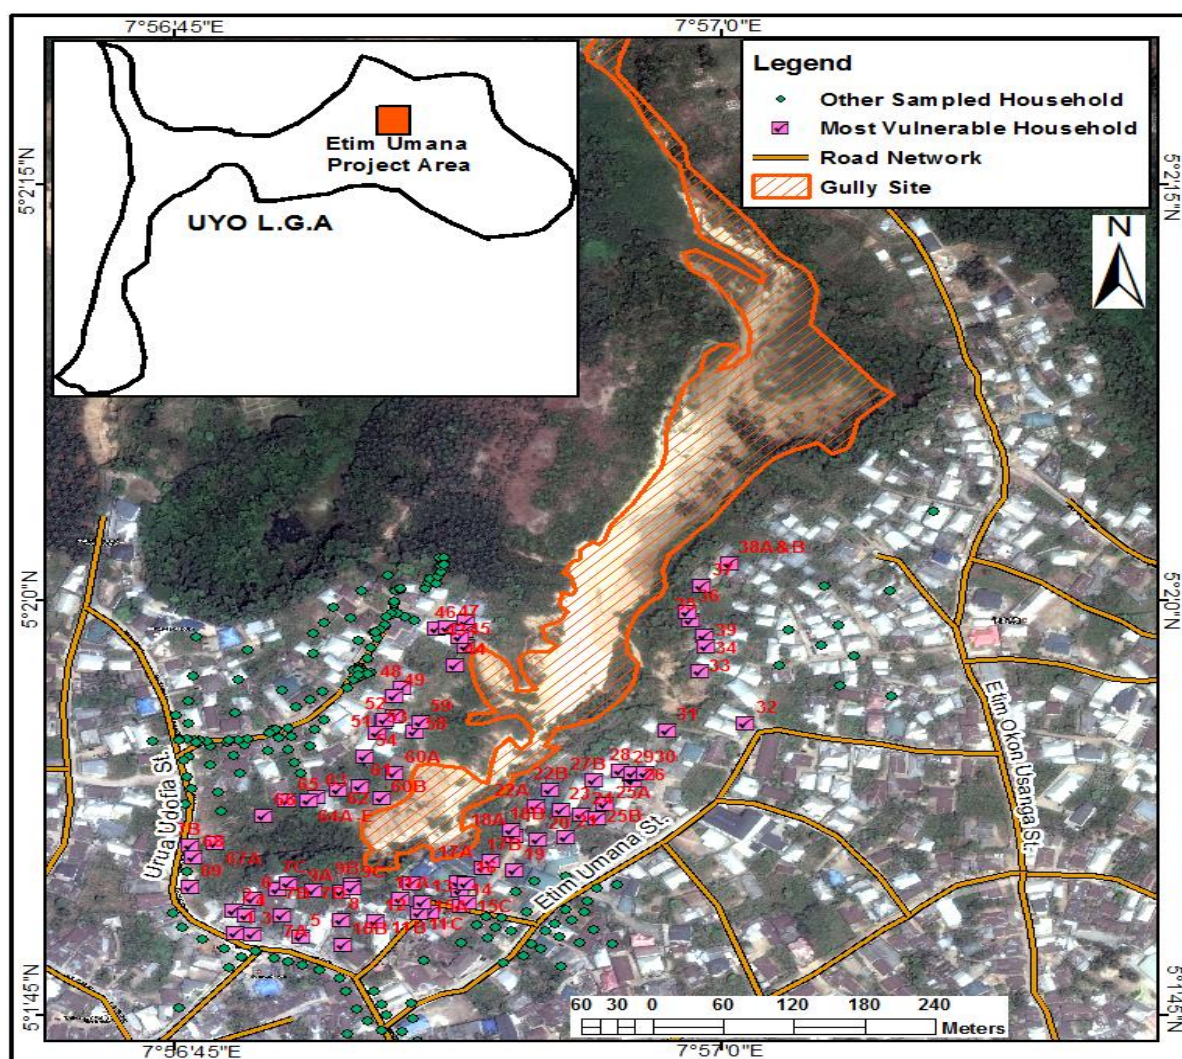
Figure 2: Base Map of Etim Umana Gully Site Showing Some of the Captured households and Key Features

The vulnerability assessment of household to gully in Etim Umana site as mapped in figure 2 suggests the relationship between land use/land cover on gully formation. As seen in figure 5, urbanization and other human activities have really crept into areas that should be regarded as ecologically sensitive. Their distributions are shown in figures 5 and 6 as well as altitude and size in tables 1 and 2 respectively of the Etim Umana gully site. Flow accumulation, slope, contour, and relief are of immense benefits in understanding the morphological dynamics of gully site in order to ascertain appropriate restoration and reclamation programmes for the people in the vulnerable areas.

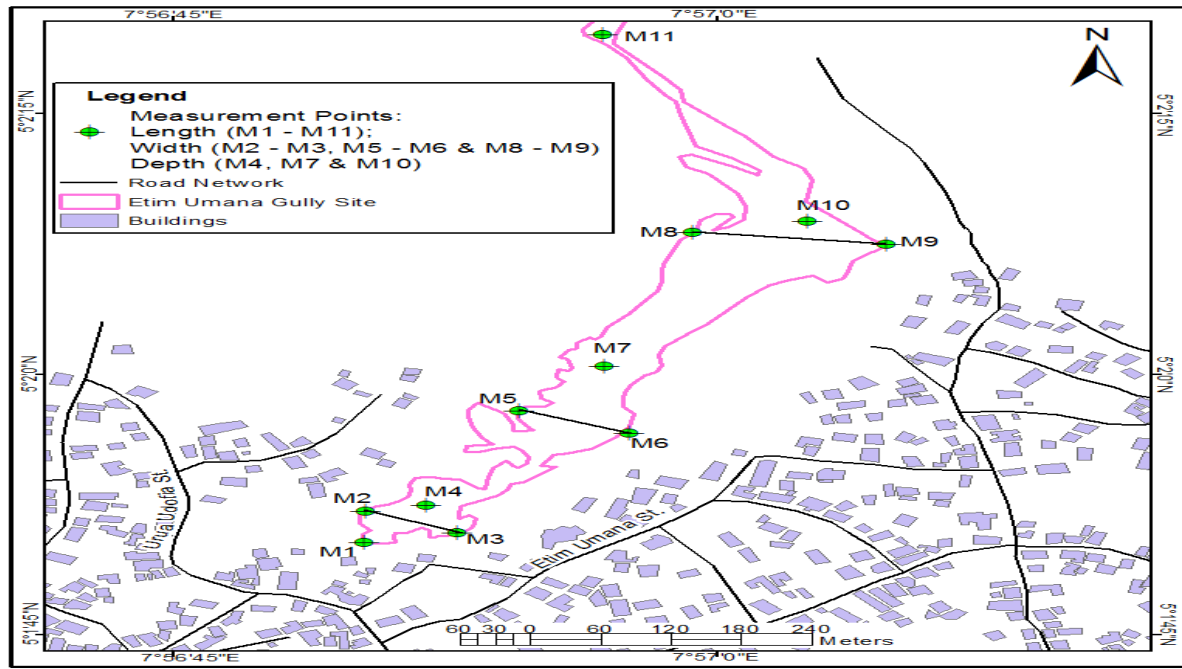
Figure 3: Base Map of Etim Umana Gully Site Showing Key Features and Parameters Measurement Points

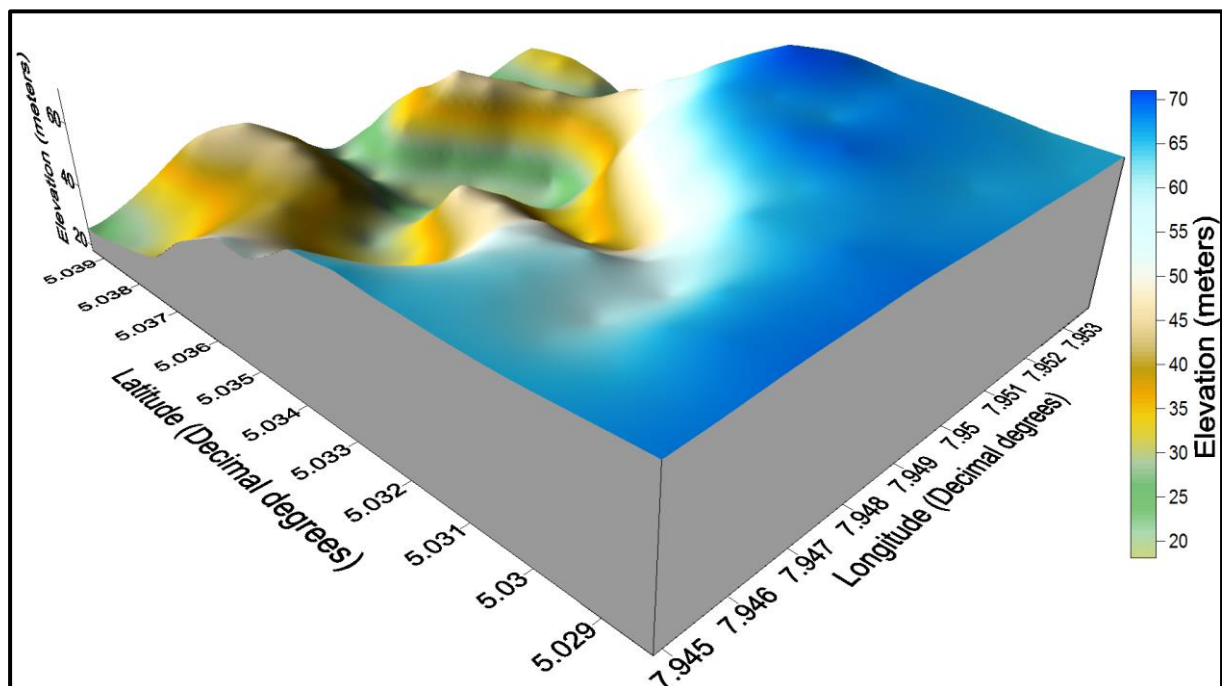
Figure 4: 3D Model of Etim Umana Gully Site

The 3-D visualization of the Etim Umana gully site as exemplified in Figure (4) enhances the examination of the area from different viewpoints. The 3-D model of gully site reflects a degree of dynamism. For instance, the headward migration yields relatively V-shape valley and continue to expand downward forming U-shape valley due to the effect of landslide and timescale. Furthermore, the topographic individuality of the concave to the almost constant slope (relief) is enhanced with respect to the dominance of the coastal plain

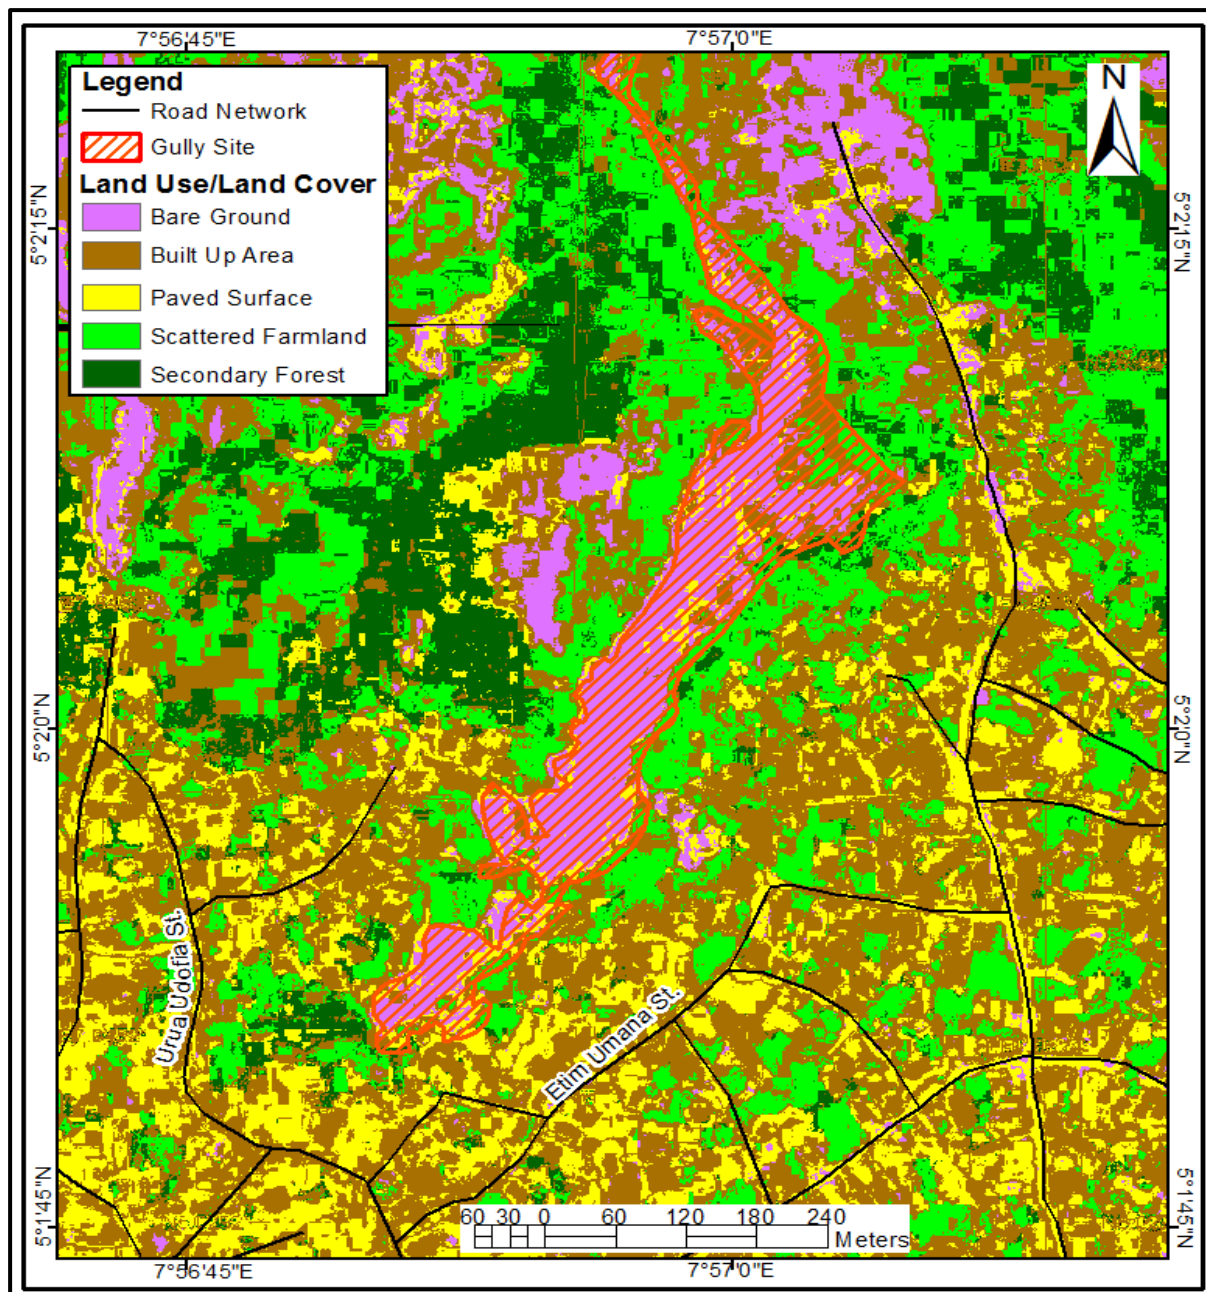
Figure 5: Land Use/Land Cover of Etim Umana Gully Site (Extracted from High Resolution Google Earth Imagery – USGS, 2016).

southeast Nigeria in spite of the locational and methodological differences. However, this result cannot be discussed in isolation without considering the role of natural factors (rainfall (the originator), relief, lithology, and magnitude of surface runoff) which define the propensity of the erodibility rate in the area. For instance, in event of policy interventions, the most vulnerable households can be directly targeted with the aid of figure 2. Also, spatial coordinates of measured location are vital in land/environmental recovery exercise with the aid of figure 3, tables 1 and 2. The terrain analysis using a three – dimensional perspective is essential in gaining more insight on the extent of land degradation as a result of headward migration and lateral expansion of gully erosion as depicted in figure 4 and 5.

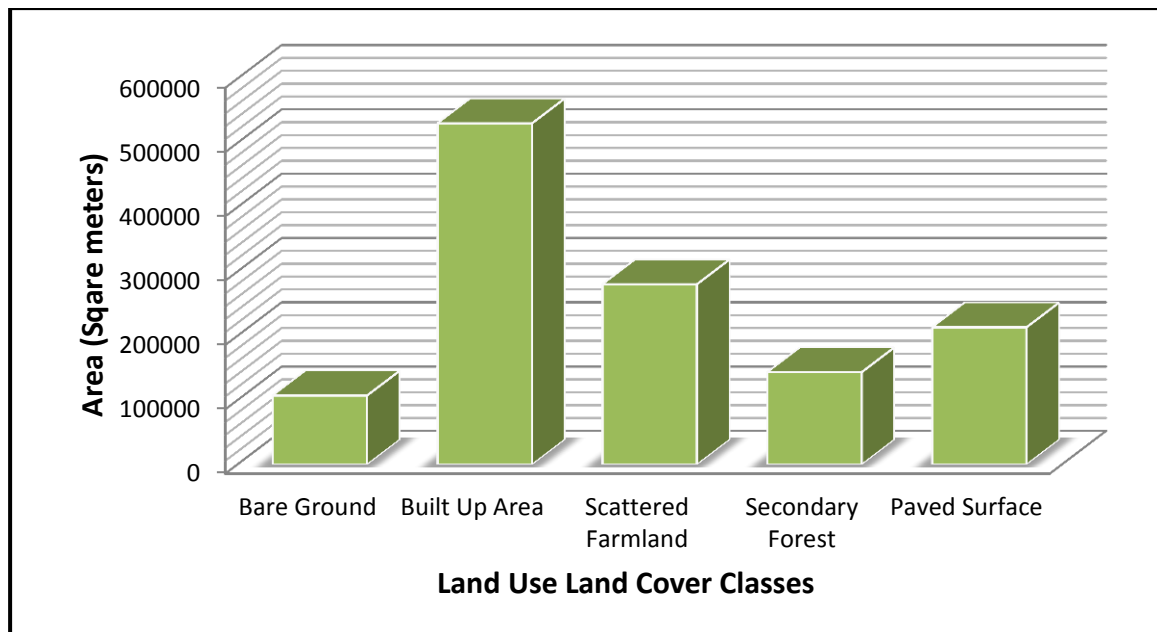
Figure 6: Land Use/Land Cover Chart of Etim Umana Gully Site.

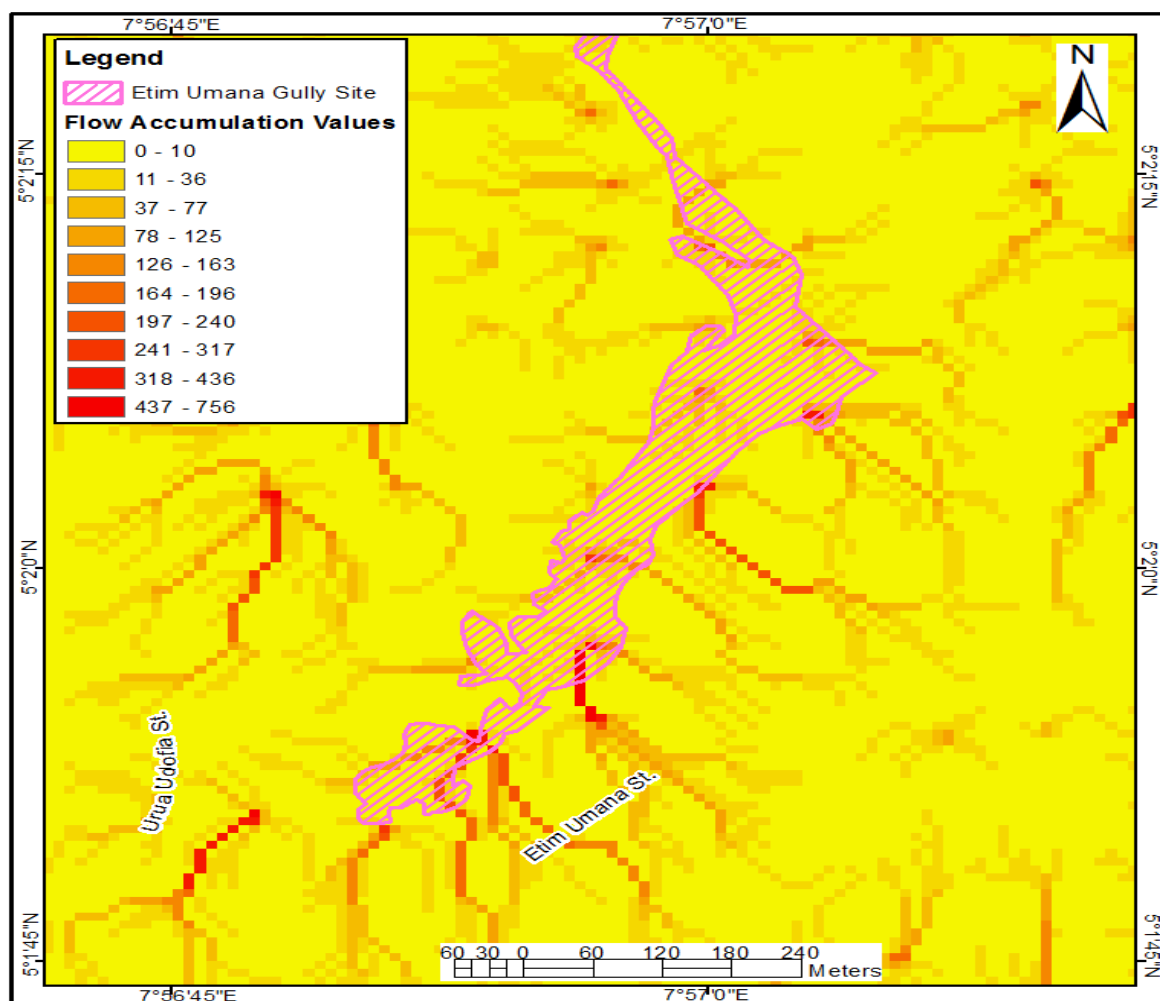
Figure 7: Flow Accumulation showing Direction of Flow in Etim Umana Gully Site.

Modern geomorphologists, environmentalists, hydrologists, and engineers will find figures 7, 8, 9, 11 and 12 useful in making an informed decision regarding roads, drainages, water resource development and use in the area. For instance, Figure 8 and 9 yielded that runoff generation from the heavily urbanized part of Eniong Offot area and beyond is diverted to the Etim Umana gully site and the flow is enhanced by the underlying natural relief as depicted in figures 11 and 12 respectively. The state of vegetation and its health is also essential since only a small proportion 11.3 percent of the area is cover by secondary vegetation (see figure 10), 41.6 percent is the build-up, and 22 percent is scattered cultivation (see Table 4). By implication, 80.3 percent of the study area is directly under pressure from anthropogenic interferences, thus suggesting that 80 percent of the gully erosion in the area is induced by human factors. Similar finding have been reached outside the study area [see 31].

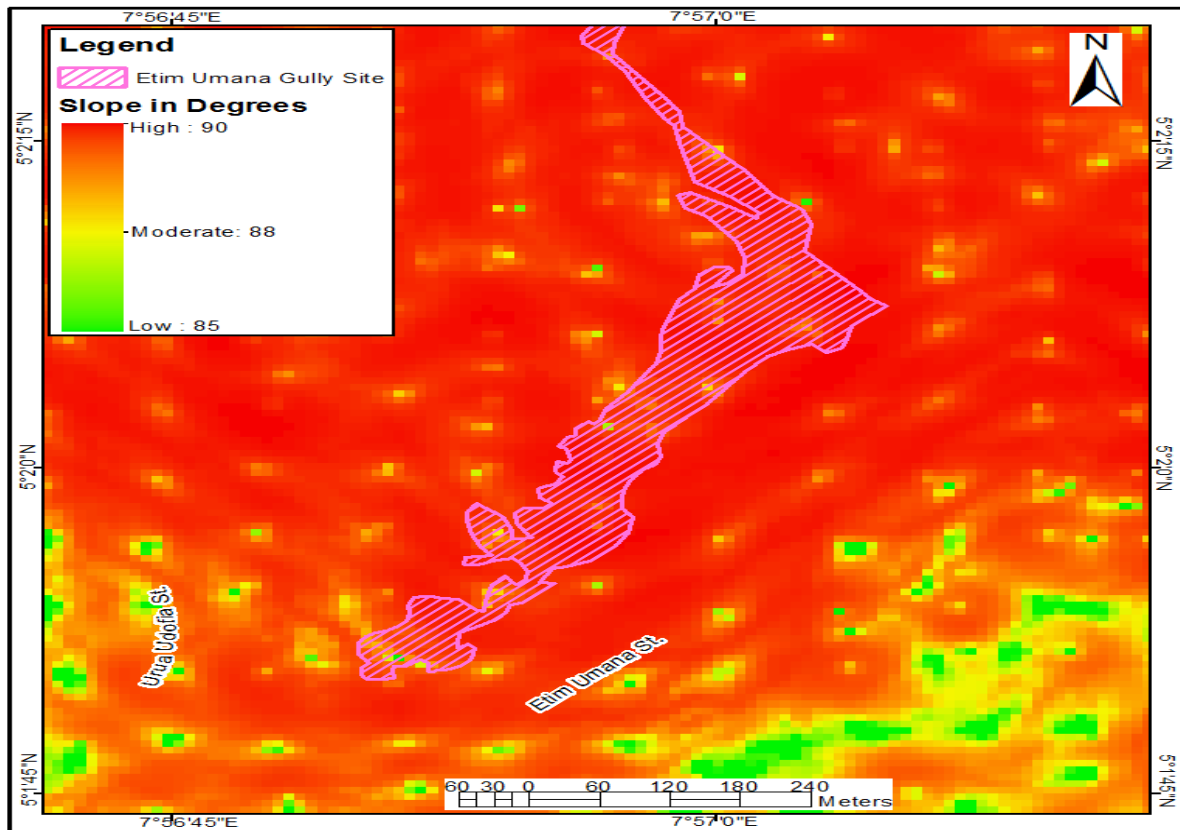
Figure 8: Etim Umana Gully Site showing varying Degrees of Slope.  
Source: Extracted from High Resolution Google Earth Imagery – USGS (2016).

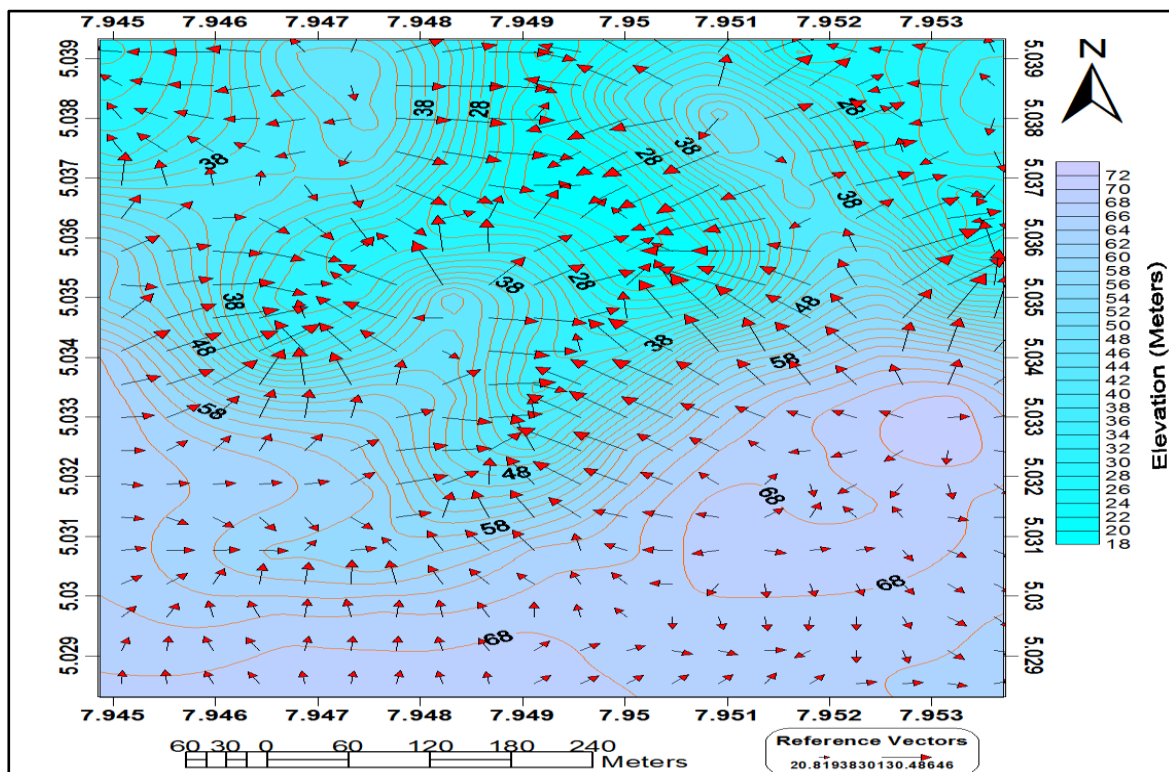
Figure 9: Vector Flow Map of Etim Umana Gully Site Overlaid on Filled Contour Map (Note: Longer arrows depict areas of steeper slopes).

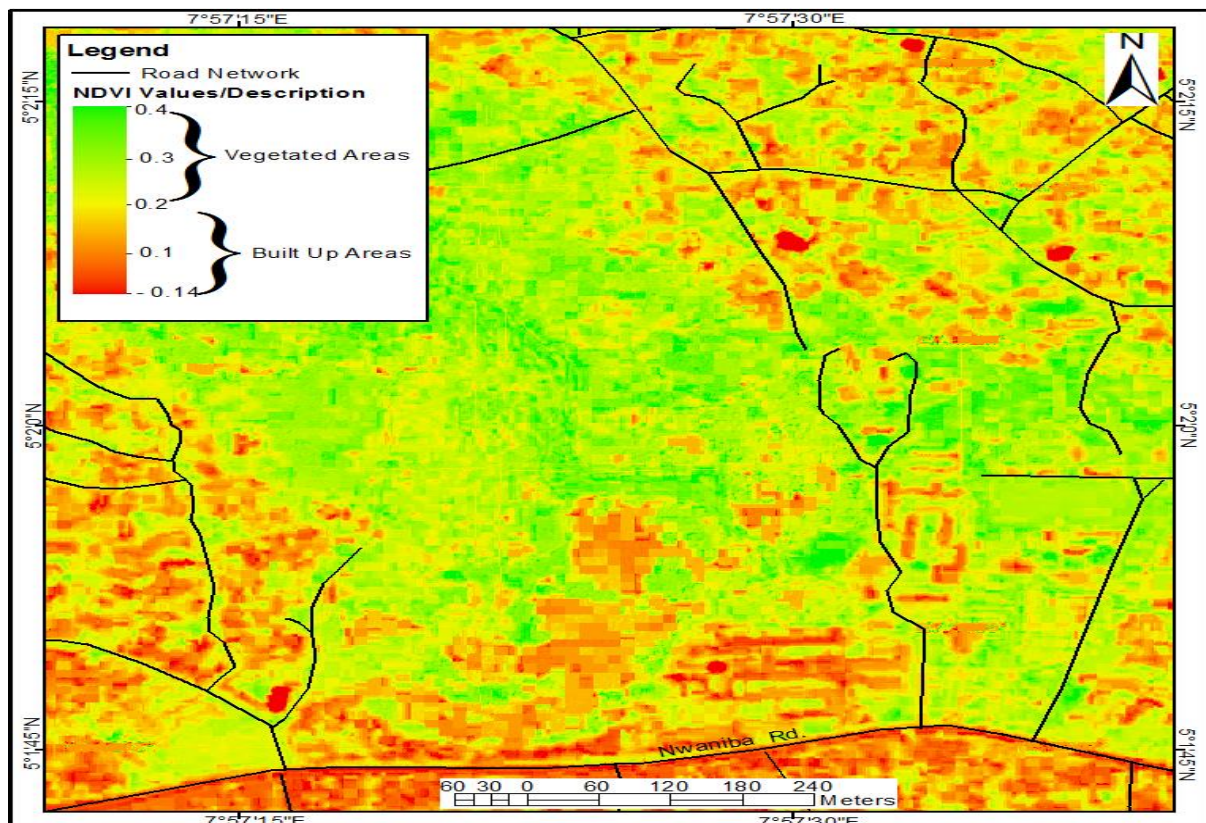
Figure 10: Normalized Difference Vegetation Index of Etim Umana Gully Site.  
Source: Extracted from High Resolution Google Earth Imagery – USGS (2016).

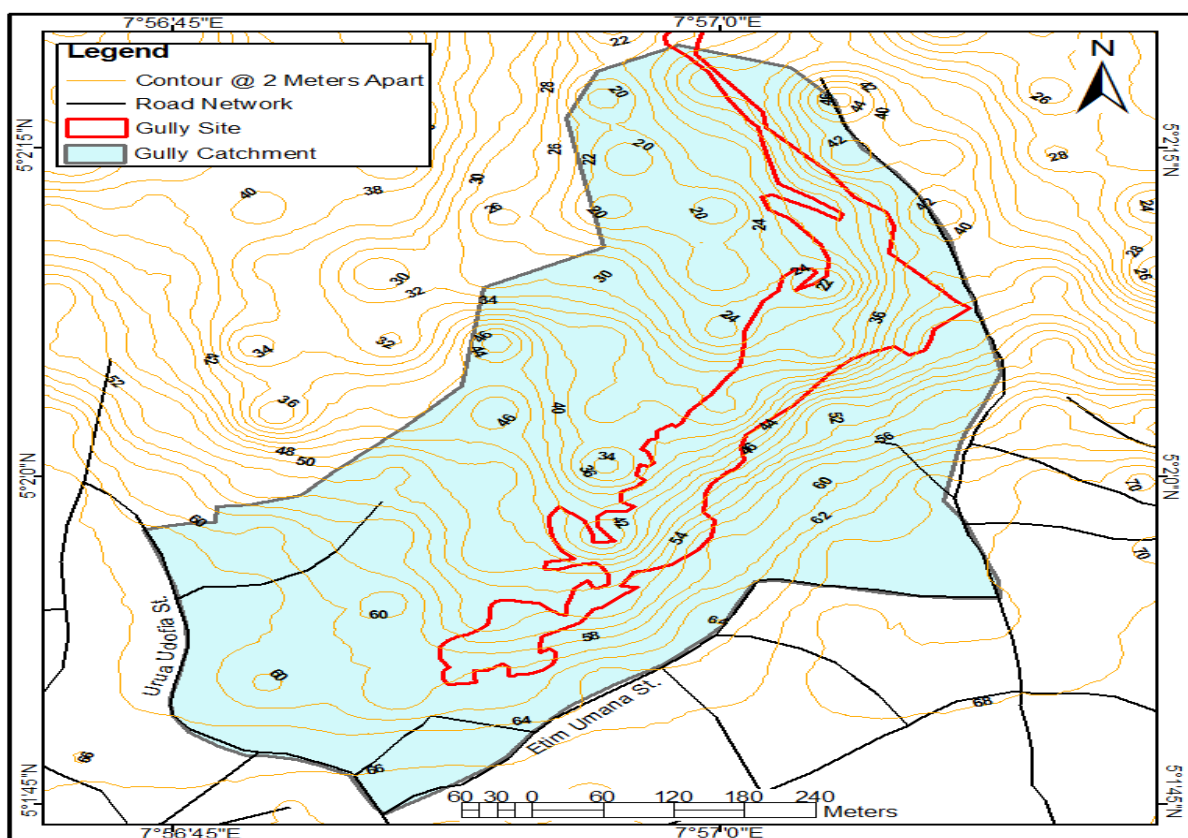
Figure 11: Contour Map of Etim Umana Gully Site.  
Source: Reproduced from High Resolution Google Earth Imagery – USGS, (2016).

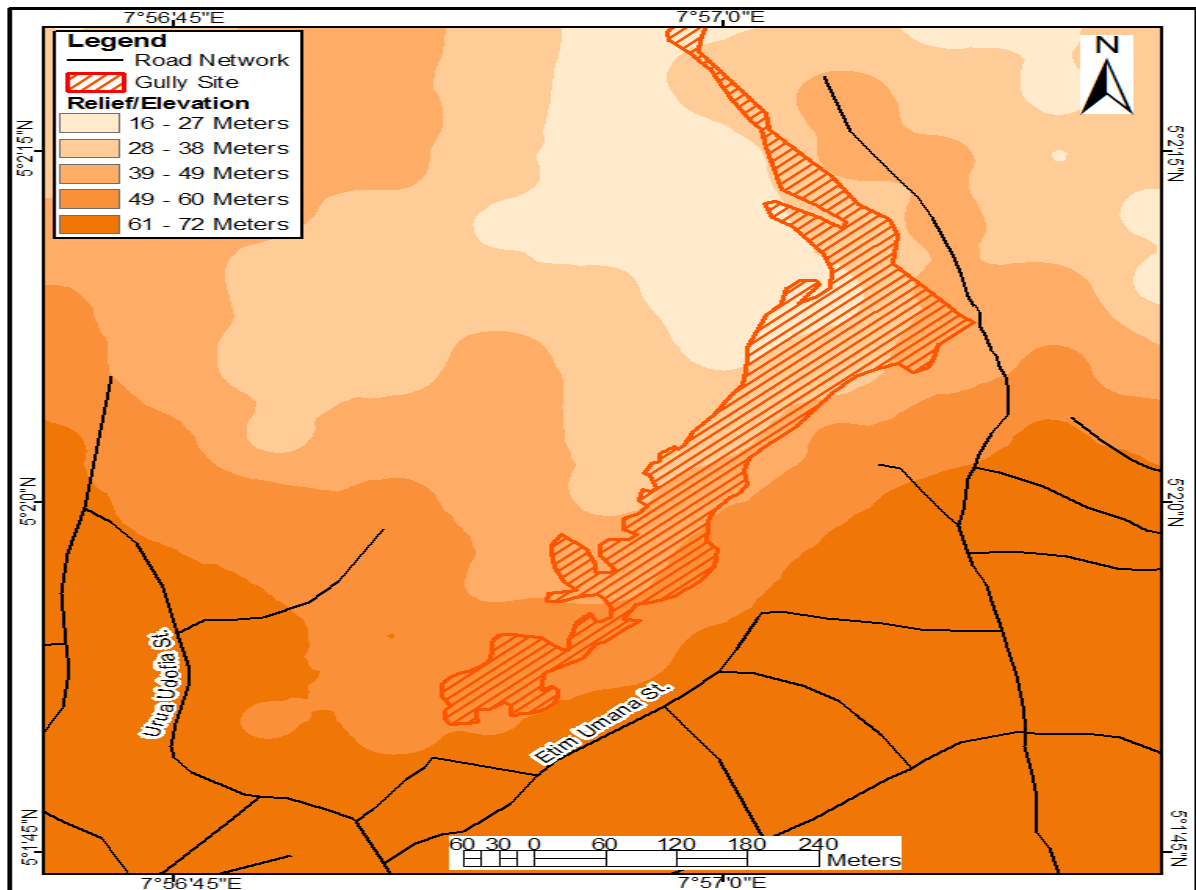
Figure 12: Relief of Etim Umana Gully Site.
