# Development of Chute Cutoff in the Lower Course of River Mayo-Inne, Yola South, Nigeria

The study investigates the development of chute cutoff in the lower course of River Mayo-Inne, Yola South LGA, Adamawa State, Nigeria. The study employed the integrated approach of Remote Sensing, Geographic Information System, Field Survey, Laboratory Analysis, Oral Interview and Personal Observation in examining the influences of some relevant channel planform parameters (Sinuosity Index, Cutoff Ratio and Braiding Index), land use/land cover, channel bank materials, water stage and channel depth on the development of the chute cutoff over a period of Twenty five years (1990-2015). Results revealed the drastic reduction of Sinuosity Index from 1.57 in 1990 to 1.46 in 2015, changing the channel from meandering to the straight pattern. The analysis of changes in cut-off ratio unveiled the development of chute cutoff in bend II, which ultimately separated the river flow, forming a weak braided channel with a braiding index of 0.43. These developments were attributed to incessant flooding in the study area and floodplain characteristics such as floodplain elevation, bank strength and changes in

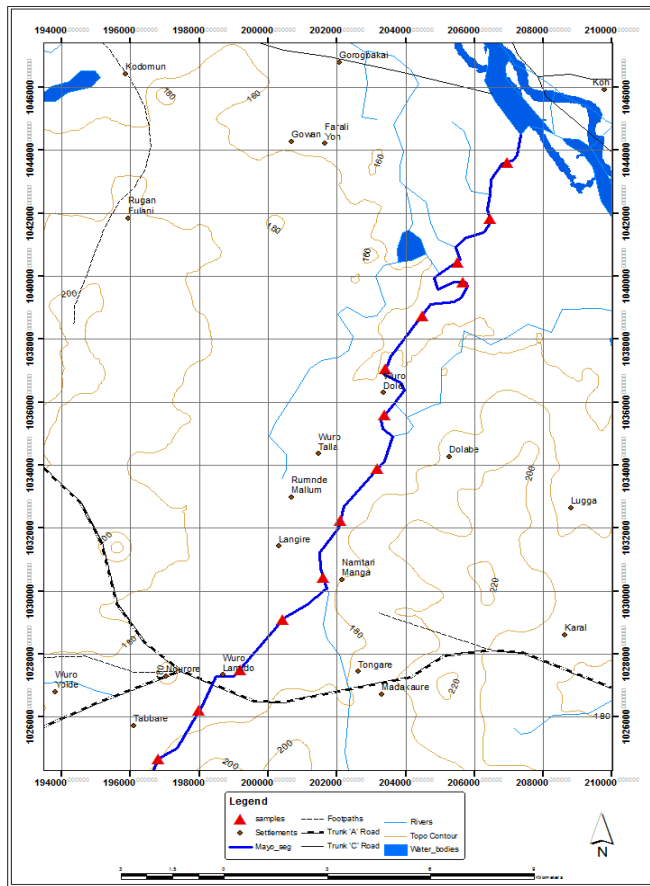
**Figure: 3 Map of the Study Area Showing Sampling Locations**

Field survey involving observations and measurements ascertained the floodplain characteristics. The coordinate of each of the sampling points in Figure 3 was obtained using Garmin 76S handheld GPS. This was used to track the exert sample point on the channel profile. A total of 28 Bank material samples were collected by scooping from both the right and left banks of the river channel for particle size analysis in the Soil Science Laboratory of Modibbo Adama University of Technology, Yola. The textures were determined using the USDA textural triangle. Water-stage data were obtained from Upper Benue River Basin Development Authority, Yola.

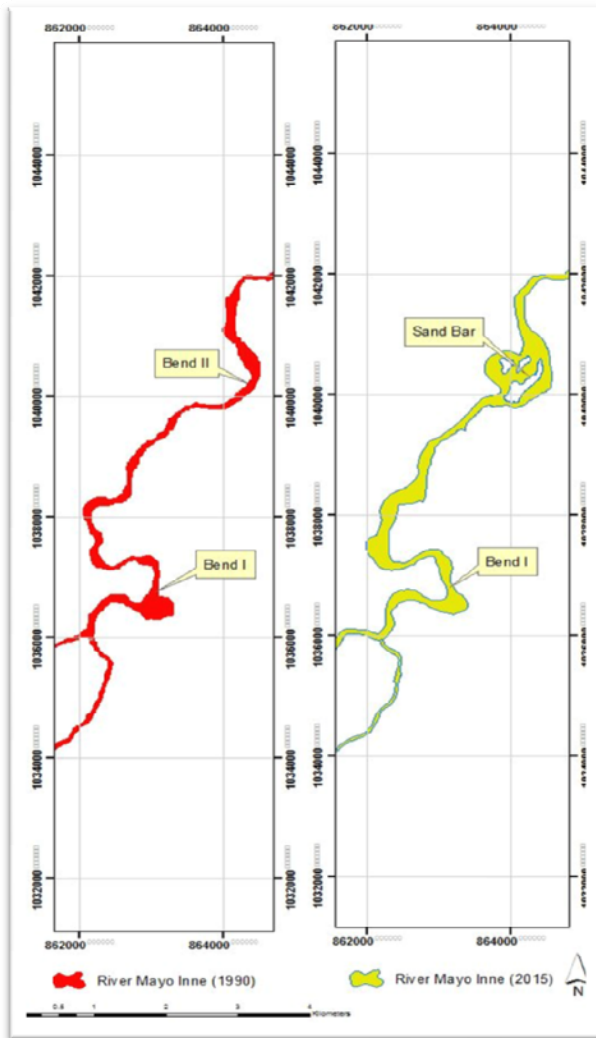
**Figure 4:** Changes in Meander Characteristics in the Study Channel  
Source: Satellite Image Analysis (2016).

The **table 1** revealed that in 1990 the sinuosity index stood at 1.57; this sort of channel is classified according to [19] as a meandering river. However, the  $S_i$  value drastically reduced from 1.57 (in 1990) to 1.46 (in 2015) changing the channel from a meandering state to a slight straight pattern. The analysis of changes in the cut-off ratio for the two critical bends in Figure 4 indicated that Bend I rose from 3.43 in 1990 to 4.09 in 2015. However, bend two experienced a drastic decrease to 1.53 in 1990 as shown in Table 2.

The period of 2015 revealed the development of chute cutoff in bend II, which ultimately separate the river flow, forming a weak braided channel with a braiding index of 0.43. The flow separation enhanced the development of three in-channel erosional bars located at the right bank, in the middle of the channel and at the left bank. The sandbar at the right bank had a length of 864m, while the middle and the remaining bank bars had 319m and 264m respectively. The reduction in sinuosity index, which changed the channel pattern from meandering to a straight one as indicated in Table 1, may not be unconnected with the development of chute cutoff in bend II of the study channel. The result of this analysis conforms with the findings of [2].

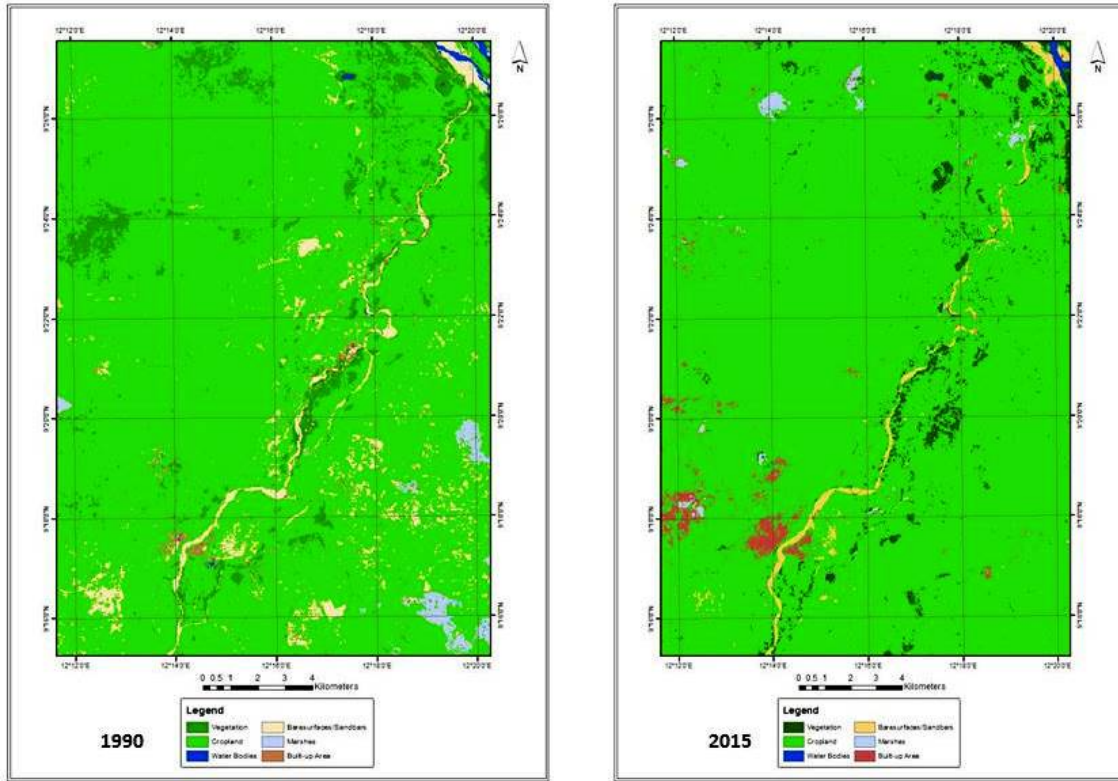
**Figure 5:** Land use/Land cover images of the study area in 1990 and 2015, respectively  
Source: United State Geological Survey

The land use/land cover change detection analysis showed that significant changes had taken place within the period of study (Fig. 5 and Table 4).

Vegetation, which constitutes the major land cover class that significantly influences the development of chute cutoff, reduced from 6.36% in 1990 to 3.62% in 2015. Changes in vegetal cover, especially riparian vegetation influence the development of chute channel; this is because vegetation increases the shear strength of bank material and reduces lateral mobility and migration rates, making river channels to become more stable. Reduction in riparian vegetation thus, makes the banks to be susceptible to widening and development of chute cutoff across a point bar or low areas of floodplains by fluvial processes.

Other land uses such as cropland increase from 87.06% in 1990 to 92.51% in 2015. The change observed over the study period may not be unconnected with an increase in population and a corresponding increase in demand for food and raw materials from the surrounding urban settlements like Jimeta, Yola, and Numan. These activities mainly the arable type helps in loosening the bonds between soil particles, making them susceptible to an agent of erosion and transportation. To this effect, the loosed soils are subsequently transported and deposited in the river channel. This increases the bed elevation causing the river to shift to a new state of dynamic equilibrium. Water bodies, bare surfaces and built up areas also show significant changes as indicated in Table 4.
