## **Vegetation Impact on the Morphodynamic Activity of the River Kapuas**

**Aims:** To understand the causes behind the spatial variability of the morphodynamic activity of the river Kapuas, West Kalimantan, Indonesia.

**Study design:** This study was designed to focus on the vegetation impact on the morphodynamic activity of the river Kapuas based on the Normalized Difference Vegetation Index (NDVI) using Landsat images.

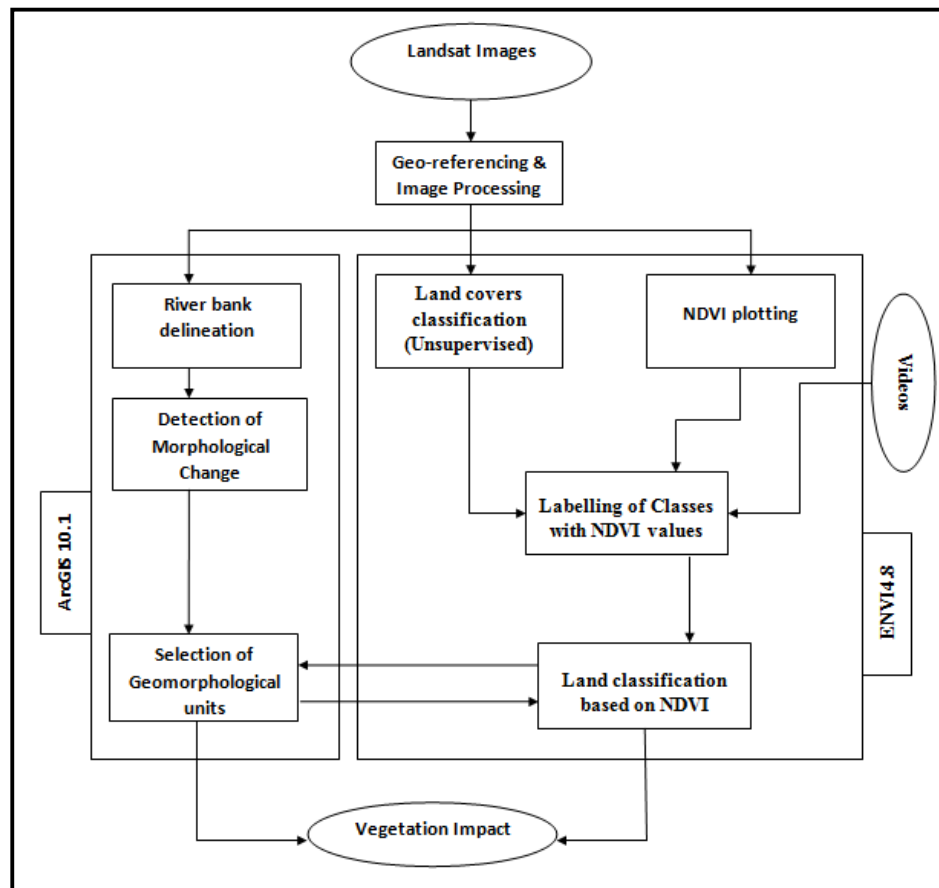
Figure 1 : Methodological flowchart of the investigation of vegetation impact

Delineation of river banks of different time series is a prerequisite for understanding morphological dynamics of a river. This research used delineated river banks from a previous research by Huisman (2014) who delineated a series of river banks from 1973 to 2013 and quantified the bank migration rates along the reaches of Kapuas. Some morphological units, at or around the river bends where the migration rates were found significant, were selected to investigate the vegetation impact and the steps followed afterwards are shown in the Figure 1.

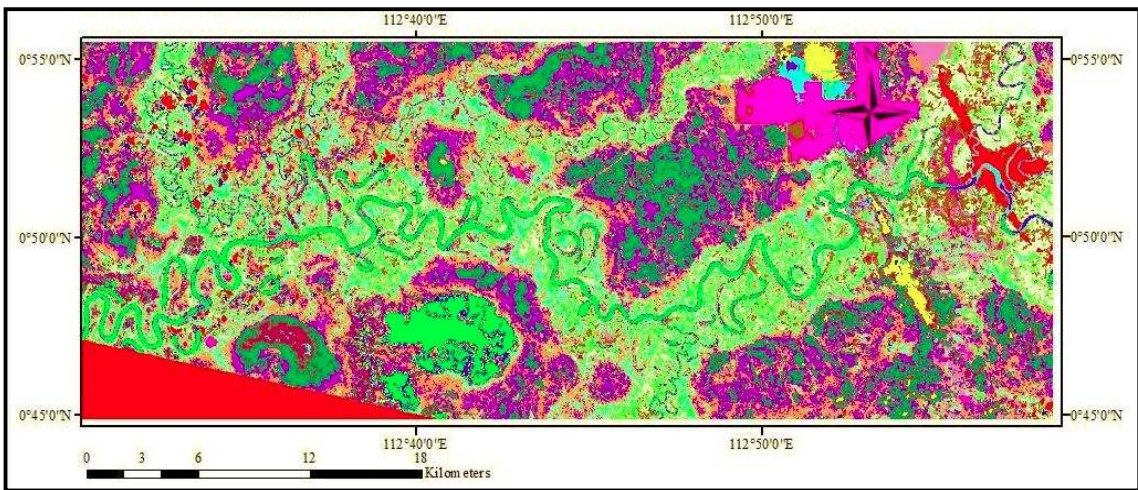
**Figure 2 : Land cover classification of the upper upstream area of Kapuas**

were used to classify the land cover around the banks of the entire length of Kapuas (Figure 2) as K-means classification is suitable for identifying seven relatively separable classes like water, rough pasture, bare soil/urban area, wood land, grass land, arable land and cloud/quarry/industrial area. However, in the K-means classification system, it is really difficult to interpret which land cover types fall within which category. Within the same image, the same land cover type shows the same category, but in case of different images or in the images of different time series it may be or may not be the same.

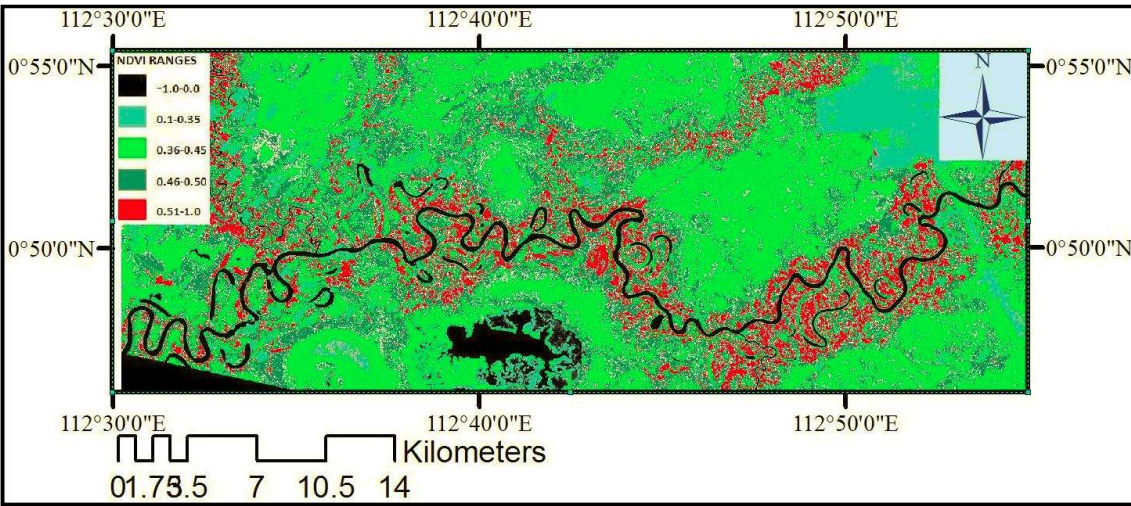
**Figure 3 : NDVI map of the upper upstream of Kapuas River, 2013**

Where VIS and NIR stand for spectral reflectance measurement acquired in the visible (red) and near-infrared regions, respectively. NDVI values vary between -1 and 1. The values from -1 to 0 indicate vegetation free surface, like bare soil, and water bodies, and they were grouped together as a value of 0. Around the Kapuas, the whole study area is covered by more or less vegetation except for the water bodies, open crop field and urban area. NDVI values of the whole study area were plotted between the year 1991 and 2013 and the ranges of values were regrouped into different colour codes (**Figure 3**). One pixel area (30 m x 30 m) represents one NDVI value, but within this pixel area the NDVI values may be different. To get a view of different NDVI values within the pixels, the contour lines of the same NDVI value were plotted that helped to identify land cover types of the same vegetation even in one pixel. In case of the same NDVI values for different land cover types (from the unsupervised classification) or the other way around, the spectral profiles of middle infrared bands were used to separate the land covers as well as vegetation types.

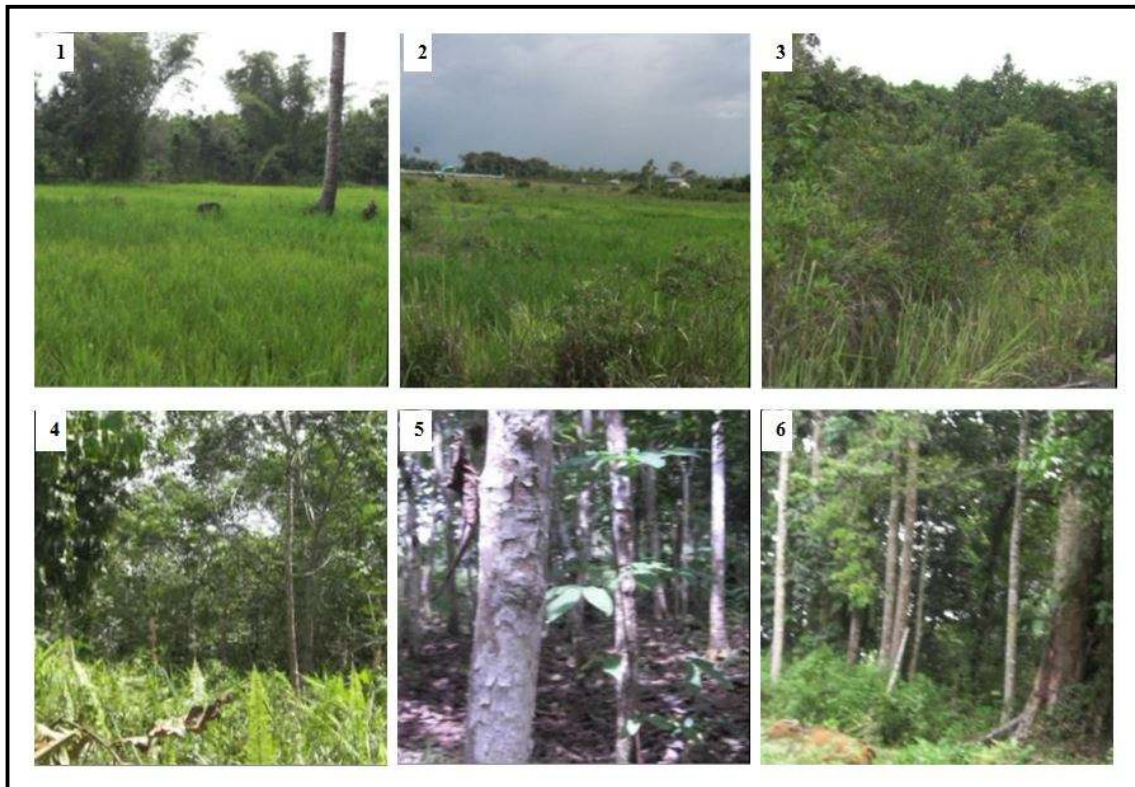
Figure 4 : Vegetation types and their corresponding increase in NDVI values. Land cover type 1 & 2 showing NDVI values 0.33-0.38; 3 & 4 showing NDVI values 0.40-0.45 and 5 & 6 showing values 0.48 and more

Throughout the entire length (upstream), both banks of the Kapuas were found more or less vegetated but of different vegetation types. NDVI values corresponding to vegetation types (Figure 4) clearly show that, with increasing vegetation density and biomass, the NDVI values are increasing. Beyond a certain range, NDVI becomes saturated for higher biomass. Box et al. (1989) suggest a saturation NDVI value of 0.40 and 0.54 was suggested by Santin-Janin et al. (2009) for saturation in case of higher biomass. In this study NDVI values larger than 0.45 are found for the vegetated area with comparatively higher biomass and more than 0.50 shows saturation of the NDVI. Within the study area (upstream) along the entire banks it is found that, river banks with NDVI values of 0.45 or

less are eroded and banks with NDVI values more than 0.45 are not eroded or almost stable. It means that the river is migrated at low biomass vegetated areas but not at high biomass vegetated areas, as high NDVI value represents vegetation of high biomass both above and below the ground. Trees reinforce the soil particles within its root zone and hold soil particles in position against erosion. A higher NDVI value is an indicator of a highly vegetated area with high aboveground biomass (Boelman et al. 2003; Santin-Janin et al. 2009) and aboveground biomass is positively correlated with the plant biomass below ground (Cairns et al. 1997).

The size, depth and distribution of biomass below the ground, roots of trees, increases with the increase of size and life span of trees above ground (Schenk & Jackson 2002), which increases the soil shear strength (Millar 2000b) to protect from erosion. The pictures of the vegetation types (Figure 4) with NDVI values clearly indicate that high NDVI values can be considered as high biomass above ground. The migrated banks are found to have NDVI values around 0.36-0.43, but not more than 0.45 whereas the area around the bends, which are not migrated or almost stable, are found to have NDVI values of 0.45 or more.

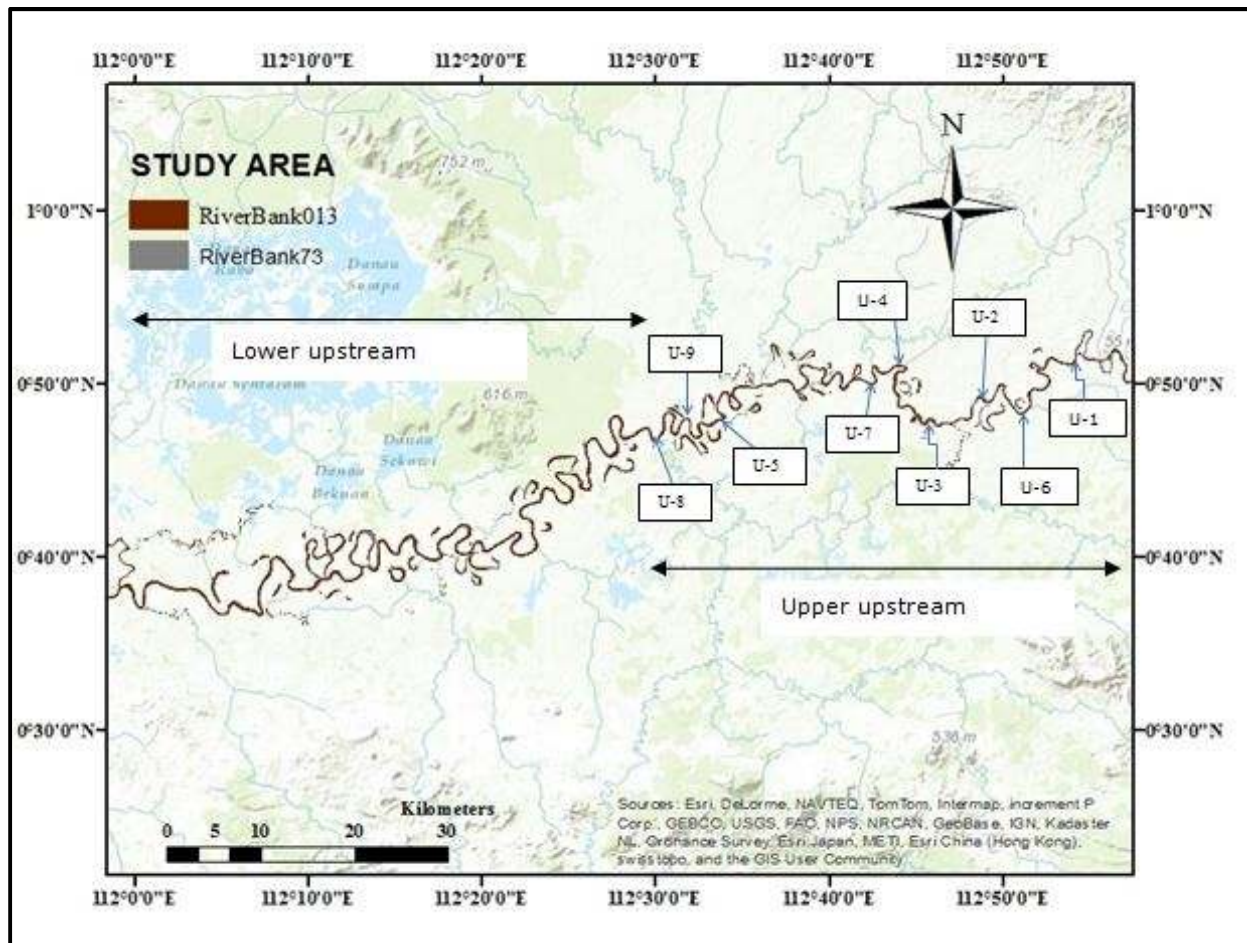
Figure 5 Selected morphological study units in the upstream of the Kapuas

From the previous research it is found that bank migration rate of the river Kapuas was higher at or around the bends rather than the straight or other reaches. To observe the vegetation impact nine morphological units were selected (Figure 5) at nine bends where some portion of the river is migrated and some portions are stable.

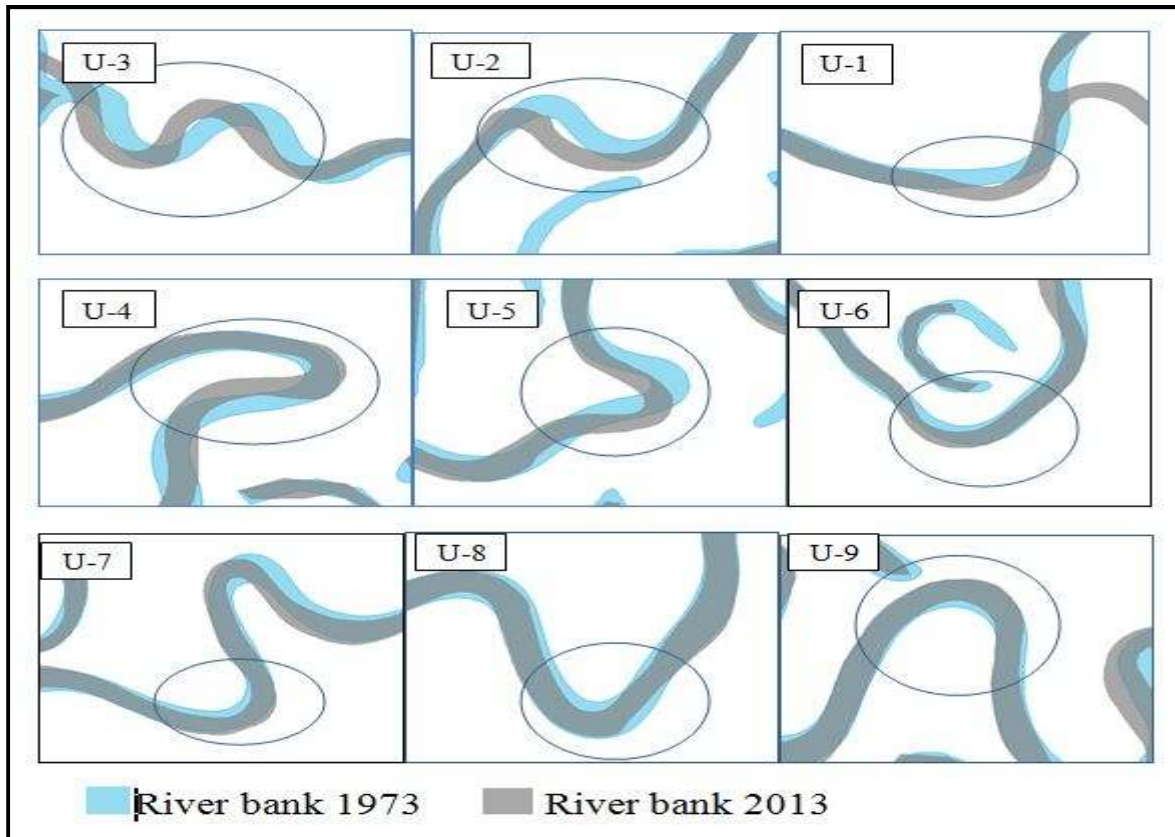
Figure 6 Selected morphological units with focusing area (ellipse) in the upper upstream of Kapuas River

To show the clear migrated area the morphological units were selected only in the upper upstream area as the migration rate was comparatively higher in the upper upstream area than the downstream area. The migrated areas are shown in the Figure 6.

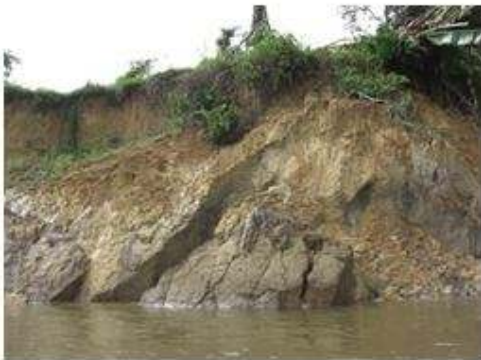
Mass failure of Banks without vegetation

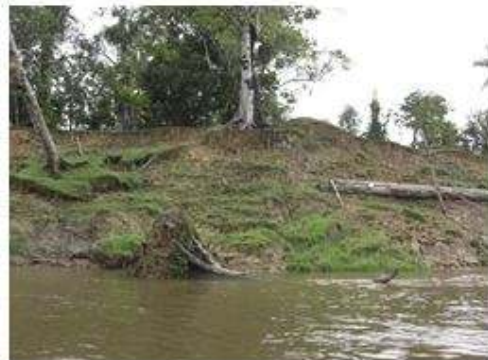
Migrated banks without vegetation

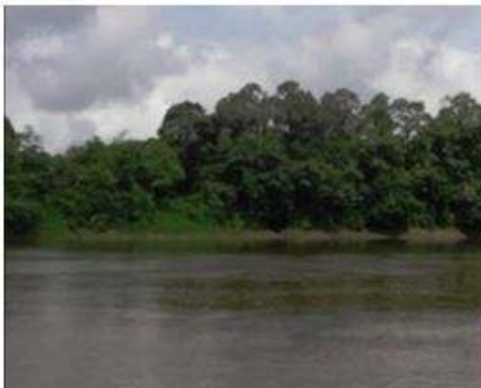
Stable bank with Vegetation

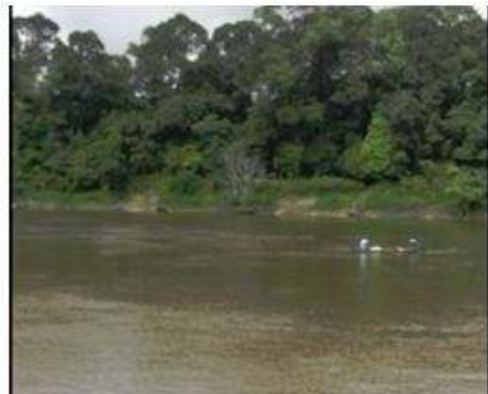
Stable bank with vegetation

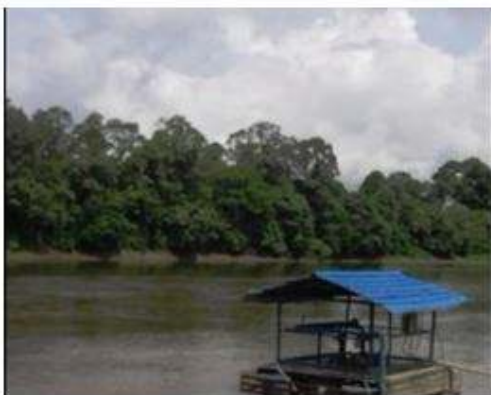
Stable bank with vegetation

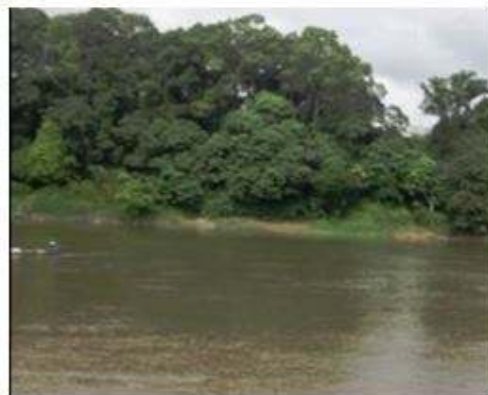
Stable bank with vegetation
