# Optimization of the rehabilitation of concrete buildings based on their dynamic properties

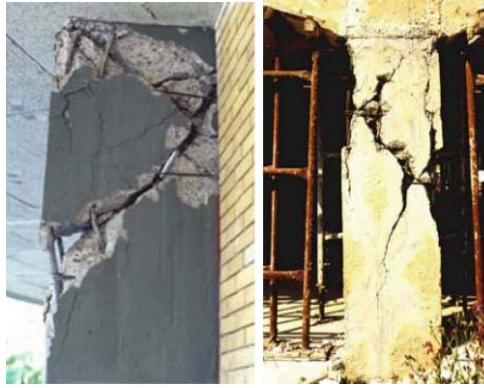
**Fig. 1. Shear failures of columns [6].**

83 Severe structural damage: It is the most critical state that can suffer the structure, are located cracks  
84 of more than 1.0 mm in width in concrete elements, the detachment of the coating in columns, the  
85 crushing of concrete (Fig.1), the breakage of stirrups and the buckling of the Reinforcement in  
86 columns as in concrete wall, cracking of flat slabs around the columns, the collapse in columns of  
87 more than 1: 100 of its height and the collapse of the building of more than 1: 100 of its height.

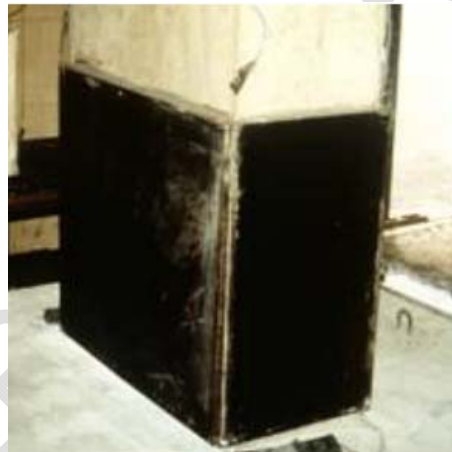
**Fig. 2. Steel jacketing of a column [7].**

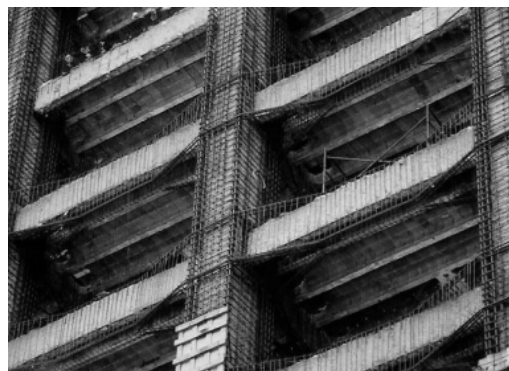
**Fig. 3. Concrete jacketing of columns and beams [8].**

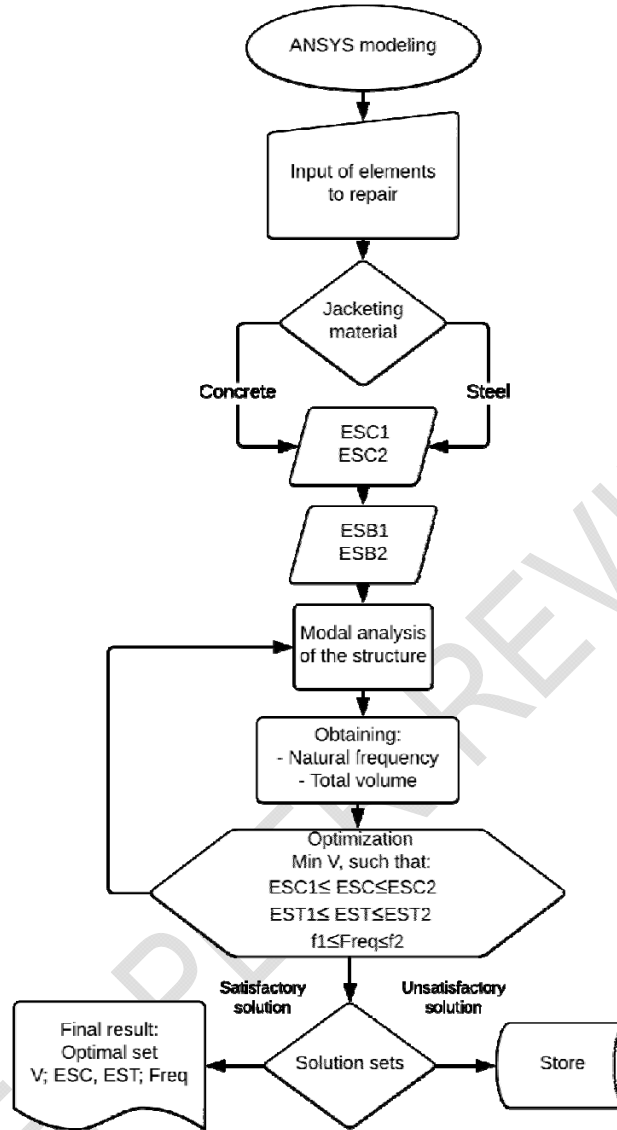
**Fig. 4. Flowchart of the optimization procedure**

Fig. 4 presents the above procedure through a flow chart.

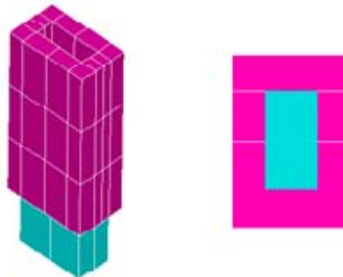
When modeling the jacketing using ANSYS, we chose a hollow box element with a uniform thickness on all four faces (Fig. 5), the rectangular element of the original element is no longer considered for the analysis, only its contribution to the total weight of the repaired building is taken into account.

**Fig. 5. Jacketing: isometric view and cross-section.**

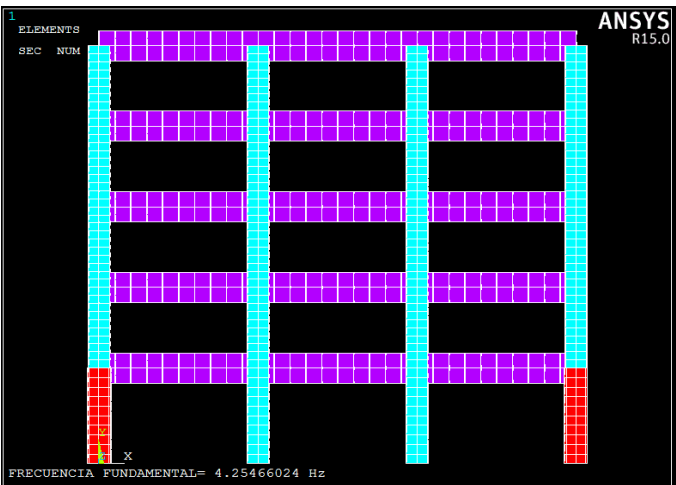
248 **Fig. 6. Five-story building with damage in the first story**

241 It was observed in cases where repairs are necessary on the ground floor (Fig.6) that the fundamental  
242 frequency was reduced in most iterations as well as an appreciably constant behavior of how much  
243 less weight is added to the major structure is this reduction in frequency, both for steel and concrete  
244 jacketings (Fig. 7). In the case of buildings where the height is exceeded considerably by its length  
245 (Fig. 8) it was observed that for concrete jacketing there is a tendency to increase the fundamental  
246 frequency (Fig. 9).

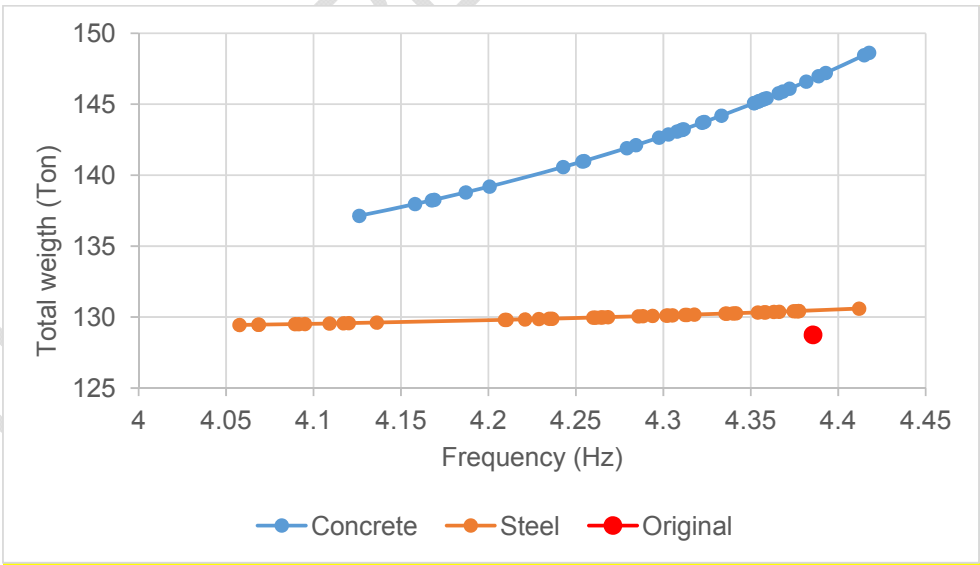
250 **Fig. 7. Variation of the weight of the rehabilitated Five-story building with respect to its**  
251 **resonance frequencies. The Damage occurs on the first story. Case1: Reinforcement concrete**  
252 **jacketing, case 2: Reinforcement Steel jacketing, case 3: No additional reinforcement**

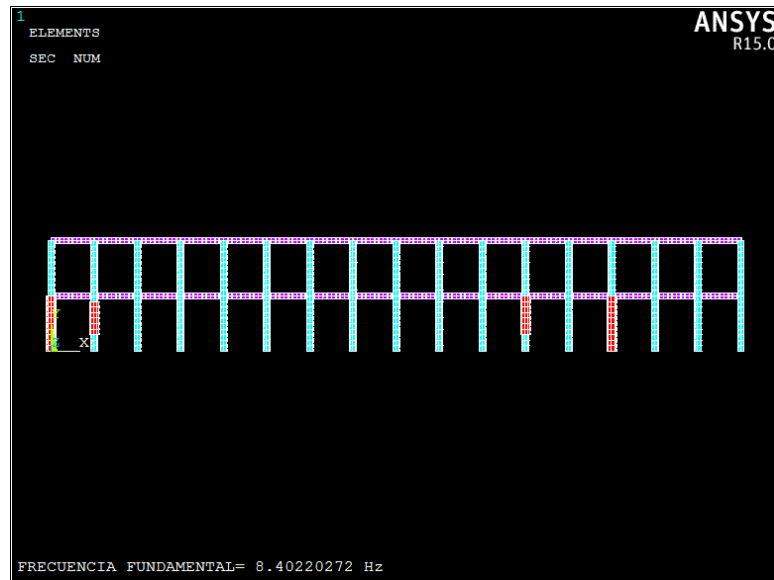
Fig. 8. Two-story building with damage in the first story

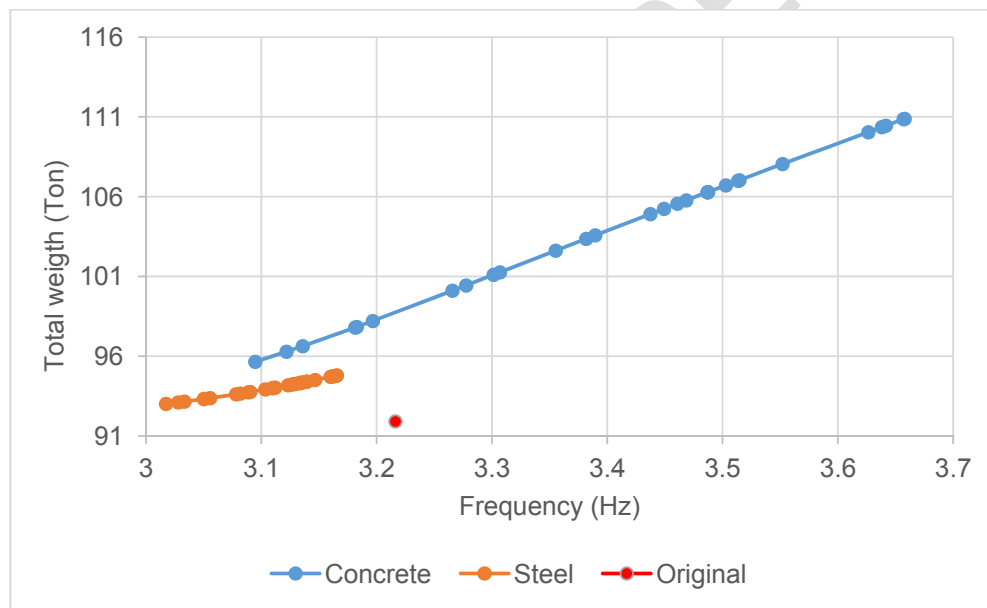
Fig. 9. Variation of the weight of the rehabilitated Two-story building with respect to its resonance frequencies. The Damage occurs on the first story. Case1: Reinforcement concrete jacketing, case 2: Reinforcement Steel jacketing, case 3: No additional reinforcement

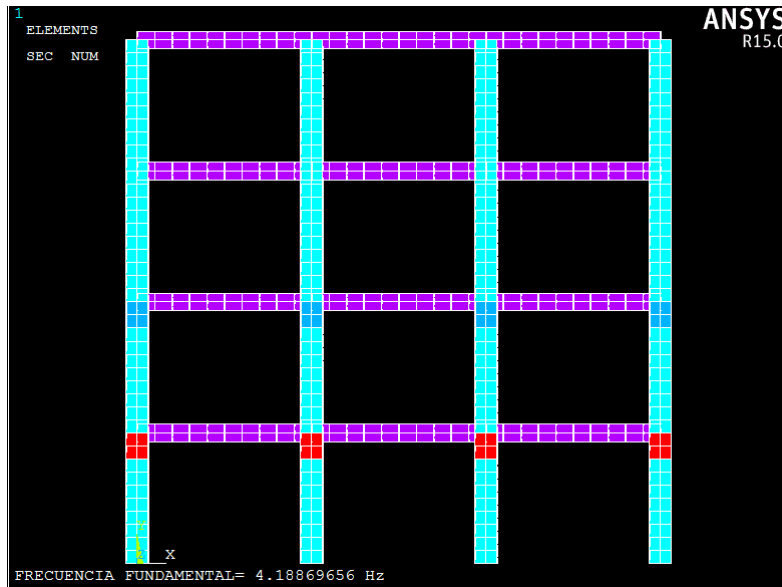
Fig. 10. Four-story building with damages in the first two stories

When the repair must be done at the top of the column as a capital (fig. 10) the end result always derives the increase of the fundamental frequency this increased stiffness gained by the jacket (Fig. 11).

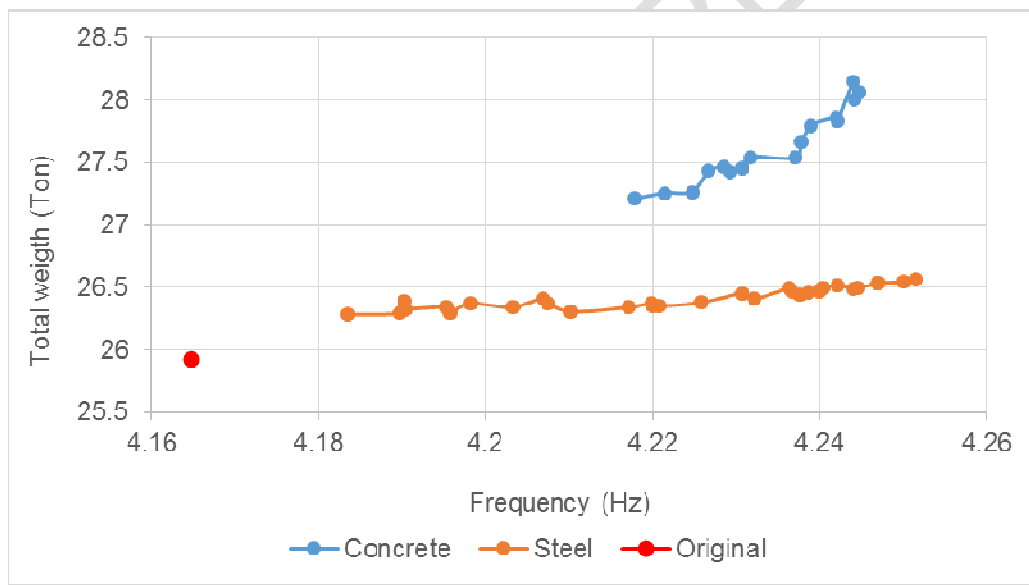
Fig. 11. Variation of the weight of the rehabilitated Four-story building with respect to its resonance frequencies. The Damage occurs on the first two stories. Case1: Reinforcement concrete jacketing, case 2: Reinforcement Steel jacketing, case 3: No additional reinforcement

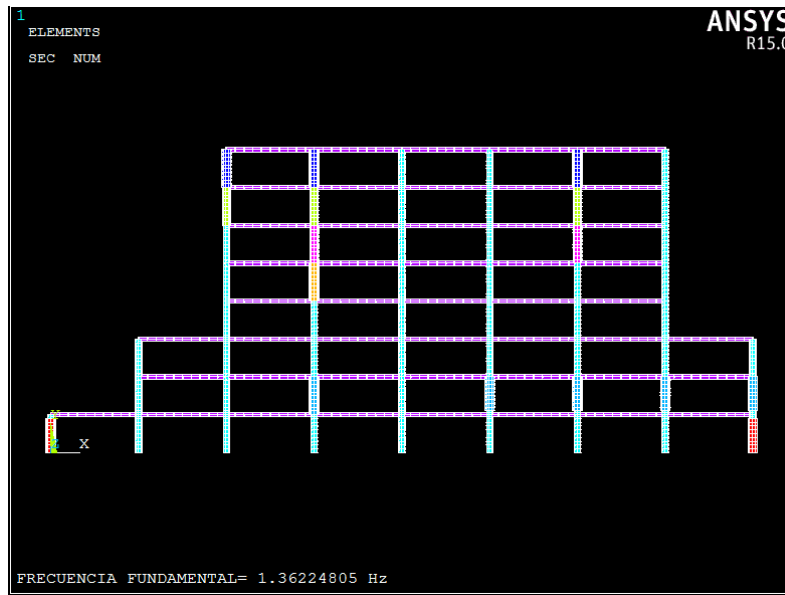
**Fig. 12. Eight-story building with damage in six of its stories**

In buildings of medium height and with irregular geometry (Fig.12), it can be seen how, for a greater number of elements to be repaired, the results become more dispersed (Fig. 13) allowing to appreciate the operation of the algorithm, in this case the steel jacketing will increase the fundamental frequency while at each iteration it offers considerably smaller than the weight of the concrete jacketing, which has the optimal solution with a natural frequency closest to the original.

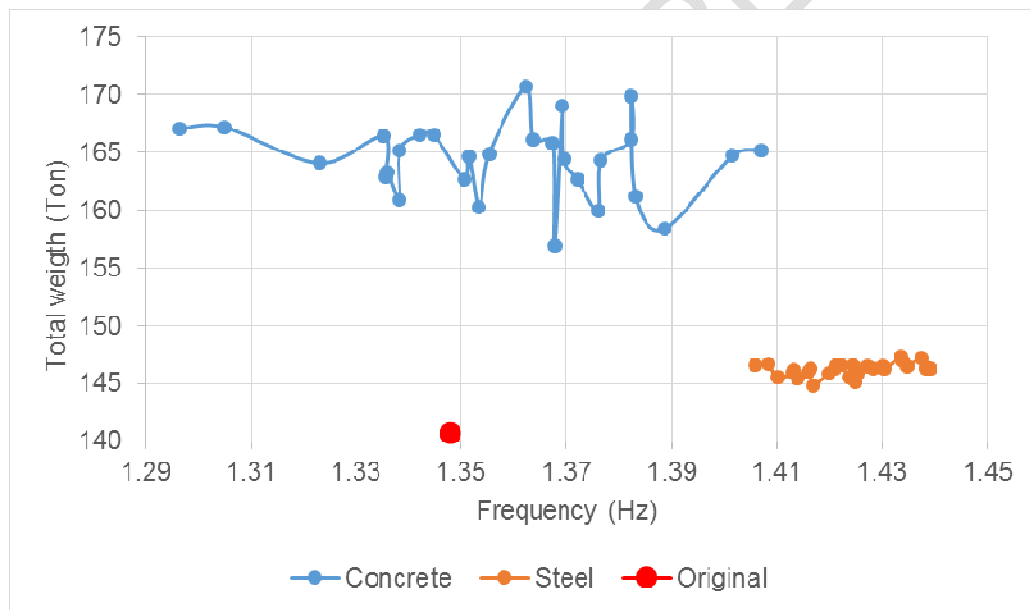
**Fig. 13. Variation of the weight of the rehabilitated Eight-story building with respect to its resonance frequencies. The Damage occurs on six of its stories. Case1: Reinforcement concrete jacketing, case 2: Reinforcement Steel jacketing, case 3: No additional reinforcement**

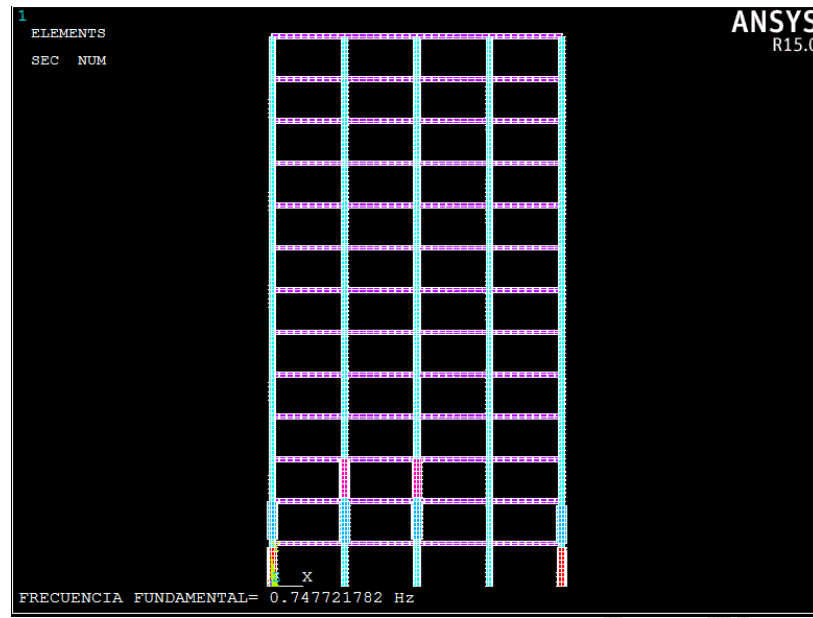
Fig. 14. 13-story building with damage on the four first stories

For buildings over 13 floors and of regular geometry (Fig. 14) it is observed how the repair in the lower floors does not have great effect on the frequency even though the weight increase for the steel jacketing is less than 2% of the original weight of the structure much less than 8% of the approximate increase of the concrete jacketing (fig.15).

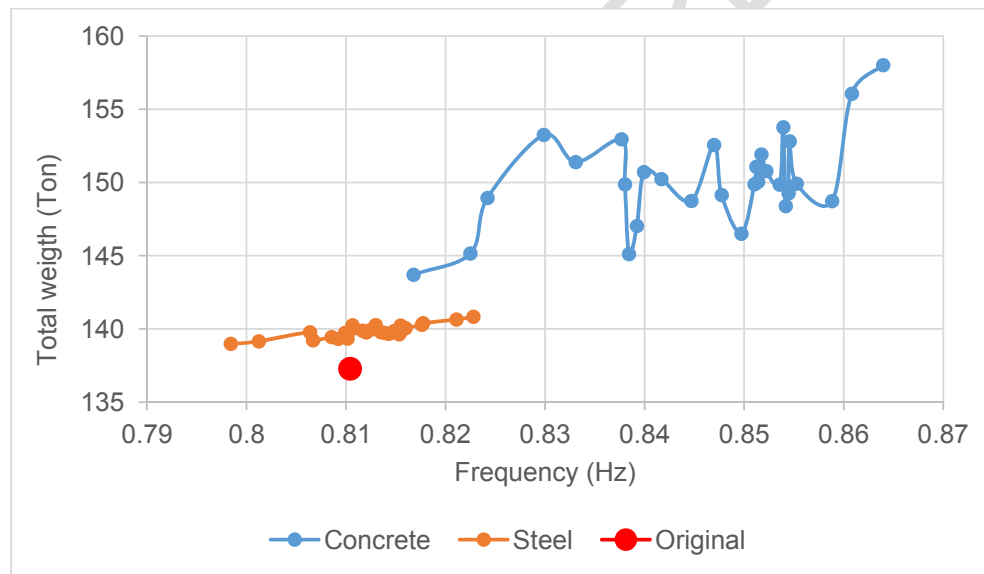
Fig. 15. Variation of the weight of the rehabilitated 13-story building with respect to its resonance frequencies. The Damage occurs on the four first stories. Case1: Reinforcement concrete jacketing, case 2: Reinforcement Steel jacketing, case 3: No additional reinforcement

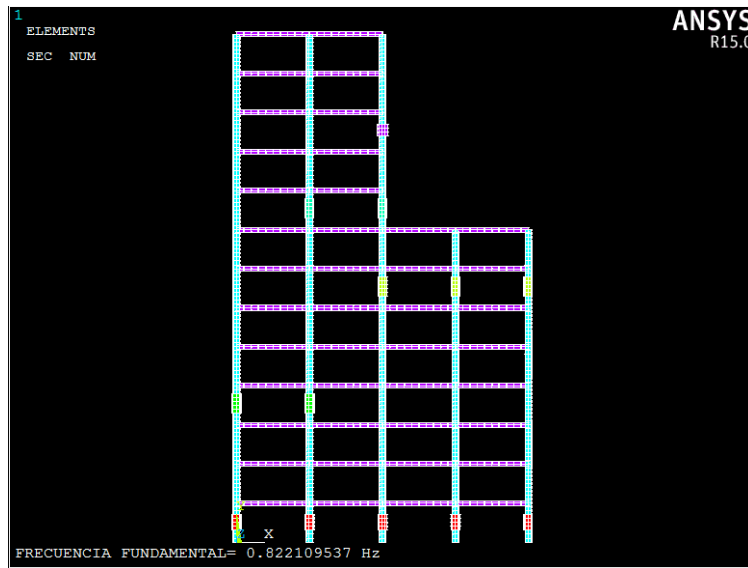
Fig. 16. 13-story building with damage in four of its stories

If the building has irregular geometry (Fig. 16) and with elements to be repaired distributed over a large part of the building, in both cases the natural frequency was reduced while the weight of the steel jacket did not vary greatly (see Fig. 17), for the different sets of the concrete jacketing a variation of up to 9 tons of difference between the minimum and the maximum is observed.

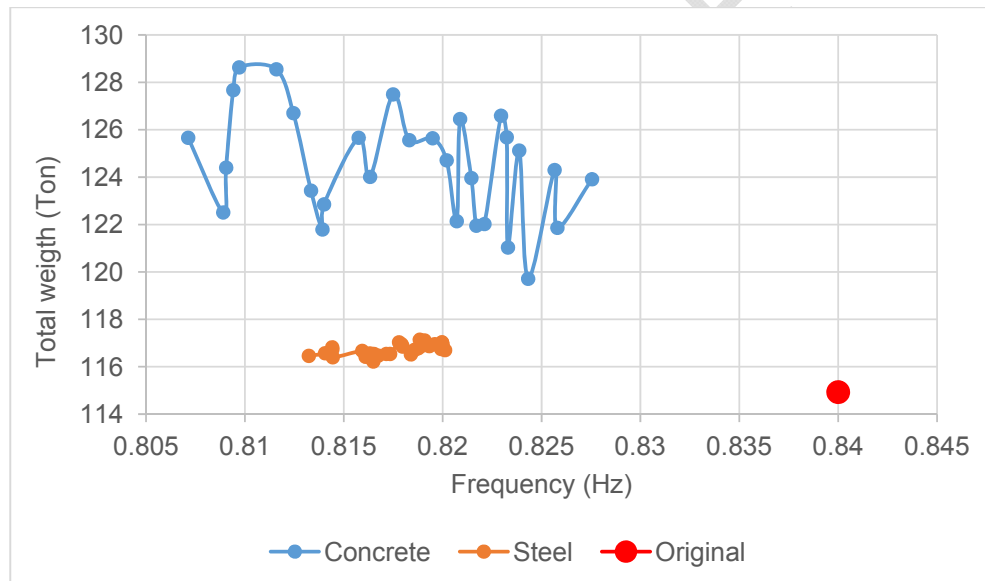
Fig. 17. Variation of the weight of the rehabilitated 13-story non-regular building with respect to its resonance frequencies. The Damage occurs on the four first stories. Case1: Reinforcement concrete jacketing, case 2: Reinforcement Steel jacketing, case 3: No additional reinforcement
