3 **Challenges and Resolution for Copper**

4 **Wirebonding on Tapeless Leadframe**

5 **Chip-On-Lead Technology**

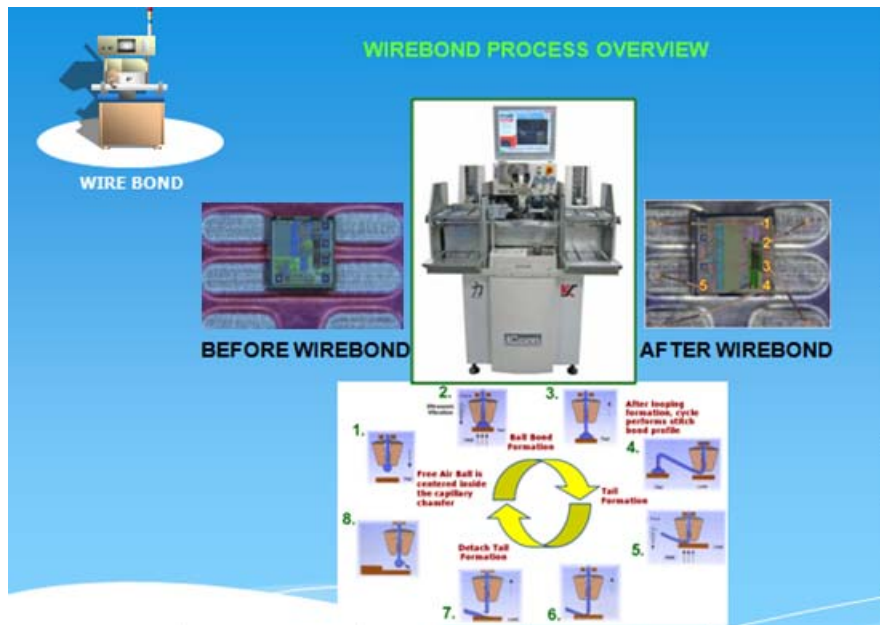
73 In the case of Device C, Copper (Cu) and ball bonding is being used. During ball bonding, a
74 ball is first formed by melting the end of the wire (which is held by a bonding tool known as a
75 capillary) through electronic flame-off (EFO). This free-air ball has a diameter ranging from

76 1.5 to 2.5 times the wire diameter. Free air ball size consistency, controlled by the EFO and
 77 the tail length, is critical in good bonding. The free-air ball is then brought into contact with
 78 the bond pad. Adequate amounts of pressure, heat, and ultrasonic forces are then applied to
 79 the ball for a specific amount of time, forming the initial metallurgical weld between the ball
 80 and the bond pad as well as deforming the ball bond itself into its final shape. The wire is
 81 then run to the corresponding finger of the leadframe, forming a gradual arc or "loop"
 82 between the bond pad and the lead finger. Pressure and ultrasonic forces are applied to the
 83 wire to form the second bond (known as a wedge bond, stitch bond, or fishtail bond) this
 84 time with the lead finger. The wire bonding machine or wire bonder breaks the wire in
 85 preparation for the next wire bond cycle by clamping the wire and raising the capillary.

87
 88
 89 **Fig. 3. Wirebonding process mechanism**
 90

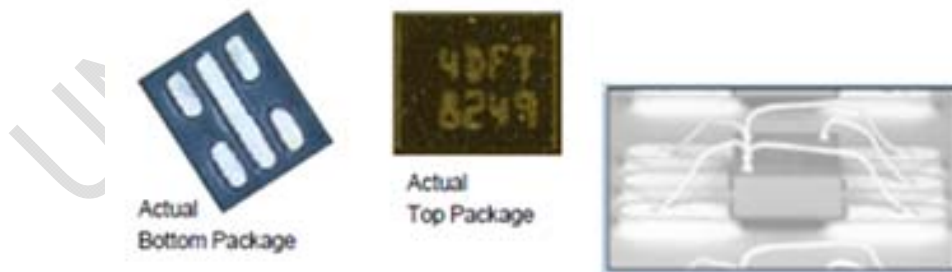
Device C is an Electrically Erasable Programmable Read-Only Memory (EEPROM) device with CMOSF8HP4 Die technology and packaged in a tapeless leadframe configuration. The package thickness is at 0.55 mm, with only 5 leads or pins. Shown in Fig. 5 is the device configuration.

Fig. 5. Device C configuration

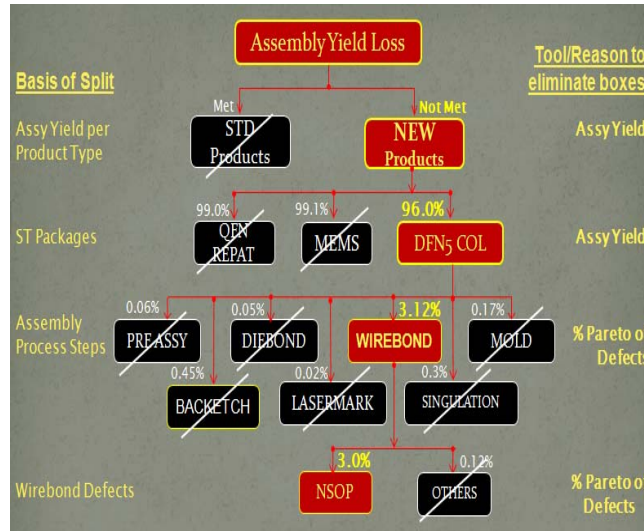
170 priority. Shown below is the Project Definition Tree (PDT) where all factors affecting the
 171 Device C low yield were considered and comprehended.
 172

173
 174
 175
 176
Fig. 8. Problem definition tree

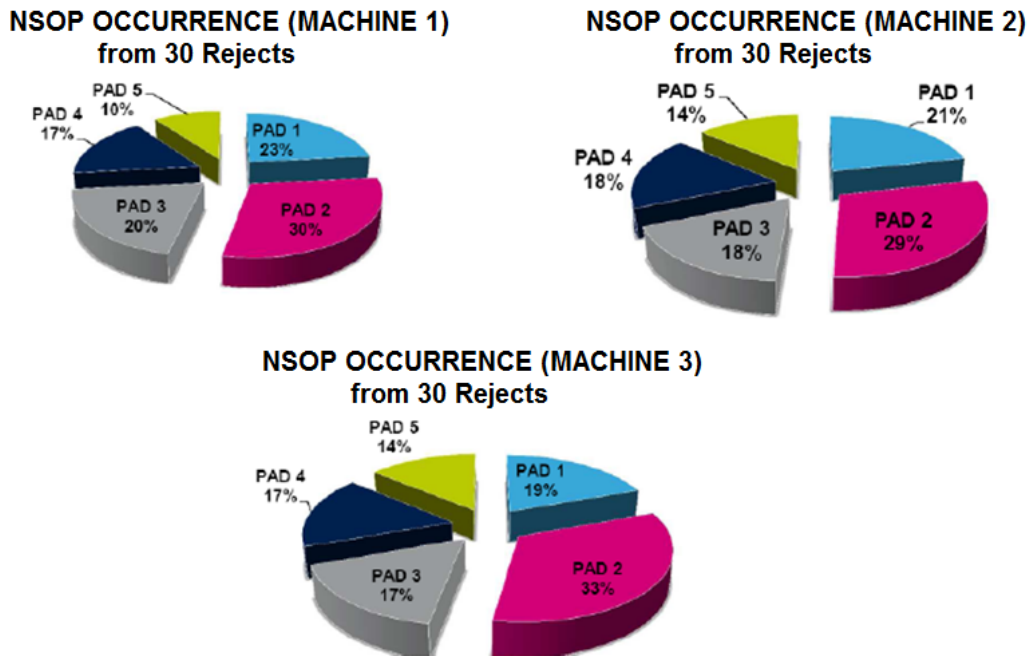
233 Machine-to-machine validation was also performed to check if NSOP defect is not machine
 234 related.
 235

236
 237
 238 **Fig. 13. Wirebond machine-to-machine comparison**
 239
 240

Table above showed the validation made on all WB machined being used to process Device C. Significant differences in ball shear results. Readings from pads 2 and 3 are passing but are significantly lower than those of pads 1, 4 and 5.

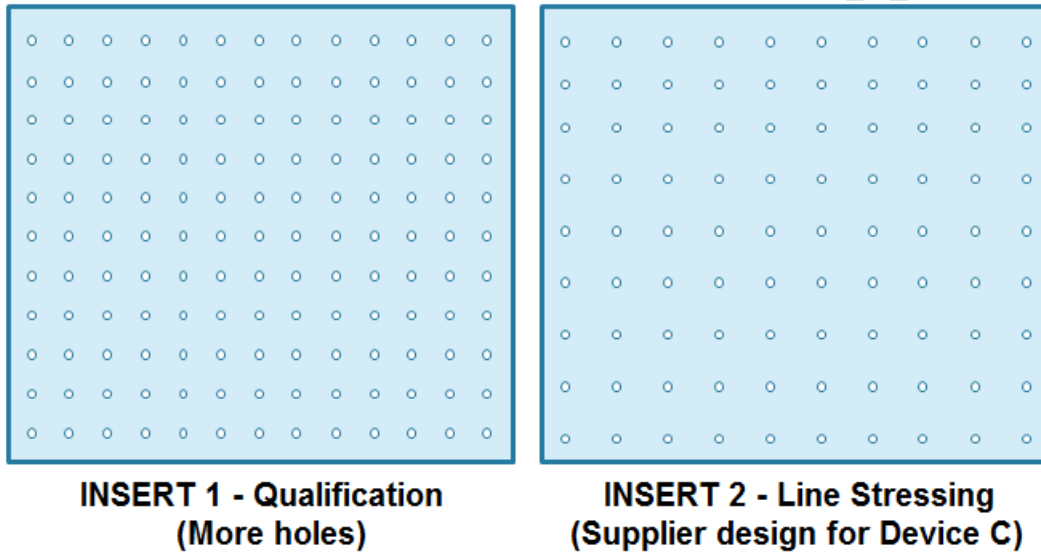
More holes on the insert avoid air traps in between units and eventually flatten the lead frame during vacuum at WB.

Fig. 15. Old and new inserts comparison

A flattened leadframe results to better wirebond quality and less probability of NSOP occurrence.

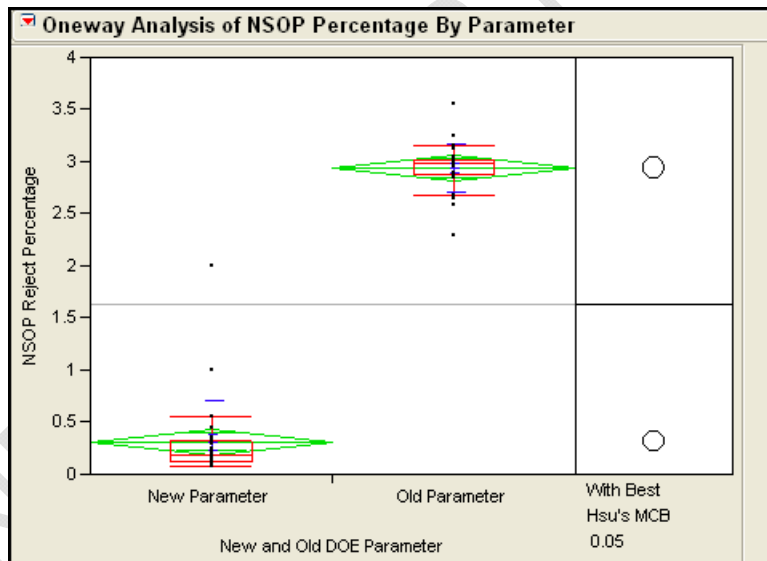
T-Test / Analysis of Variance revealed significant difference using New Design/parameters.

Fig. 17. Statistical analysis graph showing significant difference between parameters on old and new clamp and insert design in terms of NSOP attribute data
