# Challenges and Resolution for Copper Wirebonding on Tapeless Leadframe Chip-On-Lead Technology

Antonio R. Sumagpang Jr.<sup>1</sup>, Frederick Ray I. Gomez<sup>1\*</sup>

<sup>1</sup>STMicroelectronics, Inc., Calamba City, Laguna, Philippines 4027

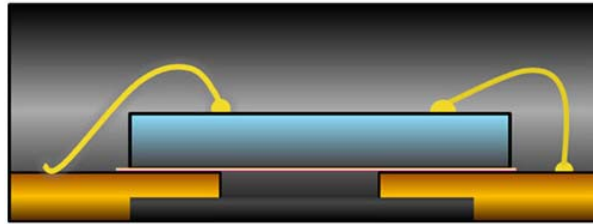
Chip-On-Lead (COL) is a technology where die or crystal is mounted on the leads of the leadframe instead of the paddle. To make it complicated, this leadframe has no tape for support during wirebonding unlike conventional leadframe. COL packages have not only provided a low cost solution on reducing body size requirements, but also have shown proven package robustness meeting target reliability performances and key quality and productivity indices that enabled a production worthy package. Shown in Fig. 1 and Fig. 2 are the package cross-section view and the typical molded package outline of COL package, respectively.

Fig. 1. Chip-On-Lead (COL) package cross-section view

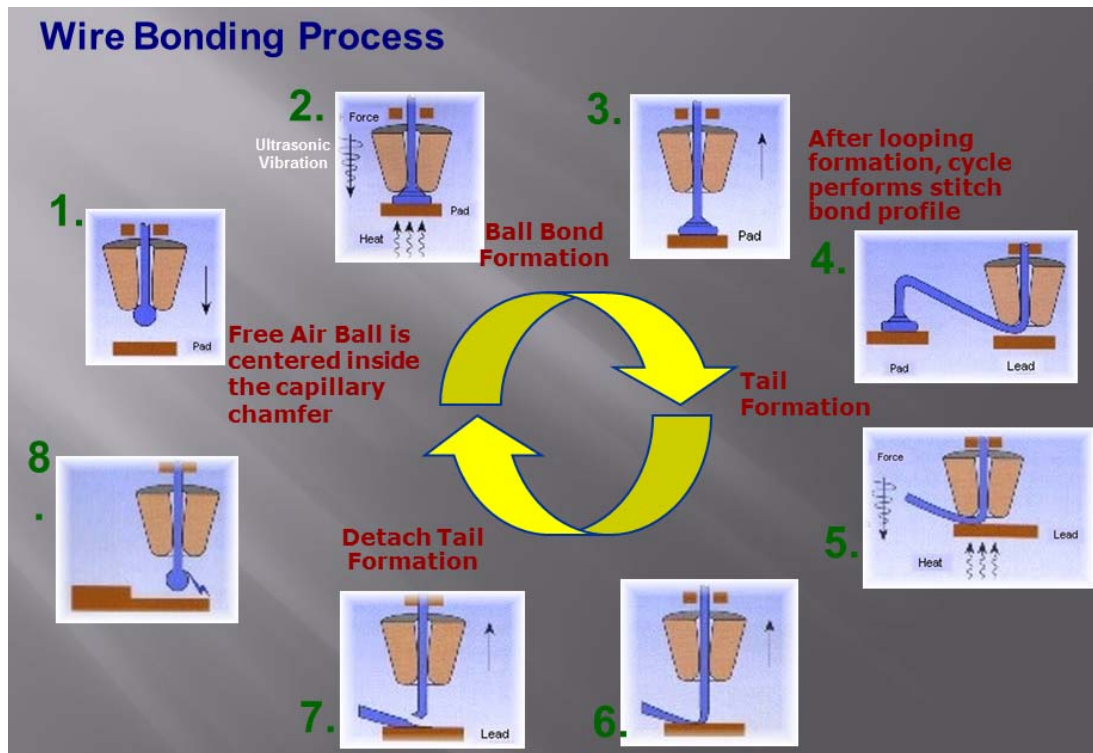
In the case of the package or device in focus (hereinafter referred to as Device C), Copper wire and ball bonding is being used. Fig. 3 illustrates the overview of the wirebond process. During ball bonding, a ball is first formed by melting the end of the wire (which is held by a bonding tool known as a capillary) through Electronic Flame-Off (EFO). This free-air ball has a diameter ranging from 1.5 to 2.5 times the wire diameter. Free air ball size consistency, controlled by the EFO and the tail length, is critical in good bonding. The free-air ball is then

brought into contact with the bond pad. Adequate amounts of pressure, heat, and ultrasonic forces are then applied to the ball for a specific amount of time, forming the initial metallurgical weld between the ball and the bond pad as well as deforming the ball bond itself into its final shape. The wire is then run to the corresponding finger of the leadframe, forming a gradual arc or "loop" between the bond pad and the lead finger. Pressure and ultrasonic forces are applied to the wire to form the second bond (known as a wedge bond, stitch bond, or fishtail bond) this time with the lead finger. The wire bonding machine or wire bonder breaks the wire in preparation for the next wire bond cycle by clamping the wire and raising the capillary.

Fig. 3. Wirebonding process mechanism

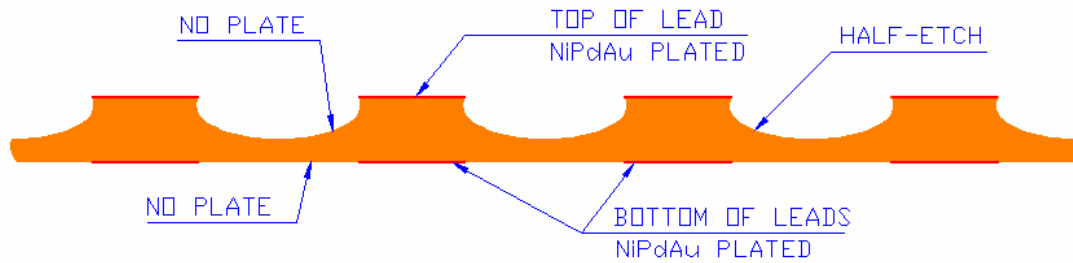
Tapeless Chip-On-Lead package is a leadframe-based package carrier or platform in which the leads footprint will be formed by back-etching process. The plant has a lot to gain with tapeless package – cheaper leadframe cost, Copper wire compatible, no tape and faster sawing speed in singulation. Shown in Fig. 4 is the tapeless leadframe configuration.

**Fig. 4. Tapeless leadframe configuration**

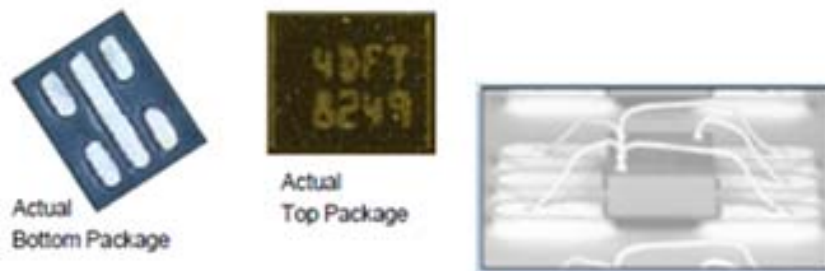
Device C is an Electrically Erasable Programmable Read-Only Memory (EEPROM) device with CMOSF8HP4 die technology and packaged in a tapeless leadframe configuration. The package thickness is at 0.55 mm, with only 5 leads or pins or pads. Shown in Fig. 5 is the device configuration.

Fig. 5. Device C configuration

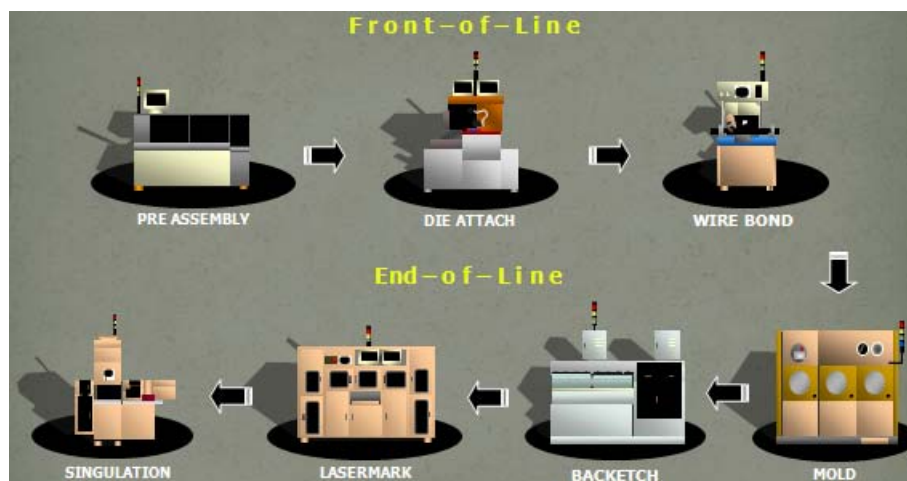
During initial phase of the investigation, all possible variables to determine the yield loss contributors were studied. In the case of Device C, the entire processes were analyzed as this product carries new process bricks and technology for the plant such as Copper wirebonding and the use of tapeless leadframe which is more sensitive than the conventional leadframe. An overview of the assembly process flow is illustrated in Fig. 6. It is worth noting that process flow varies with the product and the technology [7] [8] [9].

Fig. 6. Device C assembly process flow

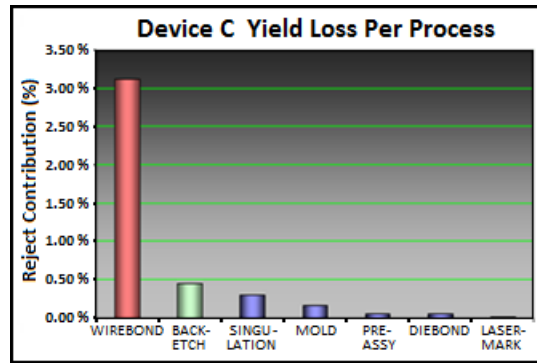
During the investigation, it was established that the major source of yield loss during ramp-up stage is wirebond. This is a substantial finding so that attention and effort for the root-cause analysis will only focus on this process. Furthermore, yield detractors and top defects were also identified by collecting defect signatures that will serve as lead to further investigate and analyze the root-cause of the problems. Pareto diagram in Fig. 7 shows the yield loss contribution per process and their corresponding rejection rate as source of yield loss during ramp-up stage.

**Fig. 7. Pareto diagram of yield loss contributor per process**

Wirebond has ~3.0% yield loss and considered as high priority among other assembly processes. Furthermore, Problem Definition Tree was established, a structured step-by-step statistical tool used in the analysis to systematically guide the team and identify the top priority. Shown in Fig. 8 is the Project Definition Tree (PDT) where all factors affecting the Device C low yield were considered and comprehended.

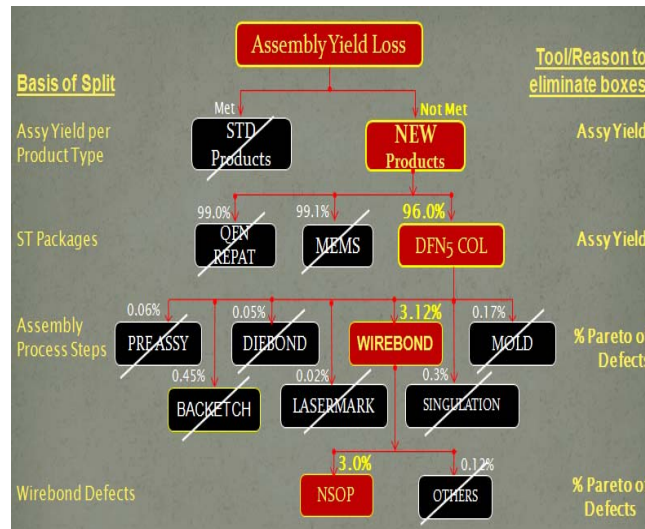
**Fig. 8. Problem definition tree**

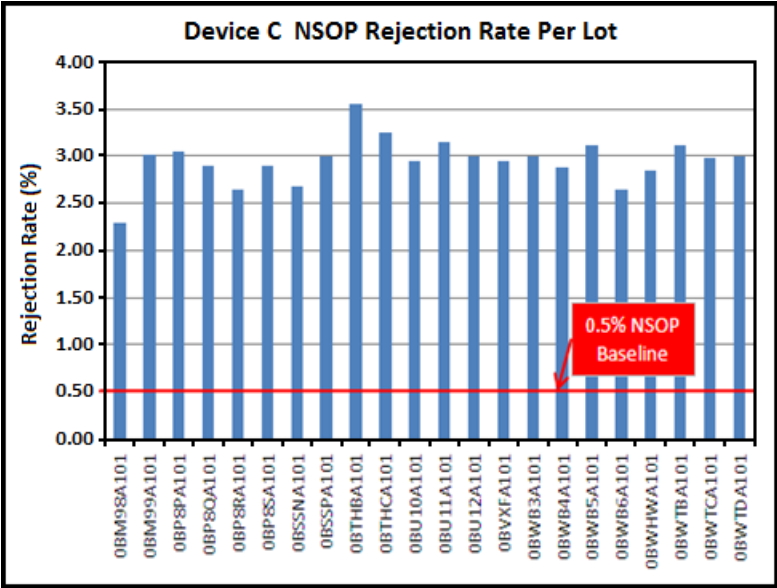
Several lots during ramp-up in production were severely affected and way above the allowable Parts Per Million (PPM) level of 0.5%, as shown in Fig. 10.

Fig. 10. NSOP rejection rate per lot

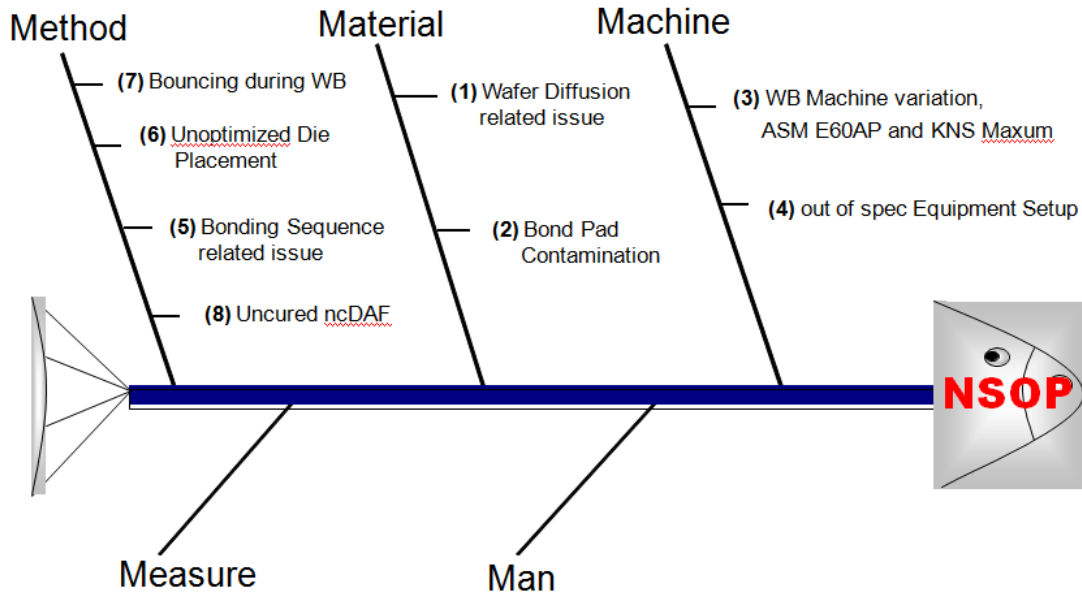
214 To capture all variables or potential causes leading to NSOP, Fishbone Diagram in Fig. 11  
215 and Cause and Effect Diagram were employed. Each of the causes was validated to come  
216 up to the true causes. Shown in Table 1 is the validations made.

Fig. 11. Fishbone diagram

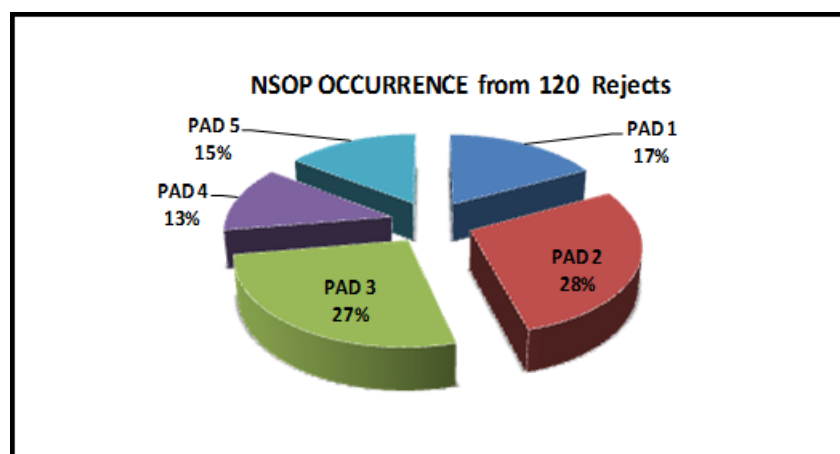
For wirebond, based on Pareto Principle, the top defect contributor is NSOP (3.0%). The 0.12% other defects (trivial many – composed of many small percentage of defects) was not included in the analysis to save time and effort. Shown in Fig. 12 is the NSOP occurrence in 5 pads of Device C.

Fig. 12. NSOP pie chart

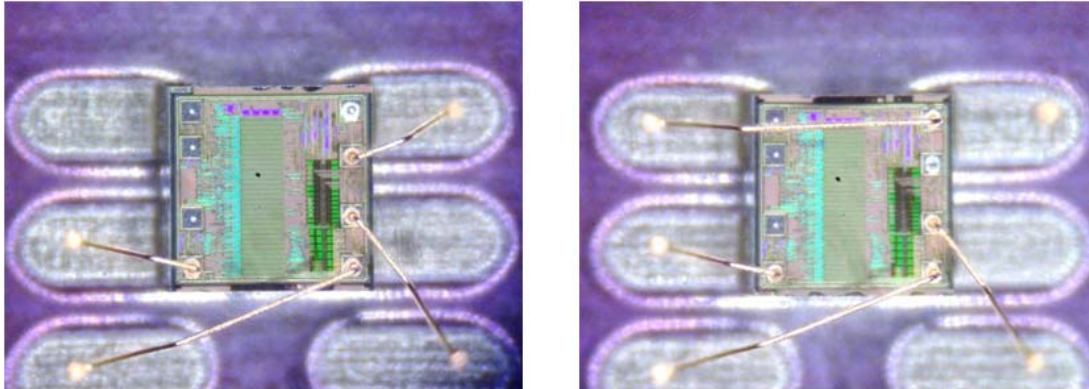
Sample photos of bonded units showing NSOP manifestation on pads 1 and 2 are shown in Fig.13. Similar manifestation occurred on pads 3, 4, and 5.

**Fig. 13. NSOP defect mechanism**

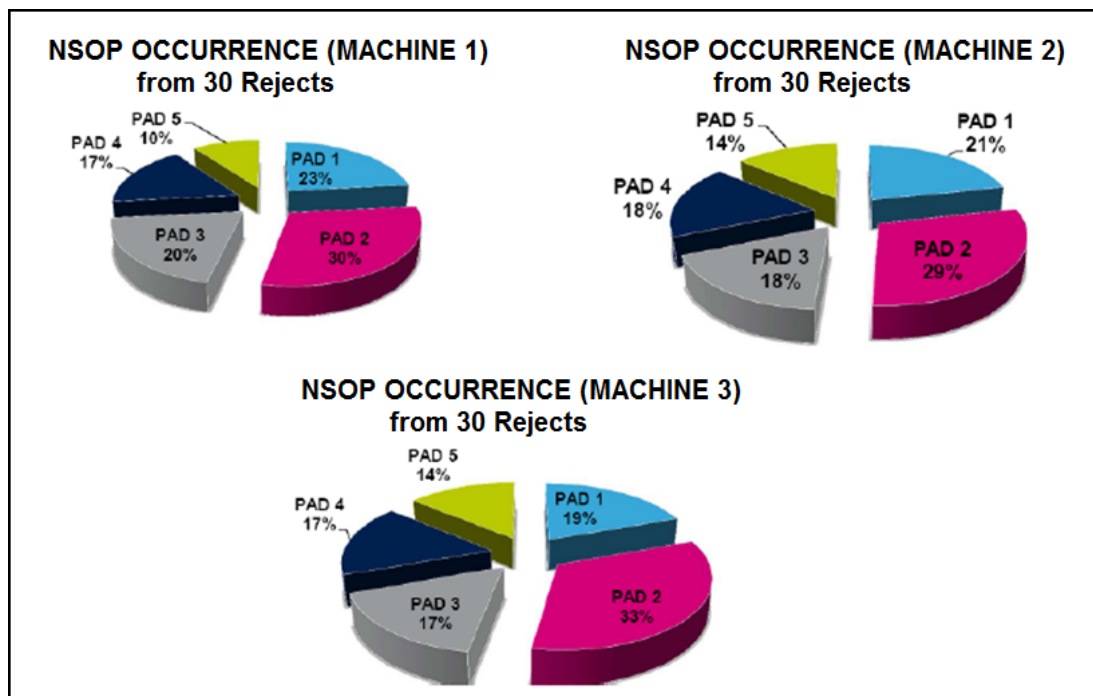
Machine-to-machine validation was also performed to check if NSOP defect is not machine related. The comparison is shown in Fig. 14.

**Fig. 14. Wirebond machine-to-machine comparison**

The same diffusion wafer batch was split into three wirebonding machines but gave the same results and level of NSOP rejects. With that, wirebond machine was set aside in the investigation.

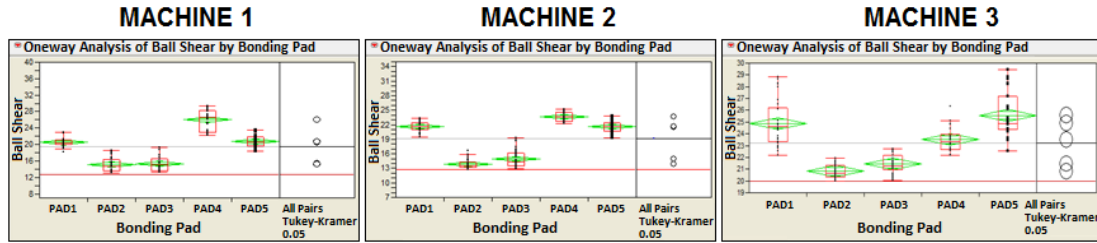
Table 1, which was earlier presented, shows the validation made on all wirebond machined being used to process Device C. Significant differences in ball shear results were observed, as illustrated in Fig. 15 using SAS-JMP software [10], a statistical tool that calculates automatically the combination of runs. Readings from pads 2 and 3 are passing but are significantly lower than those of pads 1, 4, and 5.

**Fig. 15. Wirebond machines statistical analysis**

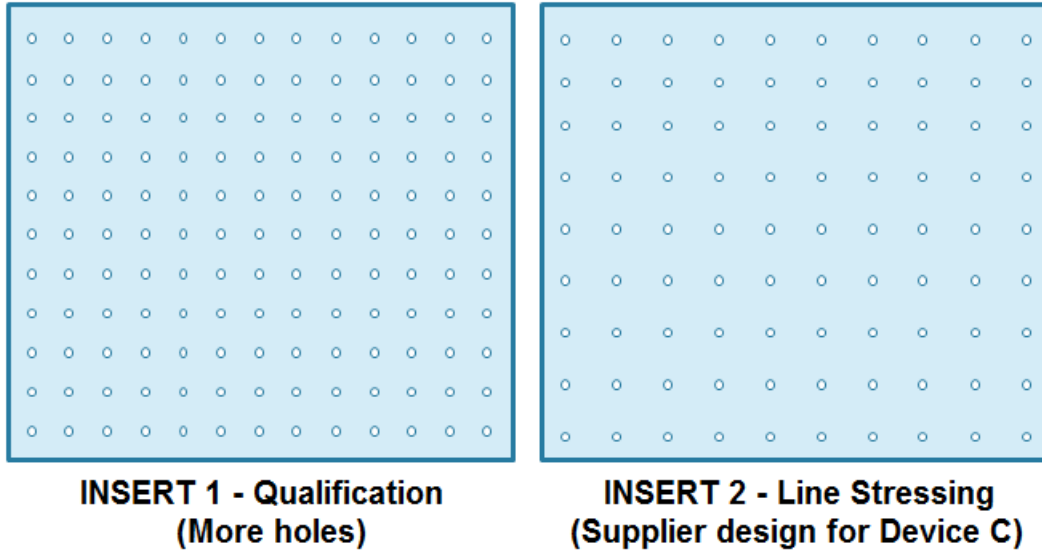
Digging deeper, further validation was made through Why-Why Analysis as exemplified in Table 2. This confirms that the “Red-X” is the configuration of the designed insert used during the line stressing lot of Device C, causing the NSOP rejection.

More holes on the insert avoid air traps in between units and eventually flatten the leadframe during vacuum at wirebonding. Fig. 16 compares the old insert design and the new insert design.

**Fig. 16.** Old and new inserts comparison

A flattened leadframe results to better wirebond quality and less probability of NSOP occurrence. Table 3 and 4 present the Why-Why Analysis of systematic root-cause and escape root-cause, respectively.

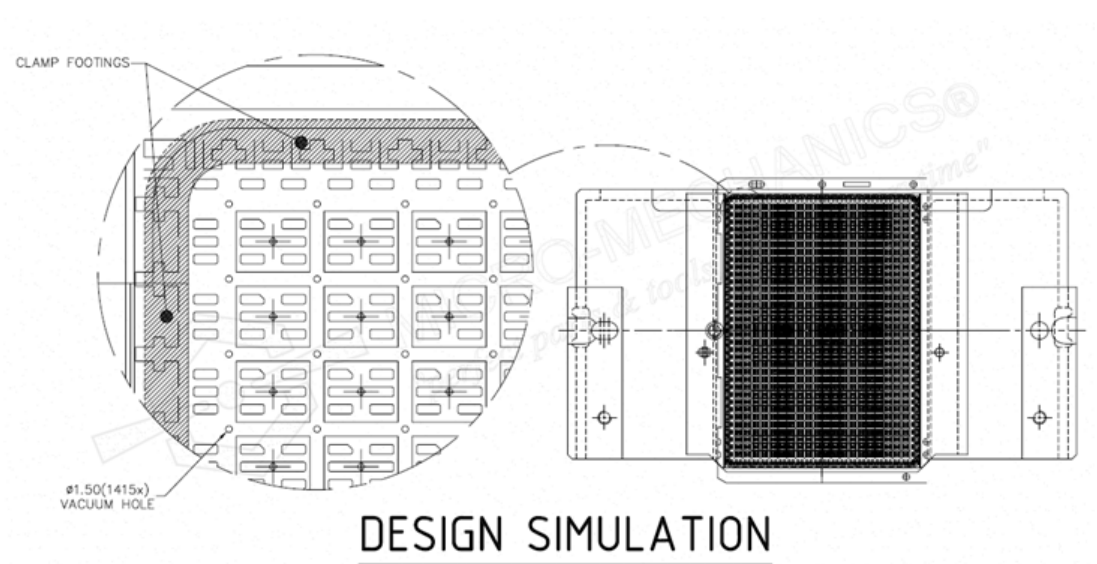
Results of comprehensive investigation through Fishbone and Why-Why Analysis showed that the root-cause of HIGH NSOP Rejection rate can be attributed to clamp and insert design, most particularly the insert design. This was identified after series of analysis and validation using different runs. The results was further strengthened by using a high speed camera that helped pinpoint the root-cause of the NSOP phenomena. Results revealed that by using the modified insert design with more holes will address NSOP rejection without sacrificing quality requirements of the products including reliability.

A Design-of-Experiment (DOE) for 1st bond parameters was conducted with the objective to determine and define window that will minimize occurrence of NSOP. New insert design (Rev 1) shown in Fig. 17 has total of 1,415 holes to hold 680 units per panel while the original insert design (Rev 0) has only 220 holes.

**Fig. 17. New design of clamp and inserts**

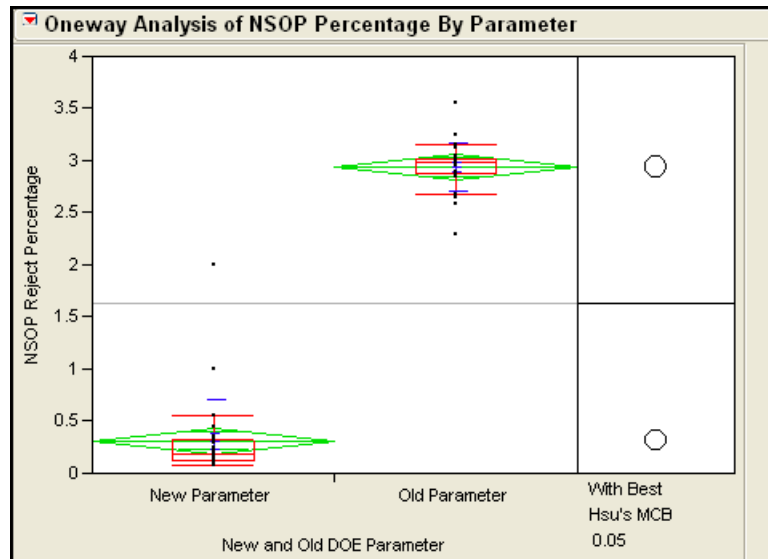
T-Test or Analysis of Variance in Fig. 18 revealed significant difference using new design or parameter over the previous design.

**Fig. 18.** Statistical analysis graph showing significant difference between parameters on old and new clamp and insert design in terms of NSOP attribute data

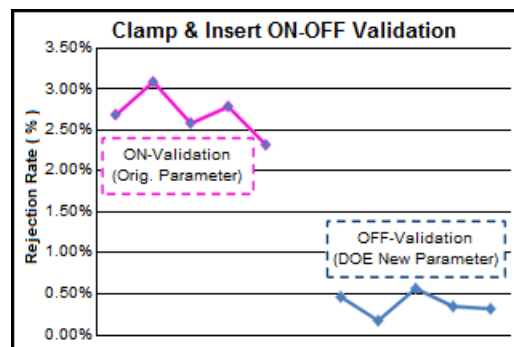
To strengthen the premise on NSOP is due to clamp and insert design. Wirebond parameters were brought back to its original set-up. Employing On-Off validation, it is evident in Fig. 19 that new clamp and insert dictates the outcome of NSOP rejection rate. Results of all experiments and validation runs strengthen the conclusion that the NSOP due to poor design of clamp and insert can be mitigated using higher new design with enhanced vacuum capability.

**Fig. 19.** Clamp and insert design/parameters On-Off validation

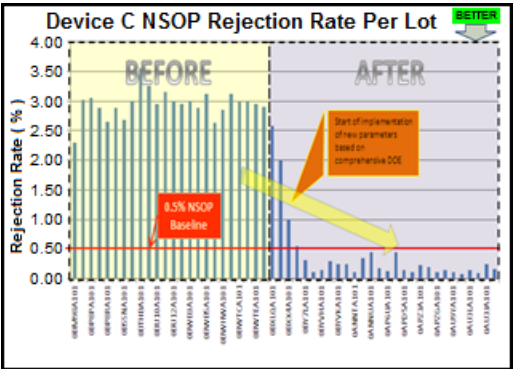
Continuous monitoring on the lots during mass production was carried out. Result of verification, showed that the lot using new clamp and insert design has an average of 0.32%

374 reject rate. NSOP trend together with the action and date of execution was monitored to  
375 confirm and validate the effectiveness of the implemented solution. Shown in Fig. 24 is the  
376 detailed monitoring graph regarding NSOP before and after the solution implementation.  
377

378  
379  
380 **Fig. 24.** NSOP lot trend before and after the implementation of the corrective actions  
381

After replacement of new clamp and insert design that mitigates the risk of NSOP defects and validations in terms of Quality and Reliability aspects, large scale evaluations were made through Line Stressing to validate effectiveness of new clamp and insert design. Error proofing was employed to identify actions that will either control or eliminate these errors.

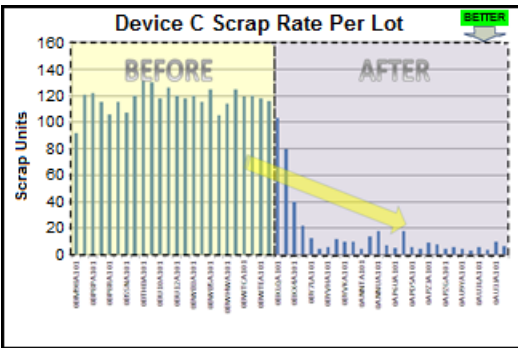
382 Other factors were also measured particularly scrapping of lots due to high NSOP rejection.  
383 Fig. 25 illustrates the positive impact after the implementation of corrective action.  
384

385  
386  
387 **Fig. 25.** Scrap rate improved after implementation of corrective actions  
388

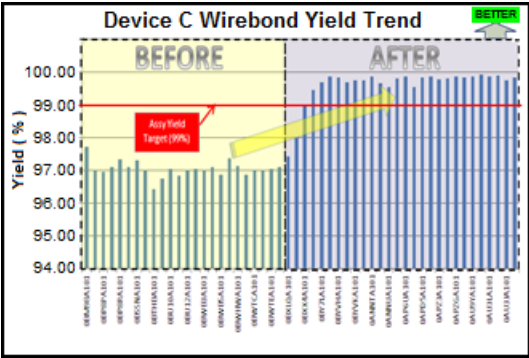
389 Significant effect was felt in the Scrap rate. Moreover, assembly yield shown in Fig. 26  
390 increased by more than 3% and meeting the wirebond yield of 99.5%. Yield trend stabilized  
391 after the implementation of corrective action.  
392

393  
394  
395 **Fig. 26.** Assembly wirebond yield trend
