## Short Research Article

## The degradation the river Nakanbé banks (Burkina Faso) facing to climate change : a participatory approach for reforestation as a sustainable solution for water resources management

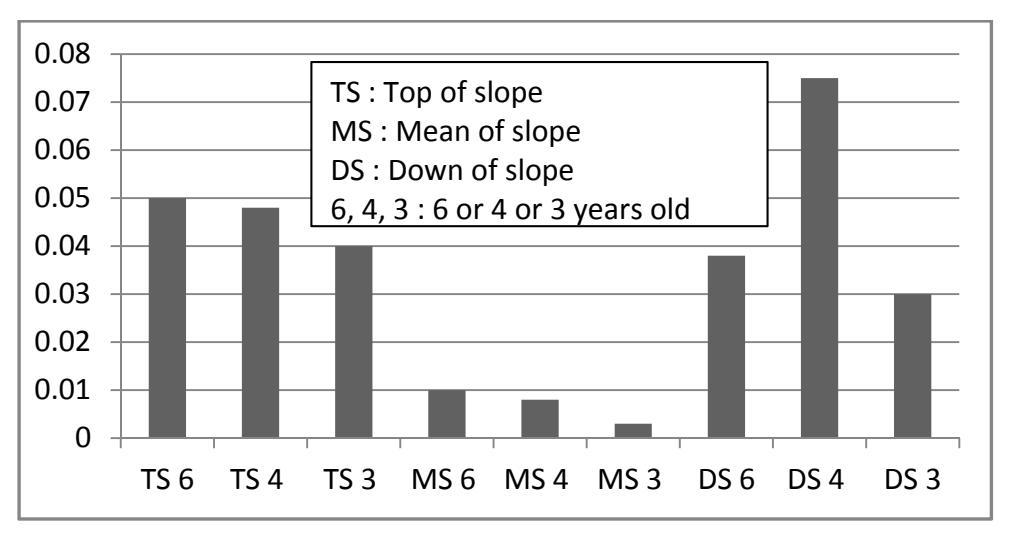
### 105 Figure 2: Ratio of woody species according to the oldness of reforested banks

106 TS = top of slope; MS = mean of slope and DS = down of slope

The analysis of the number of woody species by age of reforestation (Figure 2) show, in high and medium slope, non-significant growth with the age of reforestation ; at the bottom of the slope, the 4-year-old reforested bank have the most significant tree population (0.075 individuals/m<sup>2</sup>).

98 The analysis of the of the number of woody species by age of reforestation (Figure 2) shows, in high and 99 medium slope, the number of plants shows non-significant growth with the age of reforestation ; at the 100 bottom of the slope, the 4-year-old reforested bank has the most significant tree population (0.075 101 individuals/m<sup>2</sup>).
