## Investigating Soil and Water Contamination of Trace Metals in Tarkwa-Nsuaem Municipality, Ghana

#### Abstract

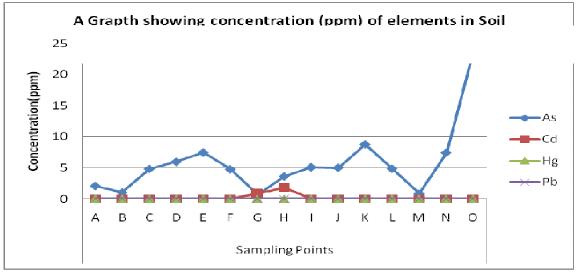
Fig. 2: A graph showing concentration (ppm) of elements in soil

Arsenic concentration in soil ranges from 0.65  $\mu$ g/g to 23.78  $\mu$ g/g (Fig 2). The highest concentration was obtained at Old Town (Tarkwa). The least concentration of  $0.65 \,\mu g/g$ was recorded at Akoon which was the control site and had no mining activity. The second highest concentration (8.75 µg/g) occurred at New Atuabo. New Atuabo and Old Town lie along the same geological plane with a steep slope and the fact that the two stations recorded high arsenic concentrations can be explained by the geology of the area and not the mining activity in the area. Arsenic level in soil increased from Tamso (5.95  $\mu$ g/g) to Eduprien (7.44  $\mu$ g/g); it then decreased from Teberebie (5.07  $\mu$ g/g) to Mile 9 (5.00  $\mu$ g/g), and further to 4.82 µg/g at Mile 7. However, the concentration fluctuated again to 7.40  $\mu$ g/g at Mile 10<sup>1</sup>/<sub>2</sub>. The decrease trend may be due to geological factors whilst the sharp increase could be blamed on some anthropogenic factors. The IAEA-Soil-7 recommended value for arsenic concentration in soils is 13.50  $\mu$ g/g. This implies that only the control site had arsenic levels below the IAEA guideline value. The high arsenic concentration recorded at Old Town can be blamed on the fact that the sampling point used to be a refuse dump hence; there could be some other anthropogenic introduction of arsenic into the soil besides mining.

The highest mercury concentration in soil  $(0.05 \ \mu g/g)$  occurred at Mile 10½. This was followed by Mile 8 which recorded 0.03  $\mu g/g$  (*Fig.2*). Nine stations including Akoon had mercury levels less than 0.01  $\mu g/g$ . Stations where mercury was detected- Mile 10½, Mile 8, Eduprien, Teberebie and Bonsaso are places where galamsey operations are very common. The IAEA-Soil-7 recommended value for mercury level in soils is 0.04  $\mu g/g$ . This means that all the stations have mercury levels within limits except Mile 10½ which had a concentration (0.05  $\mu g/g$ ) slightly above the recommended value. The sample was taken from a farmland. However, a critical observation of the trend of mercury occurrence in soils in the study area shows that mining activities, especially galamsey operations, play a significant role in mercury concentration in soils in the study area.

Cadmium level in soils at all the stations including Akoon was less than 0.01  $\mu$ g/g except at Akyempim which recorded 1.82  $\mu$ g/g (*Fig.2*). The low concentrations could be due to geological factors. The IAEA-Soil-7 recommended value for cadmium concentration in soils is 1.30  $\mu$ g/g. Akyempim had a concentration of 1.82  $\mu$ g/g which is above the IAEA guideline value and the control site of (0.86). This isolated case could be due to variations in the geochemistry of the place. Generally, it could be seen from the results that though

Lead concentration in all the samples including that of Akoon was below 0.01  $\mu$ g/g (Fig 2). The low concentration is probably due to the minute quantities in which lead minerals occur in the rocks of the area. The IAEA-Soil-7 recommended value for lead concentration in soils is 60.00  $\mu$ g/g. This means that the recorded concentrations are far below the IAEA guideline value. Hence, no soil contamination in terms of lead is occurring in the study area.

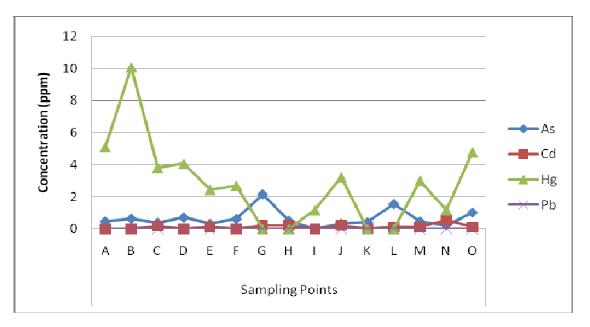
Fig. 3: A graph showing concentration (ppm) of elements in water

Concentration of Arsenic at the 15 sampling points ranges from <0.01 mg/l to 2.14 mg/l (*Fig 3*). The highest concentration, 2.14 mg/l was recorded at Teberebie (bore hole) and the lowest concentration of less than 0.01 mg/l was recorded at Akoon (bore hole). Concentration of As in ground water declines from Tamso (0.70 mg/l) to Akyempim (0.63 mg/l), and to Mile 8 (0.47 mg/l); then finally, to Mile 9 (0.32 mg/l). Given the fact that Mile 10<sup>1</sup>/<sub>2</sub> recorded a concentration of 0.22 mg/l, the sequential decline in concentration could be due to geological factors. However, Mile 7 which is located between Akyempim and Mile 8 recorded a higher arsenic level of 1.54 mg/l. This gives a strong suspicion of an anthropogenic cause such as mining. Furthermore, streams

Mercury concentration as observed from Fig. 3 ranges from <0.01 mg/l to 10.07 mg/l. The highest concentration (10.07 mg/l) occurred at Akyempim in a well. The second highest concentration was 5.09 mg/l, and this was recorded at Mile 8 in a bore hole; followed by New Atuabo which recorded a concentration of 4.78 mg/l also in a well. Concentrations less than 0.01 mg/l being the lowest occurred at Akoon, Mile 7, and New Atuabo, all in bore holes. This suggests that bore holes at these stations are quite safe for consumption. The disparity in mercury concentration between the well and the bore hole sampled at New Atuabo may be attributed to changes in groundwater flow and geological factors. The well is much shallower and is likely to receive contaminated water emanating from disturbances caused to the rock matrix through mining activities, especially galamsey operations.

Six stations including Akoon out of the fifteen, have cadmium concentrations below the detection limit (<0.01 mg/l), suggesting that cadmium is either completely absent in the samples or the concentrations are extremely low. The highest concentration was 0.55 mg/l recorded at Mile 10<sup>1</sup>/<sub>2</sub> while the least recorded concentration was 0.11 mg/l, occurring concurrently at Mile 7, New Atuabo, and Bonsaso (*Fig 3*). The WHO guideline value for cadmium in drinking water is 0.003 mg/l (WHO, 2006). This means that all the stations where Cd was detected, the concentrations are well above the WHO recommended value.

Laboratory analysis for lead in the 15 samples including Akoon taken from various locations within the study area was very low (*Fig 3*). Not a single station had Pb concentrations equal to or above 0.01 mg/l which is the WHO guideline value, and of
