# The degradation of the banks of the river Nakanbé (Burkina Faso) facing to climate change : a participatory approach for reforestation as a sustainable solution for water resources management

**Keywords:** banks' degradation; reforestation; Water resources management, participatory approach, Nakanbé Basin, Burkina Faso

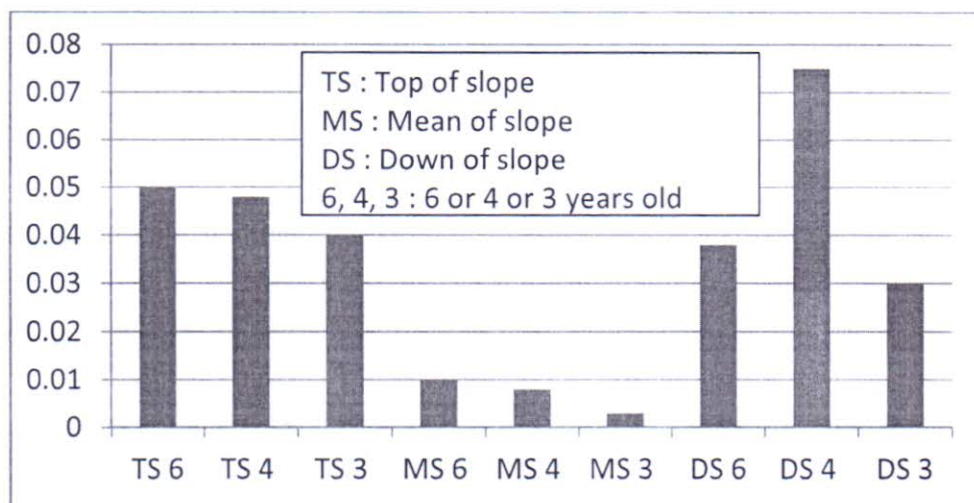
**Figure 2: Ratio of woody species according to the oldness of reforested banks**

The analysis of the number of woody species by age of reforestation (Figure 2) shows, in high and medium slope, the number of plants shows non-significant growth with the age of reforestation ; at the bottom of the slope, the 4-year-old reforested bank has the most significant tree population (0.075 individuals/m<sup>2</sup>).

TS = top of slope; MS = mean of slope and DS= down of slope

The analysis of the number of woody species by age of reforestation (Figure 2) show, in high and medium slope, non-significant growth with the age of reforestation ; at the bottom of the slope, the 4-year-old reforested bank have the most significant tree population (0.075 individuals/m<sup>2</sup>).

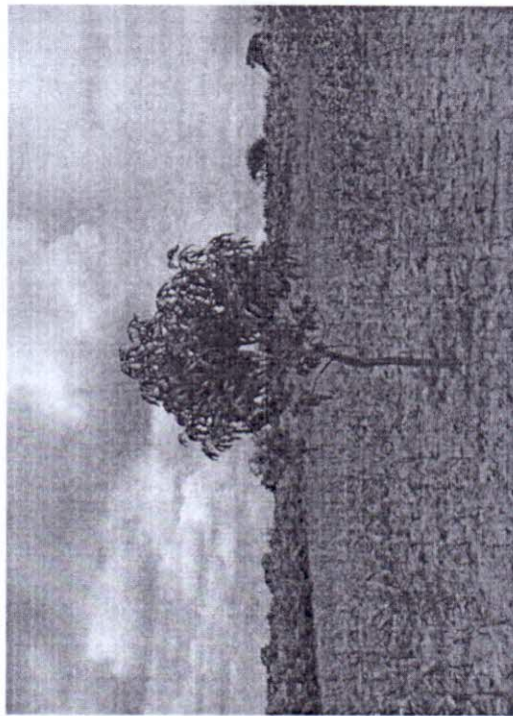
Photo 1: Area destroyed by the 2007 flood, 4 years after

The small number observed on medium slope of the banks of 4 years (picture 1, appendix) is due to the 2007 flood which destroyed almost all the plants planted in 2006 (picture 2, appendix). This flooding could also be the cause of the growth retardation observed in the plants of the 6-year-old reforested banks compared to those of the 4-year-old reforested banks. Indeed, excess water creates anaerobic conditions that alter the root metabolic functions, and can lead to poisoning and cause deterioration of the physical properties of the soil and make them more vulnerable to degradation. The oxygen required for root respiration circulates in the interstices of the ground. In case of flood, water occupies all these pores and the roots are placed in an asphyxic environment, which inhibits their growth. Plants can survive short periods of anaerobic condition (up to 0.5% oxygen). Roots require 6-8% oxygen to grow normally. Under these values the leaves become chlorotic, the growth is interrupted, the formation of new roots stops, the stems become dry and the plant dies. Flooding can also reduce sweating by almost 90%, limiting the absorption of water and nutrients and reducing photosynthesis. These anaerobic conditions at the soil level are combined during insufficient drainage of heavy soils during heavy rains and flooding [13].

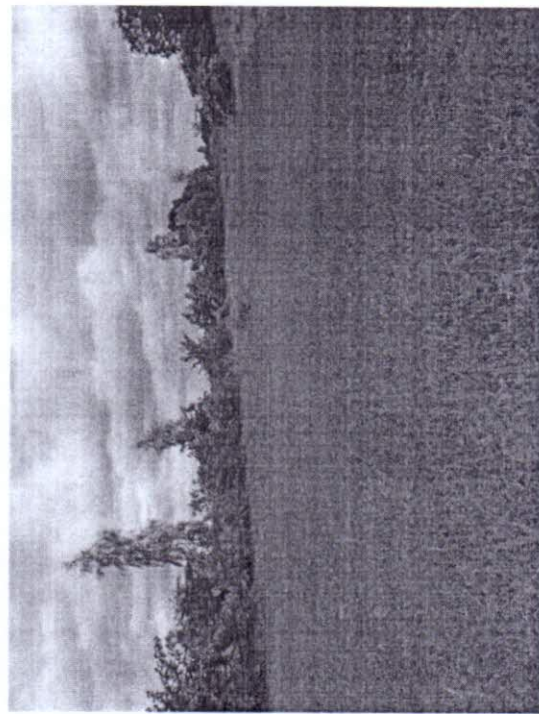
Photo 3: Average slope of banks of 3 years old

The mean slopes of the reforested 3-year-old banks are a fallow not replanted by lack of mango trees (Picture 3, appendix), hence the number of plants very low compared to other parts of the banks.
