**Environmental laws in Nigeria and occurrence of some geohazards: a review**

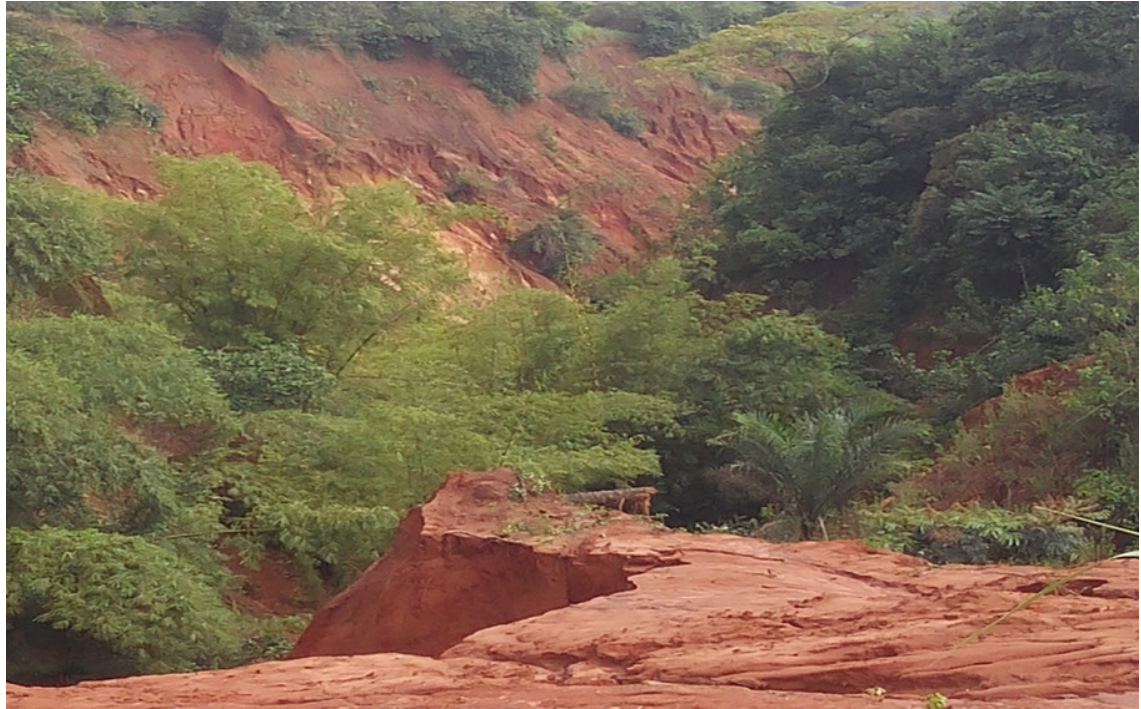
*Plate 1: Severe gully site, Umueshi, Imo State, Nigeria*

functional drainage systems, which causes runoff to wash off roads, as contributors to accelerated erosion in south-eastern Nigeria. Many communities in southern Nigeria have suffered untold hardships as a result of severe gullying, loss of farmlands as shown in Plate 1, river silting, displacement of communities, threat to vegetation, property loss and effect on lives. Abdulfatai et al (2014) documented some hazards associated with gully erosion in southern Nigeria. They stated that millions of people have been displaced and evacuated their homes following gully incidences, in Oko community of Anambra State, gully erosion has created a deep and wide crater, threatening to sweep away the homes of about 826 families. The authors added that 10 houses were lost in a single event of gully erosion in Auch area of Edo State and over 450 buildings have been lost in Edo State of Nigeria as a result of erosion. They further reported that about 23 lives have been lost in the past few years in a single event of gullying activities in Ibori, Ugbalo, Ewu-Eguare, Idogalo and Oludide communities of Edo State, Nigeria.

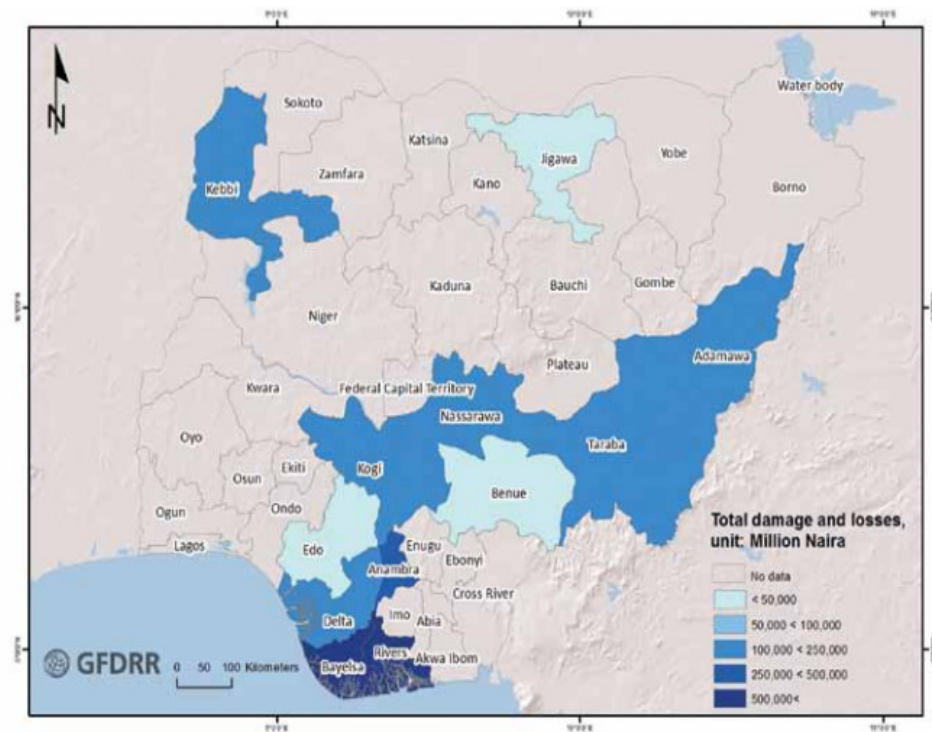
Figure 2. Most affected states by the 2012 flooding. Source; NIGERIA Post-Disaster Needs Assessment 2012 Floods, 2013

dams. In some cases, the dams were damaged; in others, water had to be released at full force to avert an overflow. 363 people were killed, 5,851 injured, 3,891,314 affected, and 3, 871, 53 displaced due to the resulting floods (Oluwaseyi, 2017), effects of the 2012 flooding in Nigeria are shown in Figure 2 and Plates2 and 3. Apart from the 2012 flooding event which has already been highlighted, some other flood events in Nigeria are presented in Table 1. Extreme rainfall is a natural climatic factor capable of causing flooding, however, studies have also implicated some human factors such as dumpsites within river channels and structural development within floodplains (Emeribeole, 2015) as causes of flooding in Nigeria.

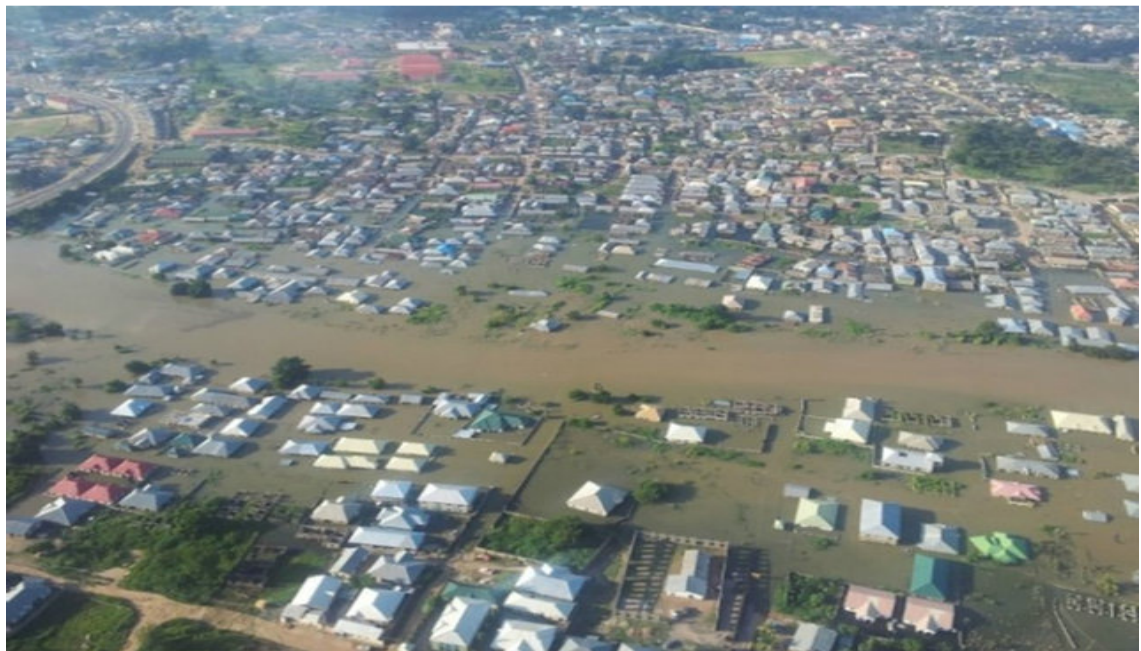
Plate 2. Submerged houses along Niger River in Lokoja, source; Nkeki et al, 2013

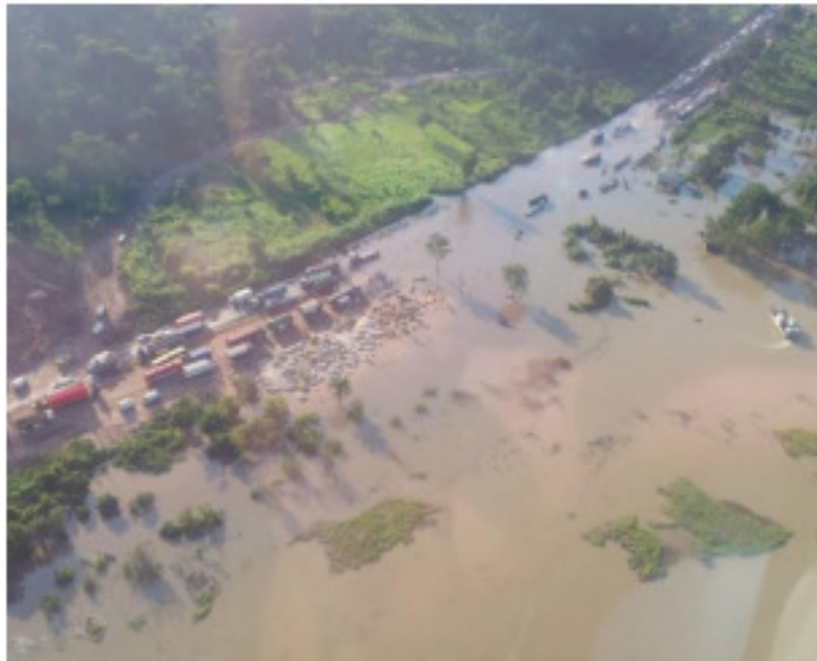
Plate 3. Severed major transportation route (Lokoja-Abuja) in Lokoja left travelers stranded, source; Nkeki et al, 2013
