Effect of Waste Tyre-Rubber Aggregate on the Strength Properties of Concrete

Original Research Article

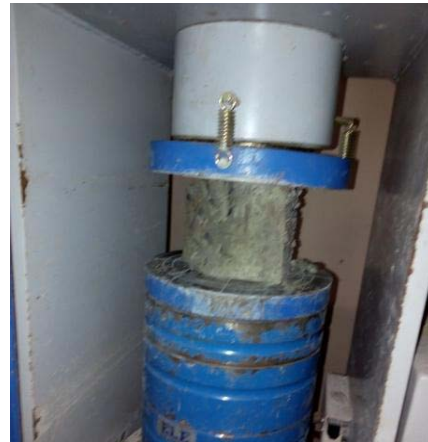
Fig. 1. Compressive strength test of concrete cube

The compressive strengths of concrete specimens were determined after 7, 14 and 28 days of standard curing, respectively.

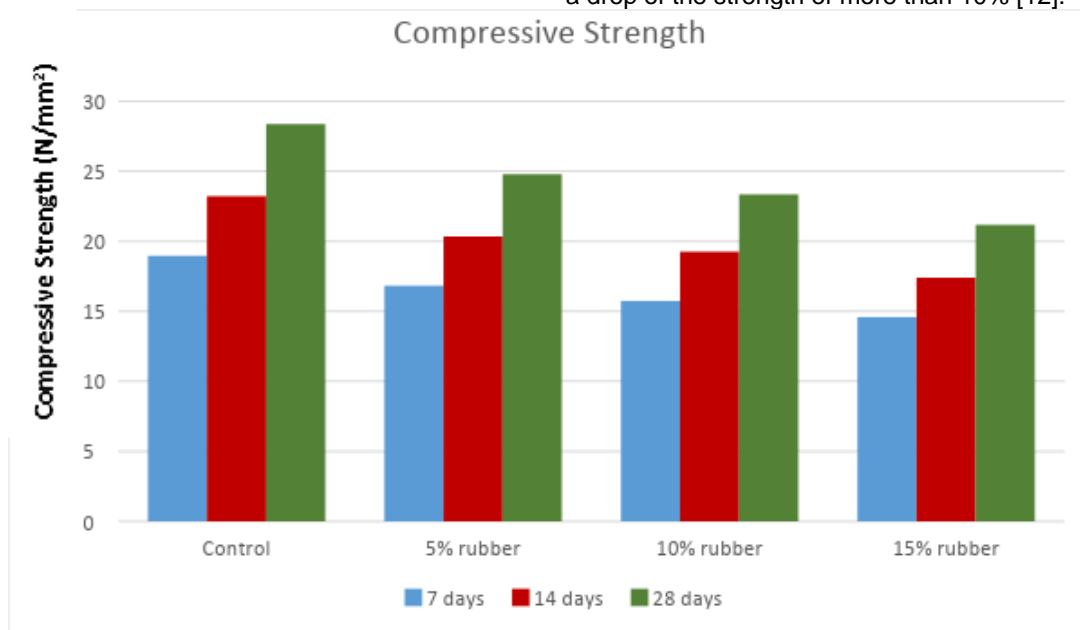
Fig. 2. Graph combining the compressive strengths of concrete cubes cured for 7, 14 and 28 days, respectively

Losses in compressive strength of 11.38%, 17.02% and 23.23% were observed when 5%, 10% and 15%, respectively, of the coarse aggregate, was replaced by an equivalent volume of rubber aggregate, after curing for 7 days. The observed losses of strength when the concrete cubes were cured for 14 days were 12.36%, 16.98% and 25.03% for 5%, 10% and 15% replacement of coarse aggregate with rubber, respectively. For rubberised concrete cured for 28 days, losses of 12.69, 17.75 and 25.33% were noticed for 5%, 10%, 15% replacement of coarse aggregate with rubber, respectively. Table 3 gives details of the compressive strengths of the control concrete and the rubberised concrete. A graphical presentation of these results is shown in Fig. 2.

Rubber has a very low modulus of elasticity (about 7MPa) and a Poisson's ratio of 0.5 [7]. Therefore, rubber aggregates tend to behave like weak inclusions or voids in the concrete, resulting in a reduction in compressive strength. It is well known that the presence of voids in concrete greatly reduces its strength. The existence of 5% of voids can lower strength by as much as 30% and even 2% voids can result in a drop of the strength of more than 10% [12].

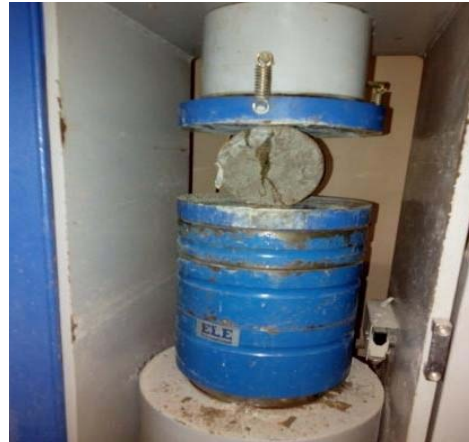
Fig. 3. Split-Tensile testing of concrete cylinder

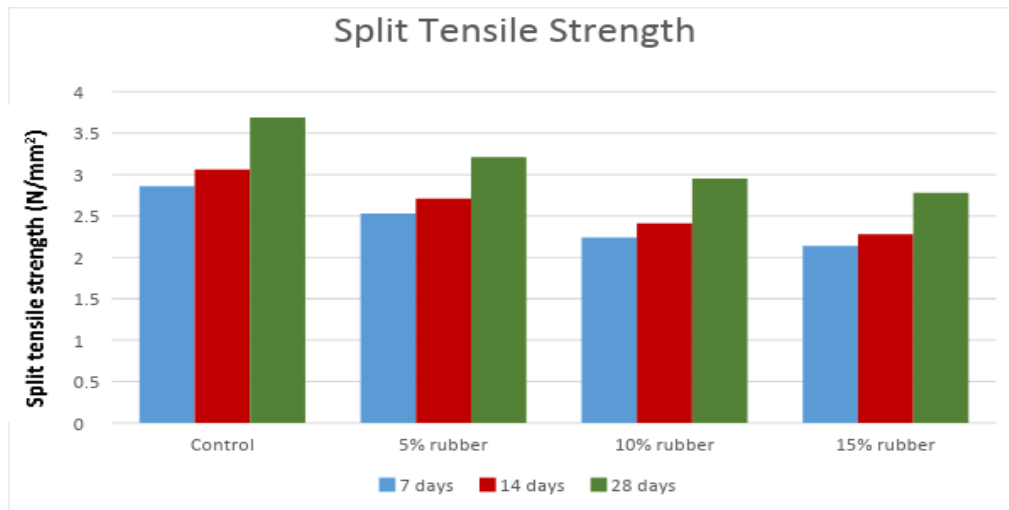
Fig. 4. Comparisons of split-tensile strength test results after 7, 14 and 28 days of cure

Losses of up to 11.54%, 21.68% and 25.17% were observed, respectively, when 5%, 10%, and 15% of the coarse aggregate was replaced by rubber after 7 days of curing.

The observed losses of strength when 5%, 10% and 15 % of coarse aggregate was replaced by rubber aggregate and cured for a period of 14 days were 11.59%, 21.35% and 25.47 %, respectively.

Likewise, for rubberised concrete containing 5%, 10% and 15 % by volume of rubber aggregate cured for 28 days, losses of 13.01%, 20.12%, and 24.76% were observed, respectively. Table 4 gives details of the split-tensile strengths of the control concrete and the rubberised concrete and Fig.4 shows a graphical presentation of the results.

One of the reasons that splitting tensile strength of the rubberised concrete is lower than the conventional concrete is that bond strength between cement paste and rubber tyre particles is poor. Besides, pore structures in rubberised concrete are much more than traditional concrete [8].

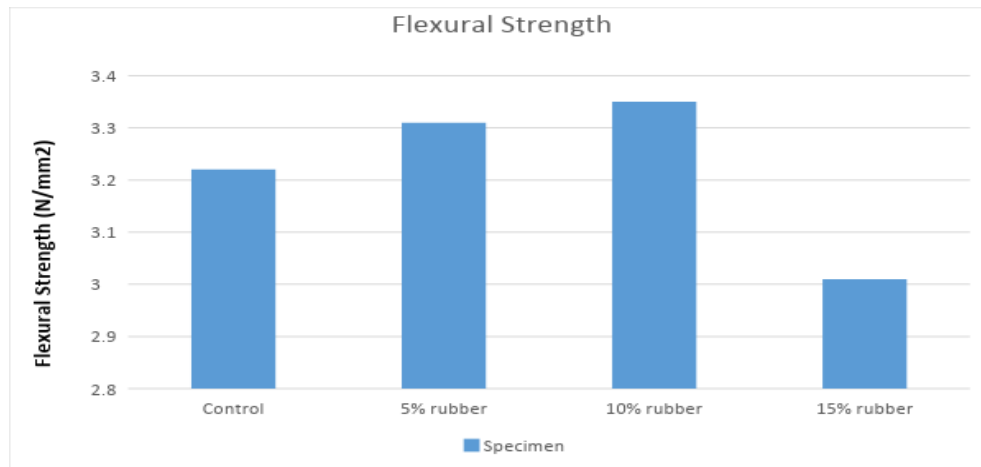
Fig. 5. Comparisons of flexural strength test results after 28 days of cure

The results show that the flexural strength increased, compared to the control mix, for rubber aggregate content of 5% and 10%. For rubber aggregate content of 15%, a flexural strength reduction was observed as compared to the control mix. This indicates that improvements in flexural strength are limited to a relatively small

rubber aggregate content. The details are given in Table 5 and presented graphically in Fig. 5.
